Site Accessibility Evaluation

Frytown Shed

1895 Angle Rd SW Kalona, IA 52247

Inspection Date: 04/24/2019
Inspector: Shelley Zuniga

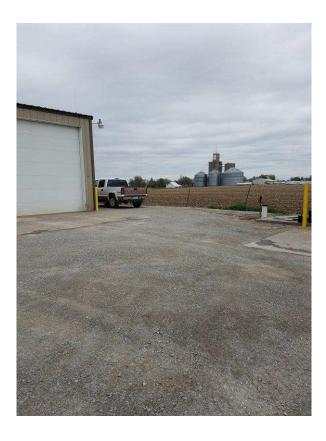
Finding: 1

There are no accessible parking stalls.

There are an unknown number of parking stalls in the parking lot that could be reasonably associated with this facility. There should be a minimum of one accessible stall with a minimum of one being designed as van accessible.

2010 ADAS Section: 208.2 gravel lot with no designated spaces

Create one or more 8' accessible parking stalls, with one 5' adjacent access aisle, with proper signage and striping based on the total number of stalls

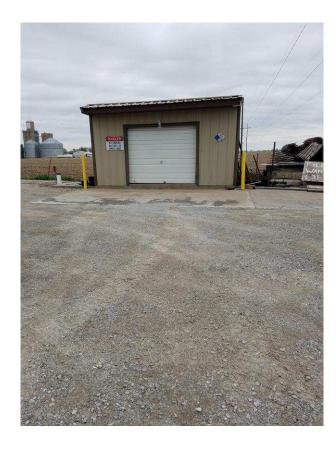
Finding: 2

There is no accessible route between the buildings.

2010 ADAS Section: 206.2.2 Gravel route

Create AR with crushed and compacted stone or similar outdoor material from building to building within the site

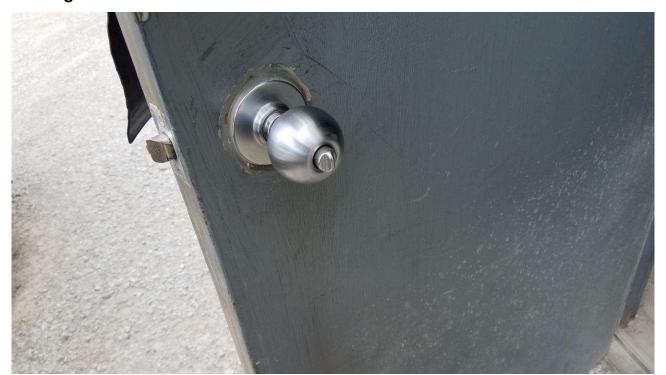
Finding #3 Continued

The threshold has a vertical change greater than 1/4 inch high.

entry- gravel surface pull side, 11#, closes fast, knob, lipped threshold, 1" CIL

For all doors along the public circulation route, provide required maneuvering clearance on push and pull side of doors

For all doors along the public circulation route, repair, bevel, or ramp CILs at door entries to max .25"

For all doors along the public circulation route, repair, provide beveled threshold

For all doors along the public circulation route, inspect, adjust, and maintain closing speed on door closers

For all doors along the public circulation route, inspect, adjust, and maintain 8.5 lbf to open exterior doors as a smart practice

For all doors along the public circulation route, replace hardware with lever hardware or hardware operable without a tight pinch or grasp

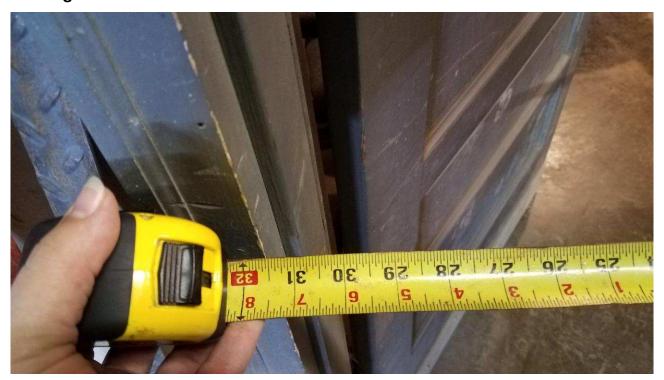
Finding #4 Continued

2010 ADAS Section: 404.2.3, 404.2.7, 404.2.4, break room- cabinet 404.2.11, 404.2.11 Exception pull side, knob, 29"

wide

For all doors along the public circulation route, provide required maneuvering clearance on push and pull side of doors

For all doors along the public circulation route, replace doors with doors having 80" overhead clearance and 32" clear width

For all doors along the public circulation route, replace hardware with lever hardware or hardware operable without a tight pinch or grasp

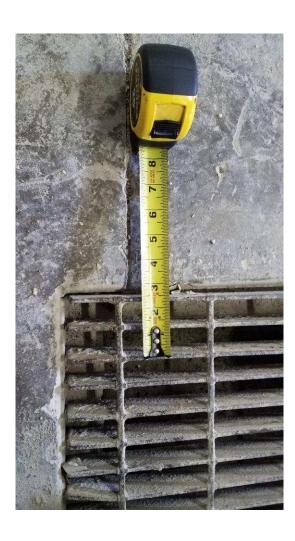
Finding: 5

Gratings are spaced greater than a 1/2 inches in the direction of traffic flow.

2010 ADAS Section: 302.3 1" grates in bays

Replace grate with one having max openings of 1/2 inch.

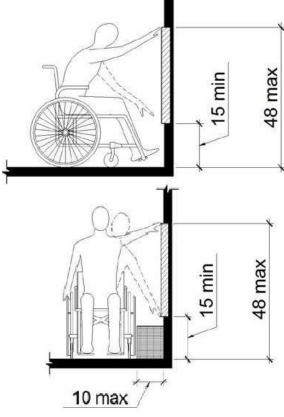
Finding: 6

The door conrol is positioned too high for either a side or front approach.

2010 ADAS Section: 308.1 overhead door

controls high in bays

For deficit, leave as is, employee work area pursuant to 2010 Standards 106.5 Defined Terms, until an employee with a disability works here

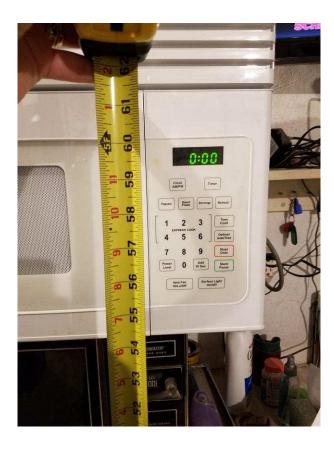
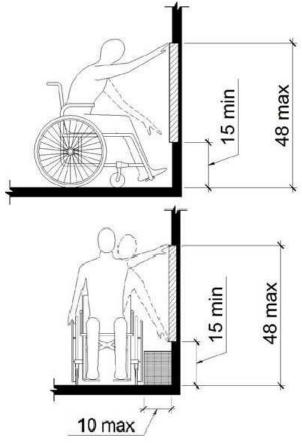
Finding: 9

The microwave is positioned too high for either a side or front approach.

2010 ADAS Section: 308.1 59" to microwave in break room

Remount operable parts to be in reach range of 15" min to 48" max

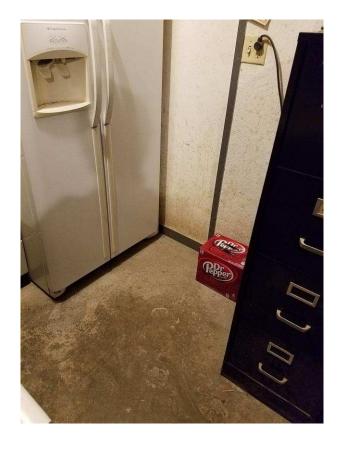
Finding: 10

The operable part is not accessible because there is not adequate clear floor space for either a forward or side approach.

2010 ADAS Section: 305.3 fridge in break room lacks, AC unit lacks

Remove, or relocate storage in CFS at fixtures and operable parts along the AR

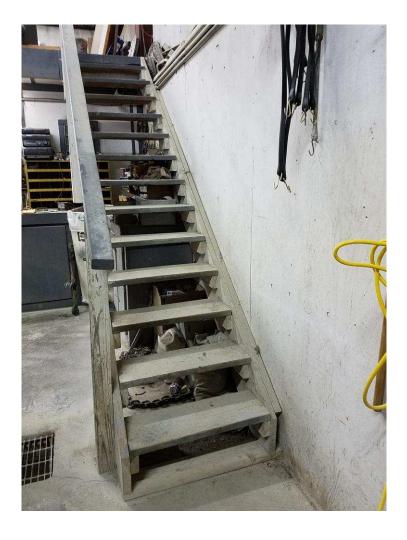
Finding: 11

There is no accessible route between the main floor and the mezzanine

2010 ADAS Section: 206.2.4 stairs to mezzanine

No AR to upper level employee area, leave as is, and reassign duties if an employee with disabilities requires access here

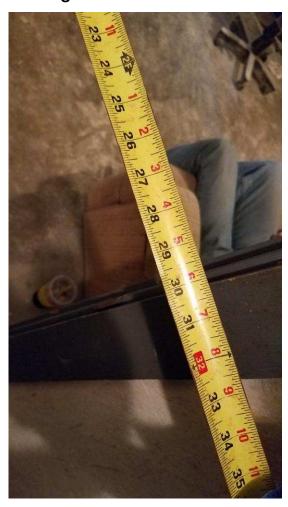
Finding #12 Continued

2010 ADAS Section: 404.2.3, 404.2.7, 404.2.4, restroom- 30" wide,

404.2.11, 404.2.11 Exception knob, cabinet pull side

For all doors along the public circulation route, provide required maneuvering clearance on push and pull side of doors

For all doors along the public circulation route, replace doors with doors having 80" overhead clearance and 32" clear width

For all doors along the public circulation route, replace hardware with lever hardware or hardware operable without a tight pinch or grasp

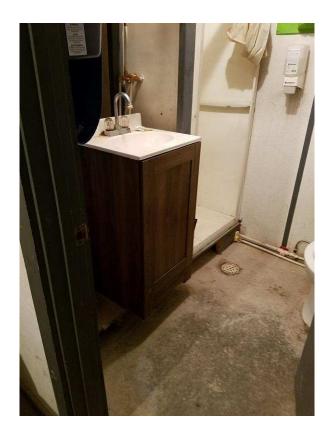
Finding: 13

The restroom is not nearly compliant.

The restroom does not have the required minimum clear floor space or maneuvering clearances for the toilet, The restroom does not have the required minimum clear floor space or maneuvering clearances for the lavatory, The entry door does not contain the required minimum maneuvering spaces on the pull/push sides, The entry door encroach into the required clear floor space for fixtures, Grab bars are missing and/or incorrectly installed, Accessories, such as toilet seat covers, paper towel holders, garbage cans, hand dryers, and mirrors are either too high or without clear floor space or both, The restroom contain floor level changes greater than a 1/2 inch of the floor drains and is slope (XX) - (XX), the shower is too small and missing numerous accessible elements.

2010 ADAS Section: 603.1 restroom lacks accessible features

Create a compliant wheelchair accessible restroom and correct all features to be accessible
