Site Accessibility Evaluation

719 S Capitol St

ADA Only

Inspection Date: 11/30/2018
Inspector: Shelley Zuniga

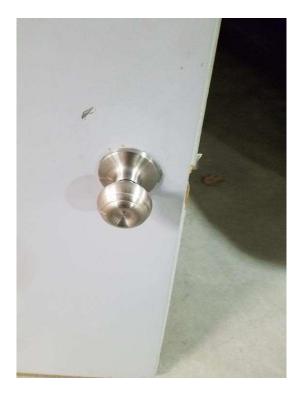
Finding: 1

Minimum maneuvering clearances at doors and gates shall comply with 404.2.4. Maneuvering clearances shall extend the full width of the doorway and the required latch side or hinge side clearance.

Hand-activated door opening hardware, handles, pulls, latches, locks, and other operating devices on accessible doors shall have a shape that is easy to grasp with one hand and does not require tight grasping, tight pinching or twisting of the wrist to operate. Hardware shall be 34 inches minimum and 48 inches maximum above the finish floor or ground.

2010 ADAS Section: 404.2.3, 404.2.7, 404.2.4, Kitchen - knob, 1" CIL

For all doors along the public circulation route, provide required maneuvering clearance on push and pull side of doors; bevel CIL at door

Replace hardware with lever hardware or hardware operable without a tight pinch or grasp

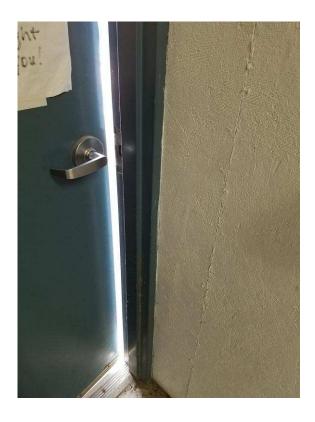
Finding: 2

Minimum maneuvering clearances at doors and gates shall comply with 404.2.4. Maneuvering clearances shall extend the full width of the doorway and the required latch side or hinge side clearance.

Exterior doors are recommended to be maintained at 8.5 lbf as a smart practice. Force is to be measured at the operating hardware or 30 inches from the hinges, whichever is greater.

2010 ADAS Section: 404.2.3, 404.2.7, 404.2.4, Kitchen exit - wall in 404.2.11, 404.2.11 Exception push, 9.7% slope ext,

For all doors along the public circulation route, provide required maneuvering clearance on push and pull side of doors; correct slope in doorway clearance to max 2.08%

For all doors along the public circulation route, inspect, adjust, and maintain 8.5 lbf to open exterior doors as a smart practice

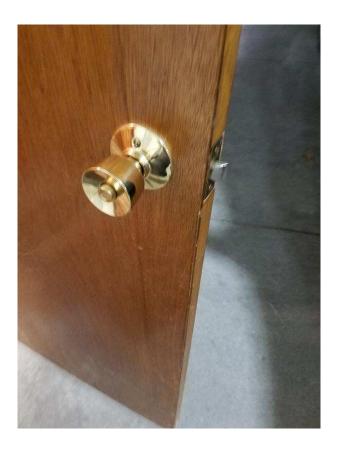
Finding: 3

The door operating hardware is not accessible.

Hand-activated door opening hardware, handles, pulls, latches, locks, and other operating devices on accessible doors shall have a shape that is easy to grasp with one hand and does not require tight grasping, tight pinching or twisting of the wrist to operate. Hardware shall be 34 inches minimum and 48 inches maximum above the finish floor or ground.

2010 ADAS Section: 404.2.7 W RR - knob

Replace hardware with lever hardware or hardware operable without a tight pinch or grasp

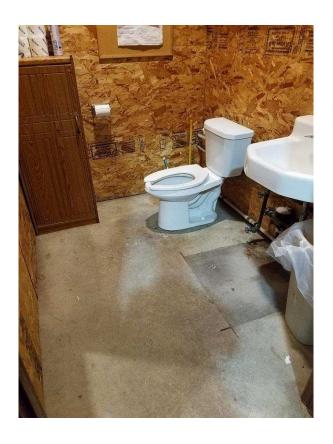
Finding: 4

The restroom is not nearly compliant.

The restroom does not have the required minimum clear floor space or maneuvering clearances for the toilet, The restroom does not have the required minimum clear floor space or maneuvering clearances for the lavatory, The entry door does not contain the required minimum maneuvering spaces on the pull/push sides, The entry door encroach into the required clear floor space for fixtures, Grab bars are missing and/or incorrectly installed, Accessories, such as toilet seat covers, paper towel holders, garbage cans, hand dryers, and mirrors are either too high or without clear floor space or both, The restroom contain floor level changes greater than a 1/2 inch of the floor drains and is slope (XX) - (XX), the shower is too small and missing numerous accessible elements.

2010 ADAS Section: 603.1 W RR - no accessible features, 64" x 84"

Create a compliant wheelchair accessible restroom and correct all features to be accessible

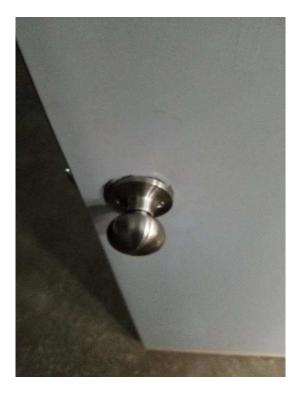
Finding: 5

Minimum maneuvering clearances at doors and gates shall comply with 404.2.4. Maneuvering clearances shall extend the full width of the doorway and the required latch side or hinge side clearance

Hand-activated door opening hardware, handles, pulls, latches, locks, and other operating devices on accessible doors shall have a shape that is easy to grasp with one hand and does not require tight grasping, tight pinching or twisting of the wrist to operate. Hardware shall be 34 inches minimum and 48 inches maximum above the finish floor or ground.

2010 ADAS Section: 404.2.3, 404.2.7, 404.2.4, Lounge - knob, 1" CIL

For all doors along the public circulation route, provide required maneuvering clearance on push and pull side of doors; bevel CIL at doorway.

Replace hardware with lever hardware or hardware operable without a tight pinch or grasp

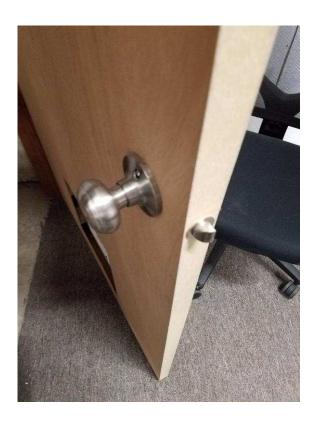
Finding: 6

Minimum maneuvering clearances at doors and gates shall comply with 404.2.4. Maneuvering clearances shall extend the full width of the doorway and the required latch side or hinge side clearance.

Hand-activated door opening hardware, handles, pulls, latches, locks, and other operating devices on accessible doors shall have a shape that is easy to grasp with one hand and does not require tight grasping, tight pinching or twisting of the wrist to operate. Hardware shall be 34 inches minimum and 48 inches maximum above the finish floor or ground.

2010 ADAS Section: 404.2.3, 404.2.7, 404.2.4, Furnace off lounge - 404.2.11, 404.2.11 Exception knob, no entry

Replace hardware with lever hardware or hardware operable without a tight pinch or grasp

Leave as is lack of maneuvering clearance, closet

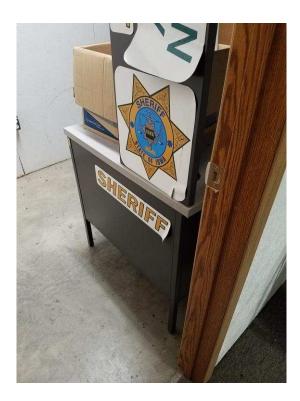
Finding: 7

Minimum maneuvering clearances at doors and gates shall comply with 404.2.4. Maneuvering clearances shall extend the full width of the doorway and the required latch side or hinge side clearance.

Hand-activated door opening hardware, handles, pulls, latches, locks, and other operating devices on accessible doors shall have a shape that is easy to grasp with one hand and does not require tight grasping, tight pinching or twisting of the wrist to operate. Hardware shall be 34 inches minimum and 48 inches maximum above the finish floor or ground.

2010 ADAS Section: 404.2.3, 404.2.7, 404.2.4, Hot water closet off 404.2.11, 404.2.11 Exception lounge - storage on

pull, knob

For all doors along the public circulation route, provide required maneuvering clearance on push and pull side of doors

Replace hardware with lever hardware or hardware operable without a tight pinch or grasp

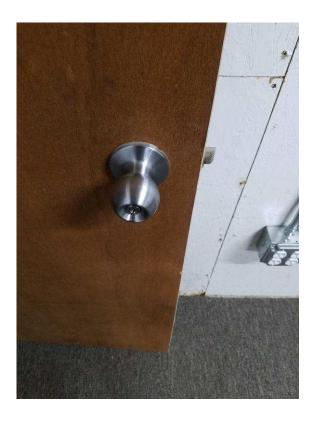
Finding: 8

Minimum maneuvering clearances at doors and gates shall comply with 404.2.4. Maneuvering clearances shall extend the full width of the doorway and the required latch side or hinge side clearance.

Hand-activated door opening hardware, handles, pulls, latches, locks, and other operating devices on accessible doors shall have a shape that is easy to grasp with one hand and does not require tight grasping, tight pinching or twisting of the wrist to operate. Hardware shall be 34 inches minimum and 48 inches maximum above the finish floor or ground.

2010 ADAS Section: 404.2.3, 404.2.7, 404.2.4, Stairwell - stairs on

404.2.11, 404.2.11 Exception push, knob

Leave as is lack of maneuvering clearance due to stairs, infeasible to correct

Replace hardware with lever hardware or hardware operable without a tight pinch or grasp

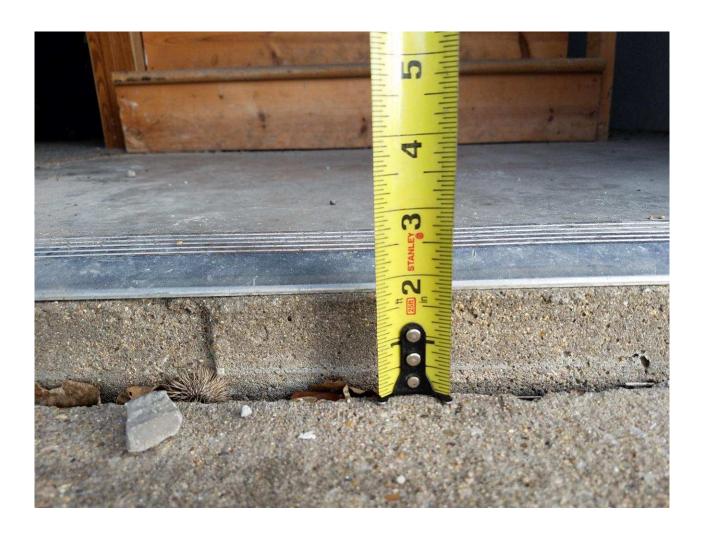
Finding: 9

Minimum maneuvering clearances at doors and gates shall comply with 404.2.4. Maneuvering clearances shall extend the full width of the doorway and the required latch side or hinge side clearance; bevel CIL at door

2010 ADAS Section: 404.2.3, 404.2.7, 404.2.4, Stair exit - 2" CIL,

404.2.11, 404.2.11 Exception small pad

For all doors along the public circulation route, provide required maneuvering clearance on push and pull side of doors

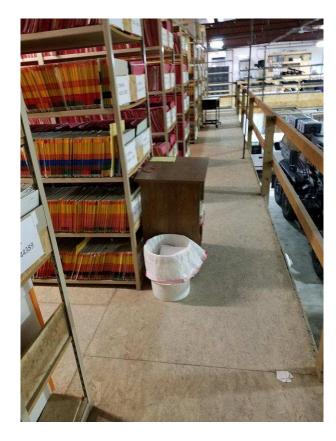
Finding: 10

There is insufficient turning space within this room or space.

The space required for a wheelchair to make a 180-degree turn is a clear space of 60 inches in diameter or a T-shaped space.

2010 ADAS Section: 304.3.1, 304.3.2 mezzanine lacks AR

and turning

For deficit, leave as is, employee work area pursuant to 2010 Standards 106.5 Defined Terms, until an employee with a disability works here

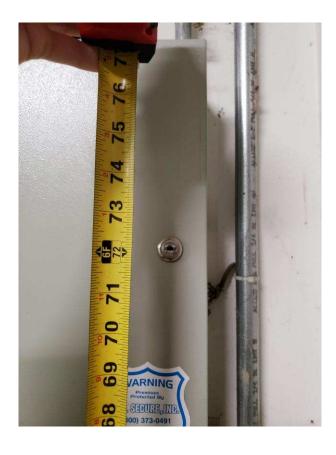
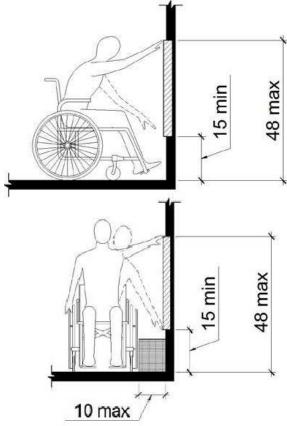
Finding: 11

The keybox is positioned too high for either a side or front approach.

2010 ADAS Section: 308.1 main garage- keybox

72"

For deficit, leave as is, employee work area pursuant to 2010 Standards 106.5 Defined Terms, until an employee with a disability works here

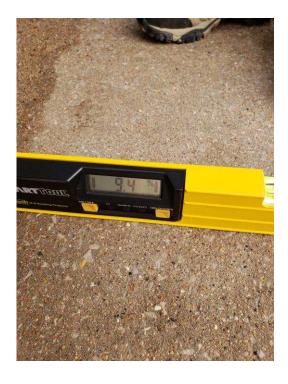
Finding: 12

Minimum maneuvering clearances at doors and gates shall comply with 404.2.4. Maneuvering clearances shall extend the full width of the doorway and the required latch side or hinge side clearance.

Exterior doors are recommended to be maintained at 8.5 lbf as a smart practice. Force is to be measured at the operating hardware or 30 inches from the hinges, whichever is greater.

2010 ADAS Section: 404.2.3, 404.2.7, 404.2.4, entry- 2" CIL, table on 404.2.11, 404.2.11 Exception push, 10#, 9.4% slope

For all doors along the public circulation route, provide required maneuvering clearance on push and pull side of doors; repair CIL and correct slope in maneuvering clearance to max 2.08%

For all doors along the public circulation route, inspect, adjust, and maintain 8.5 lbf to open exterior doors as a smart practice

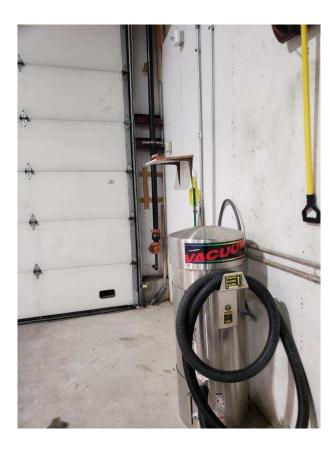
Finding: 13

The shelves project more than 4 inches into the circulation path.

Wall-mounted objects that have leading edges between 27 inches and 80 inches from the floor must not project more than 4 inches into the circulation path. Protruding objects that extend to the floor or within 27 inches of the floor are cane detectable and are therefore not hazardous. Where it is necessary or desirable to have objects protrude from the wall, a manner of cane detection must be provided.

2010 ADAS Section: 307.2 garage- shleves

For deficit, leave as is, employee work area pursuant to 2010 Standards 106.5 Defined Terms, until an employee with a disability works here

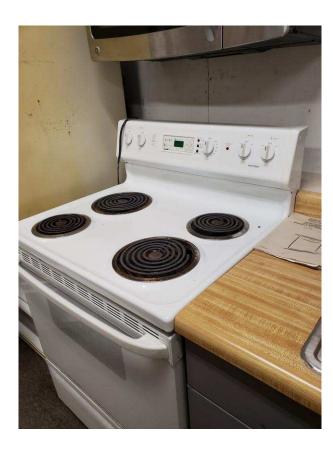
Finding: 14

The controls are located such that operation require reaching across burners.

Where knee and toe space is provided, the underside of the range or cooktop shall be insulated or otherwise configured to prevent burns, abrasions, or electrical shock. The location of controls shall not require reaching across burners

2010 ADAS Section: 804.6.4 kitchen- oven controls on back

panel

Replace oven with one having controls on the front panel

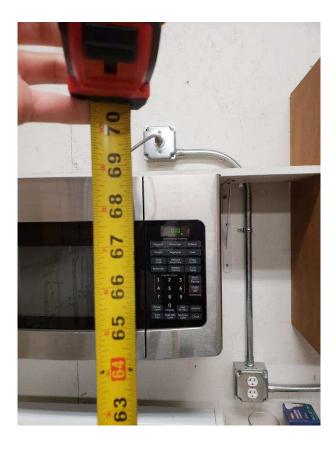
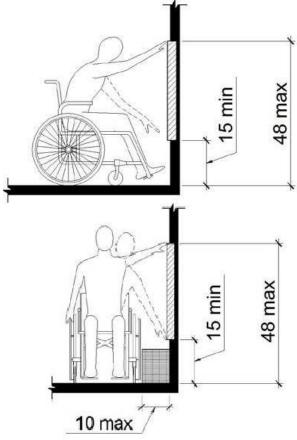
Finding: 15

The microwave is positioned too high for either a side or front approach.

2010 ADAS Section: 308.1 kitchen- 67"

microwave

Remount operable parts to be in reach range of 15" min to 48" max

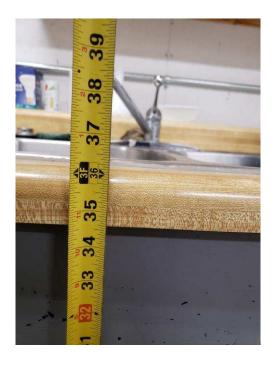
Finding: 16

The sink is not accessible.

A clear floor space at least 30 inches by 48 shall be provided in front of a sink to allow forward approach.

kitchen- 36" rim and lacks knee clearance

Lower sinks to max 34" aff to front of rim

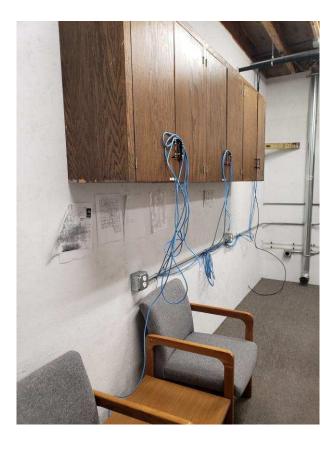
Finding: 17

The cabinets projects more than 4 inches into the circulation path.

Wall-mounted objects that have leading edges between 27 inches and 80 inches from the floor must not project more than 4 inches into the circulation path. Protruding objects that extend to the floor or within 27 inches of the floor are cane detectable and are therefore not hazardous. Where it is necessary or desirable to have objects protrude from the wall, a manner of cane detection must be provided.

2010 ADAS Section: 307.2 kitchen- 2 sets of

cabinets

Relocate protruding objects or place cane detectable warning or bollard at foot of item

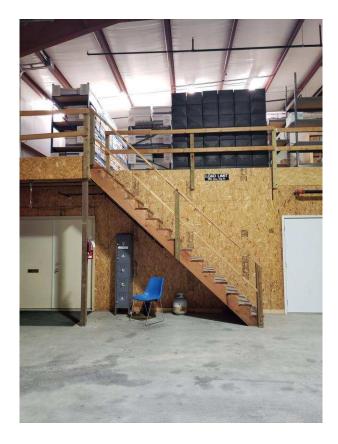
Finding: 18

There is no accessible route to the mezzanine

At least one accessible route shall be provided to accessible facilities, accessible elements, and accessible spaces that are on the same site. The clear width must be a minimum 36 inches.

2010 ADAS Section: 206.2.2 stairs to mezzanine-only access up; stairs

1991 ADAS Section: 4.1.3 to larger mezzanine,

no other route

Stairs only to upper level storage, leave as is, employee area only; reassign duties if an employee with a disability requires access here

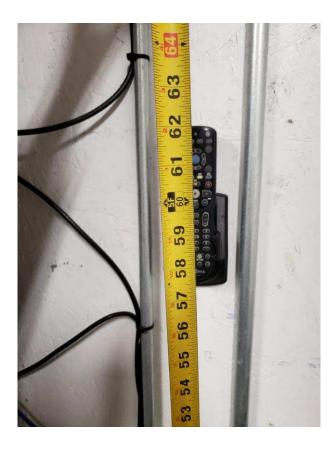
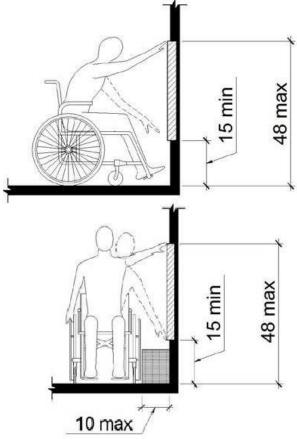
Finding: 19

The TV remote is positioned too high for either a side or front approach.

2010 ADAS Section: 308.1 lounge- tv remote

Remount operable parts to be in reach range of 15" min to 48" max

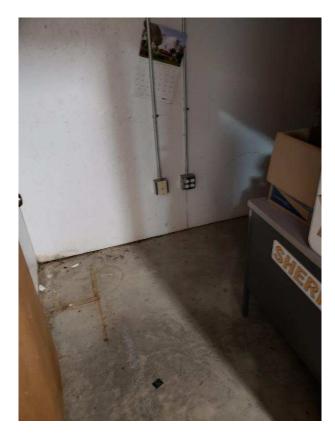
Finding: 20

There is insufficient turning space within this room or space.

2010 ADAS Section: 304.3.1, 304.3.2 storage in lounge-

furniture

For deficit, leave as is, employee work area pursuant to 2010 Standards 106.5 Defined Terms, until an employee with a disability works here

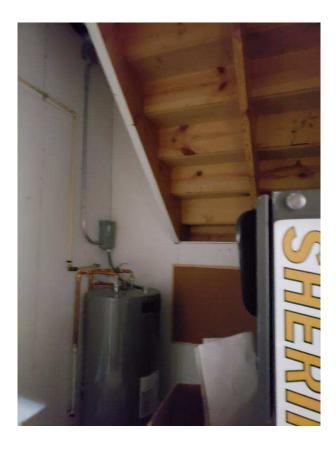
Finding: 21

The stairway extends down too close to the route of travel.

Any obstruction that overhangs a route of travel must be a minimum of 80 inches above the walking surface as measured from the bottom of the obstruction.

2010 ADAS Section: 307.4 storage in lounge-

stairs low

For deficit, leave as is, employee work area pursuant to 2010 Standards 106.5 Defined Terms, until an employee with a disability works here

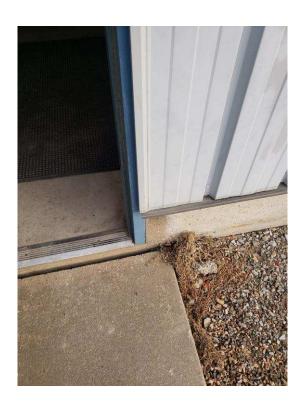
Finding: 22

Minimum maneuvering clearances at doors and gates shall comply with 404.2.4. Maneuvering clearances shall extend the full width of the doorway and the required latch side or hinge side clearance.

Exterior doors are recommended to be maintained at 8.5 lbf as a smart practice. Force is to be measured at the operating hardware or 30 inches from the hinges, whichever is greater.

rear exit by evidence-13#, cement pad ends on pull, cement pad back on pull, 1" gap, 1.75" CIL

For all doors along the public circulation route, provide required maneuvering clearance on push and pull side of doors; enlarge pad for maneuvering clearance

For all doors along the public circulation route, inspect, adjust, and maintain 8.5 lbf to open exterior doors as a smart practice
