Site Accessibility Evaluation

Administration Building

913 S Dubuque St
Iowa City, IA 52240

Inspection Date: 11/27/2018
Inspector: Shelley Zuniga

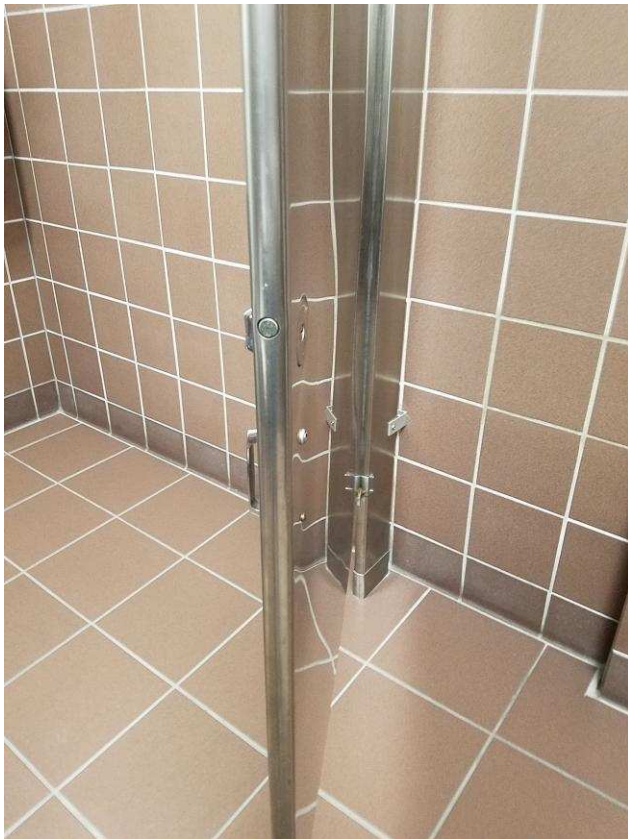
First Floor Men's

fails to self close, no exterior hardware

Adjust stall door to be self-closing and install exterior hardware that is operable without a tight pinch or grasp

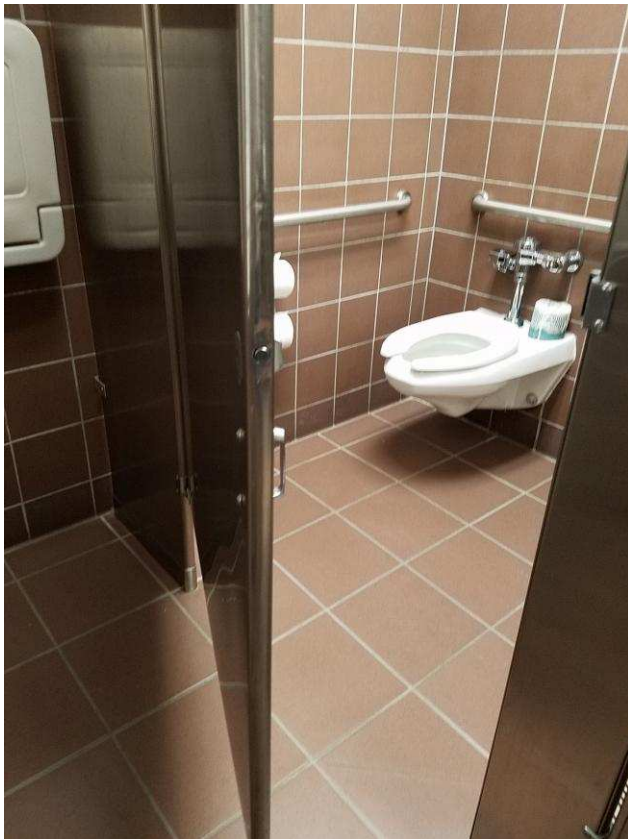
First Floor Women's

fails to self close, no exterior hardware

Adjust stall door to be self-closing and install exterior hardware that is operable without a tight pinch or grasp
