Site Accessibility Evaluation

Johnson County Poor Farm

**4811 Melrose Ave
Iowa City, IA 52246**

*Inspection Date: 10/25/2018
Inspector: Shelley Zuniga*

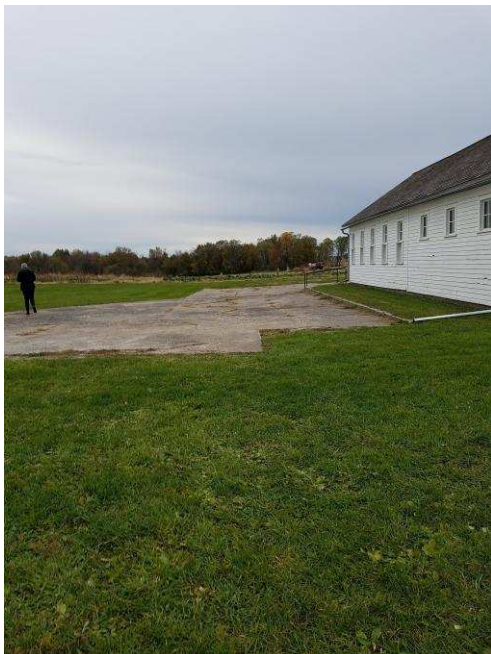
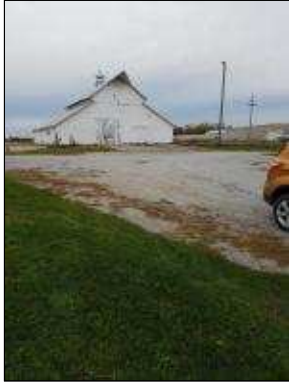
Finding: 1

There are no accessible parking stalls.

There are an unknown number of parking stalls in the parking lot that could be reasonably associated with this facility. There should be a minimum of one accessible stall with a minimum of one being designed as van accessible.

cracked pavement at
asylum building

Create one or more 8' accessible parking stalls, with one 5' adjacent access aisle, with proper signage and striping based on the total number of stalls

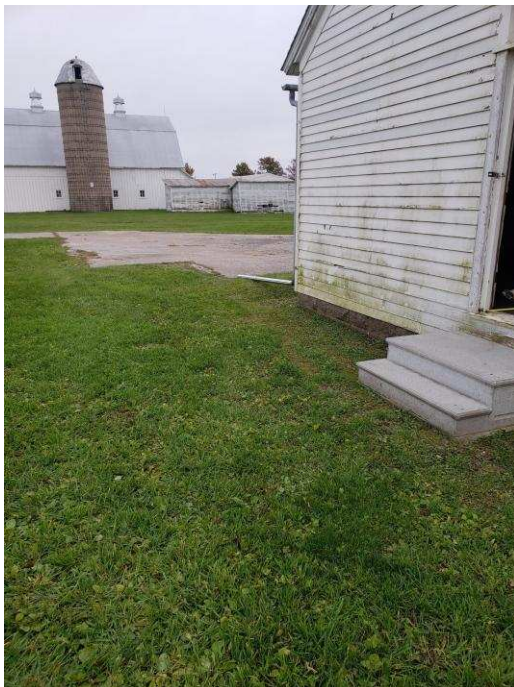
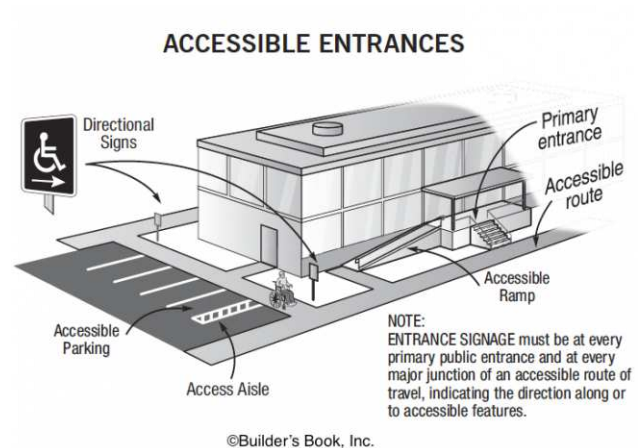
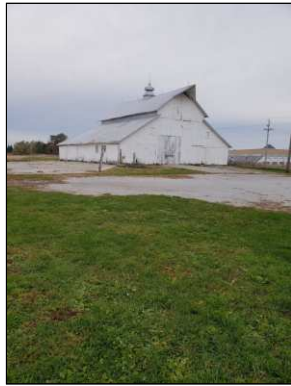
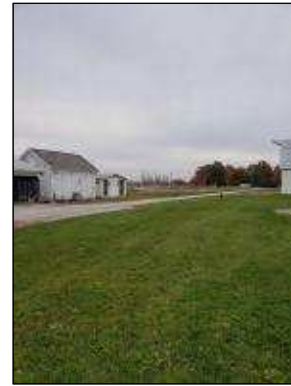
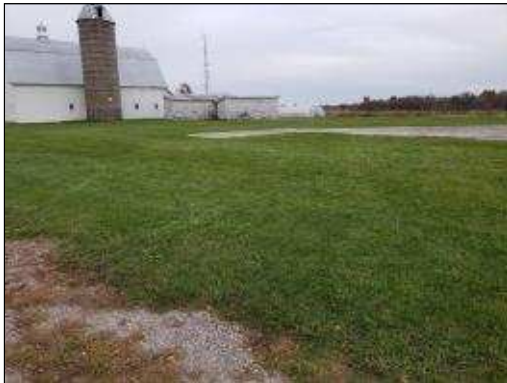
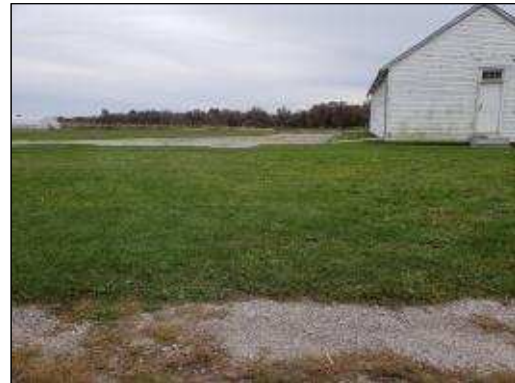
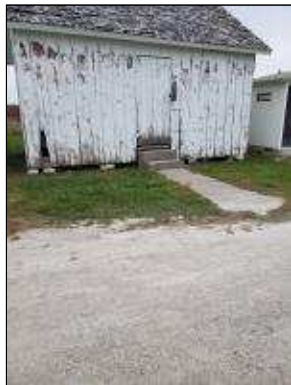
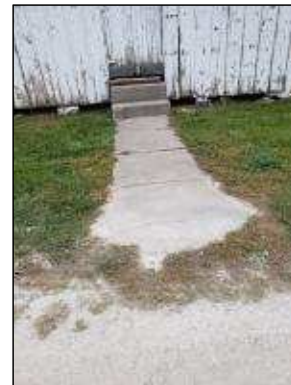
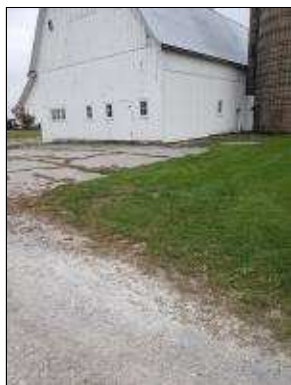
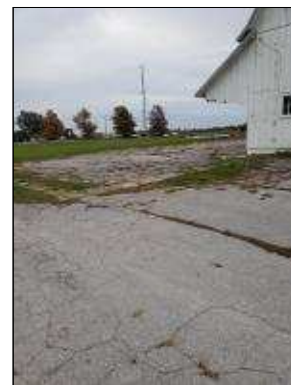
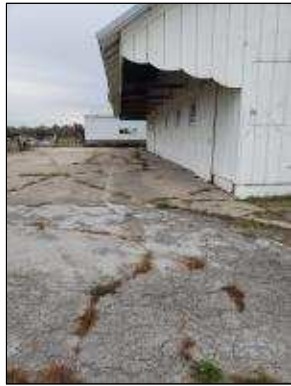
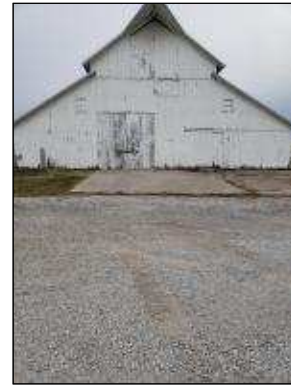
Finding: 2

There is no accessible route between the buildings.

lacks routes from all buildings, grass impedes where small parking area is; CIL, loose gravel, and uneven surfaces leads to all buildings

Create AR with crushed and compacted stone or similar outdoor material from building to building within the site

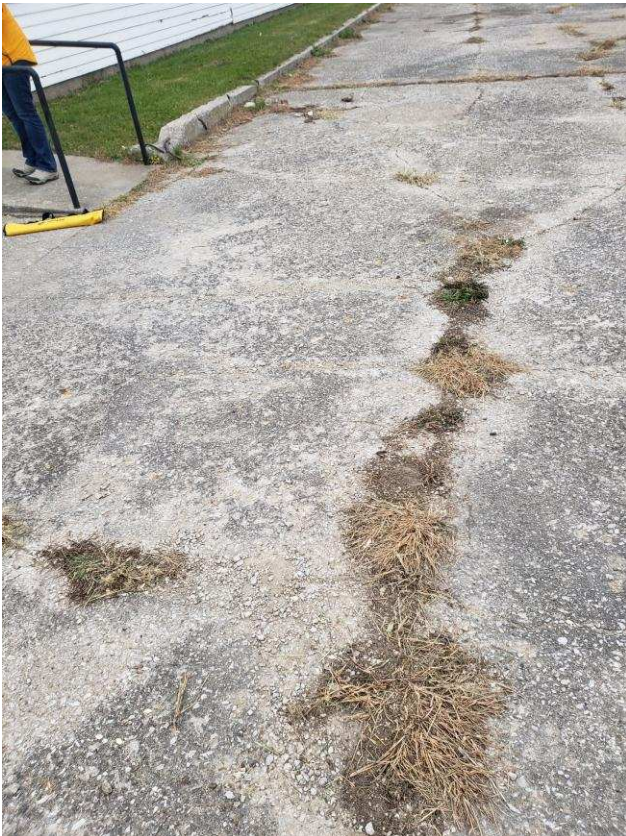
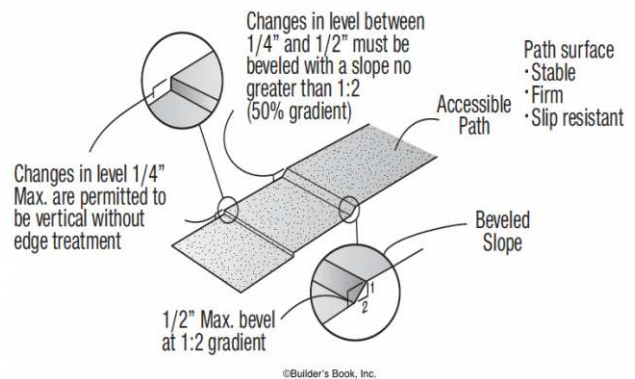
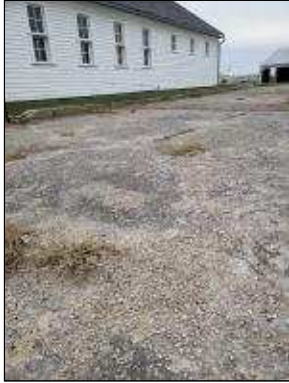
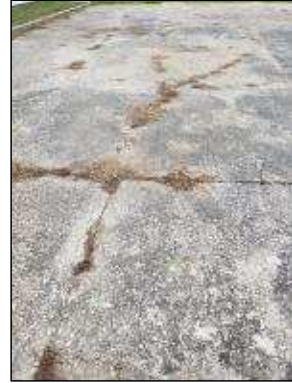
Finding: 3

The accessible route contains loose gravel and/or surfaces that do not provide for a stable, firm slip resistant surface.

asylum parking- old
deteriorated where
people park for entry

Resurface AR where deterioration occurs

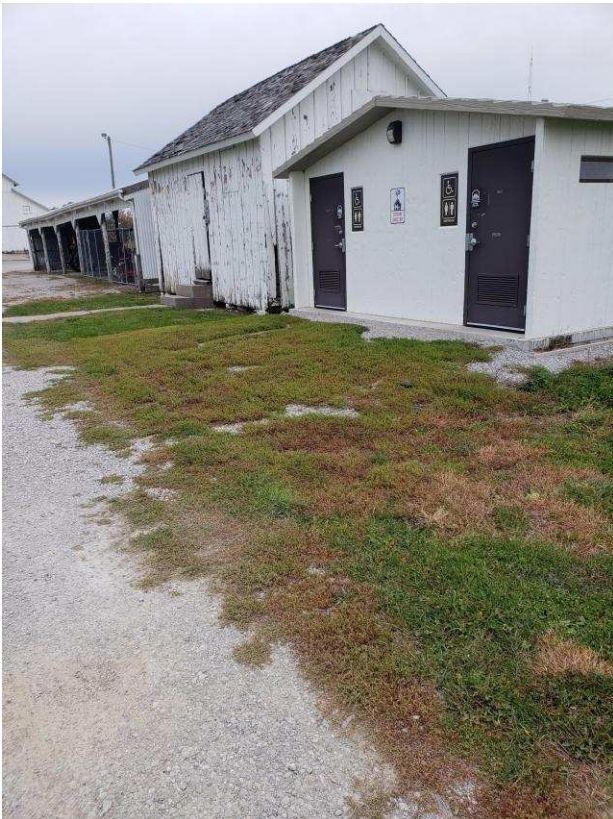
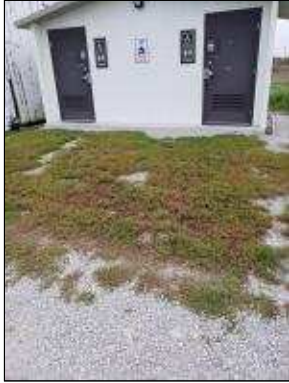
Finding: 4

The public/common use restrooms serving the facility are not on an accessible route.

grass into restrooms

Create AR with crushed and compacted stone or similar outdoor material from building to building within the site

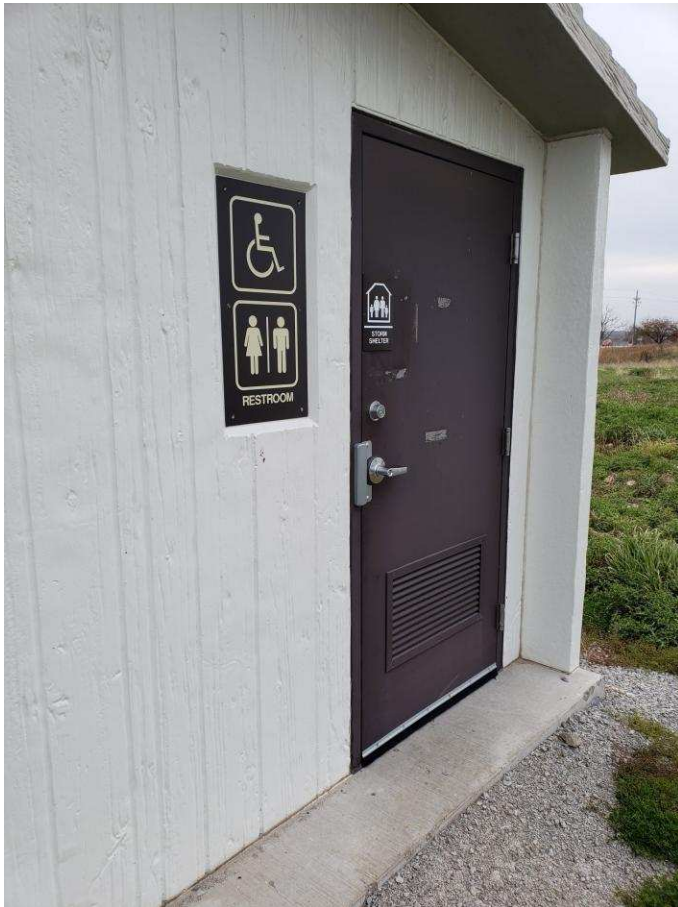
Finding: 5

Element meets all standards and requirements

signage good

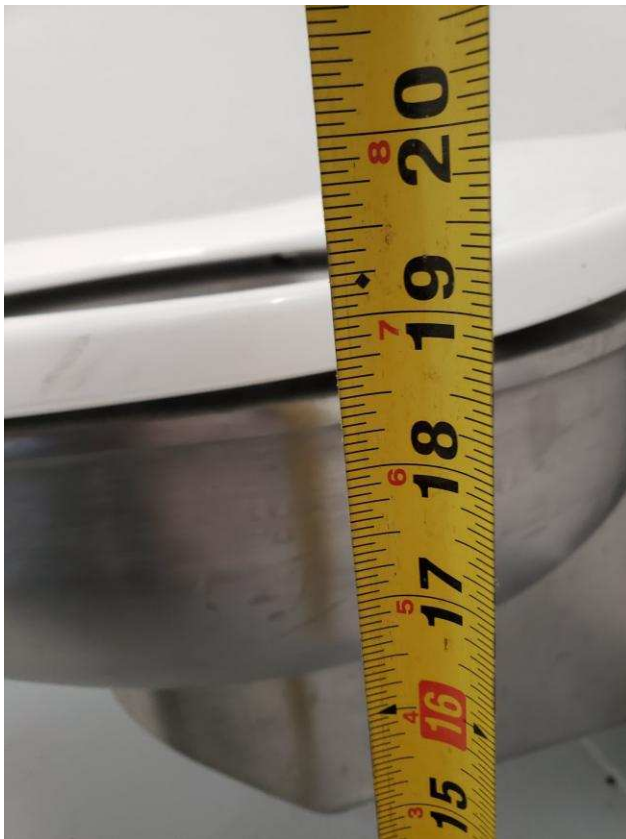
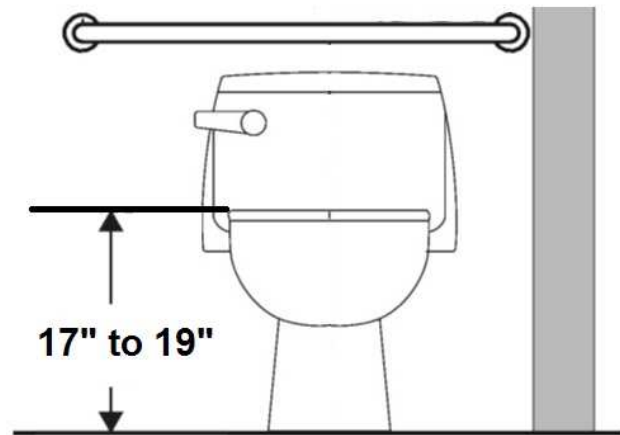
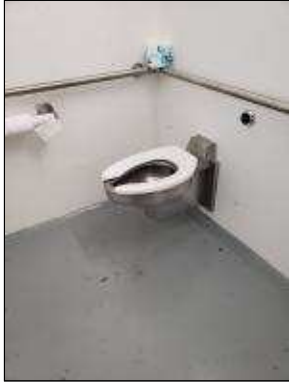
Finding: 8

The toilet seat is not located within the range allowed off the floor.

19" seat height;
centerline and grab
bars compliant

Replace toilet seat, or re-set or replace toilet to 17" to 19" aff

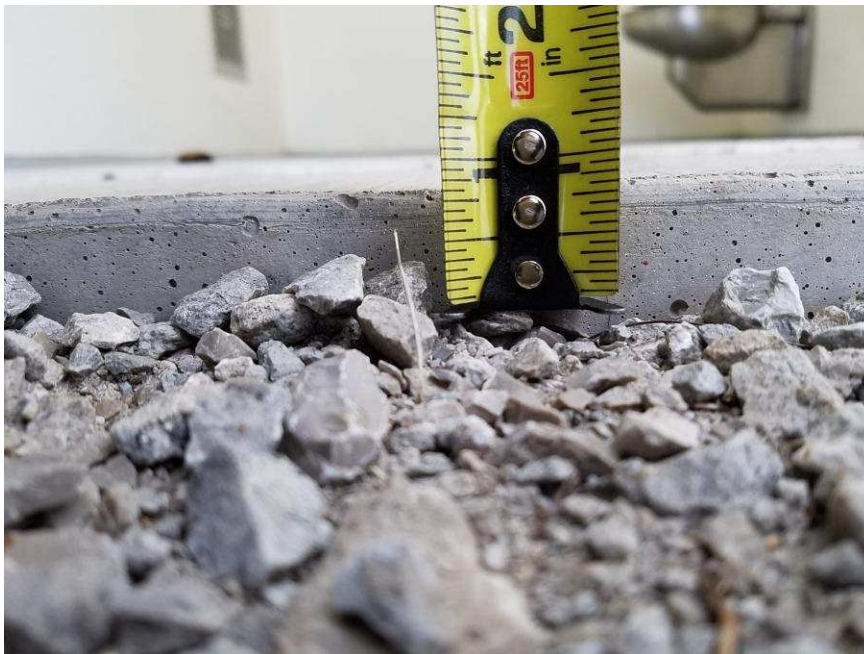
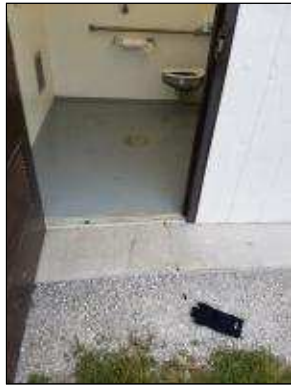
Finding: 9

CIL in MC of 1", 10#

For all doors along the public circulation route, provide required maneuvering clearance on push and pull side of doors

For all doors along the public circulation route, inspect, adjust, and maintain 8.5 lbf to open exterior doors as a smart practice

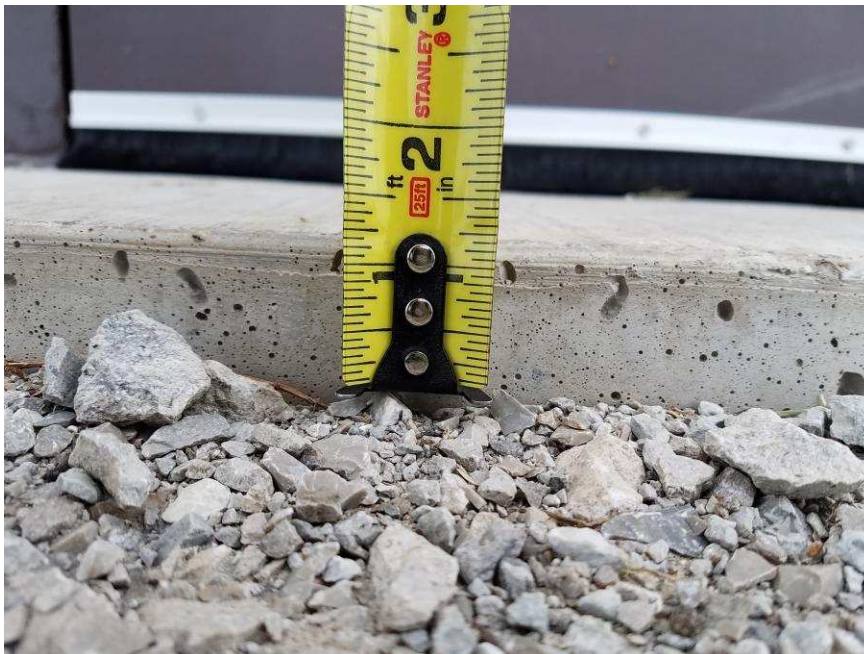
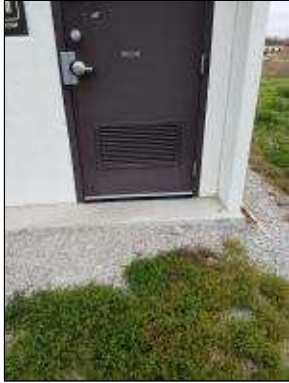
Finding: 10

CIL in MC of 1", 10#

For all doors along the public circulation route, provide required maneuvering clearance on push and pull side of doors; repair CIL in maneuvering clearance

For all doors along the public circulation route, inspect, adjust, and maintain 8.5 lbf to open exterior doors as a smart practice

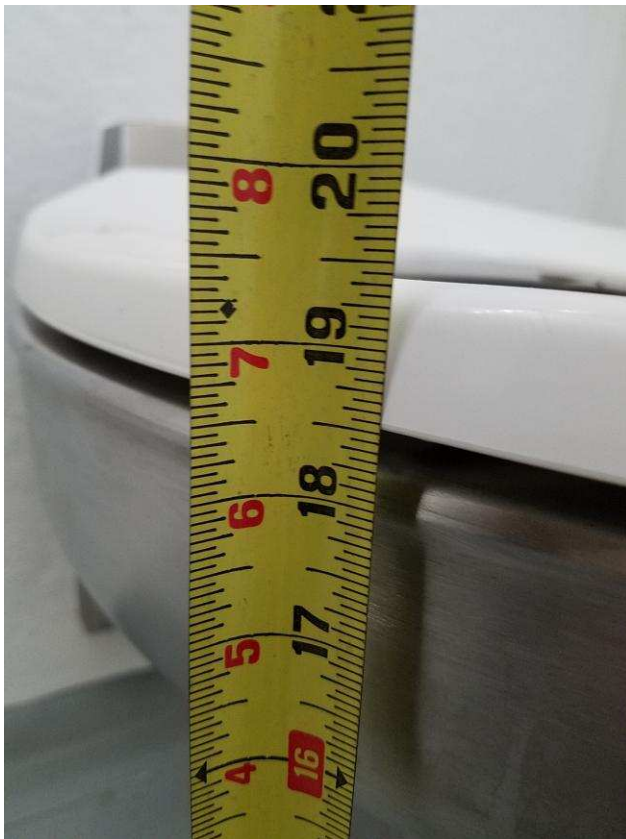
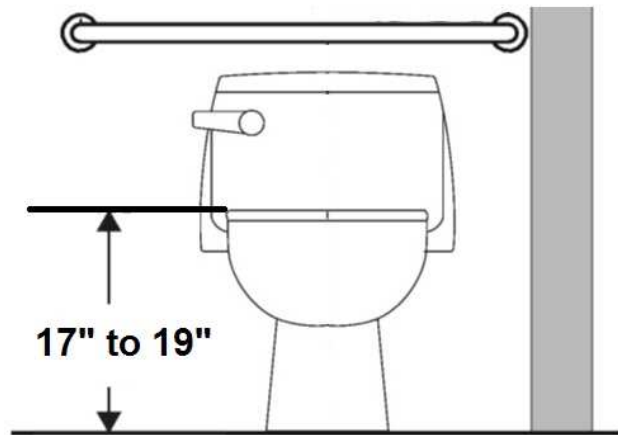
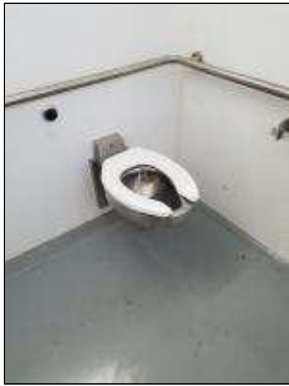
Finding: 14

The toilet seat is not located within the range allowed off the floor.

19.5" to seat;
centerline and grab
bars comply

Replace toilet seat, or re-set or replace toilet to 17" to 19" aff

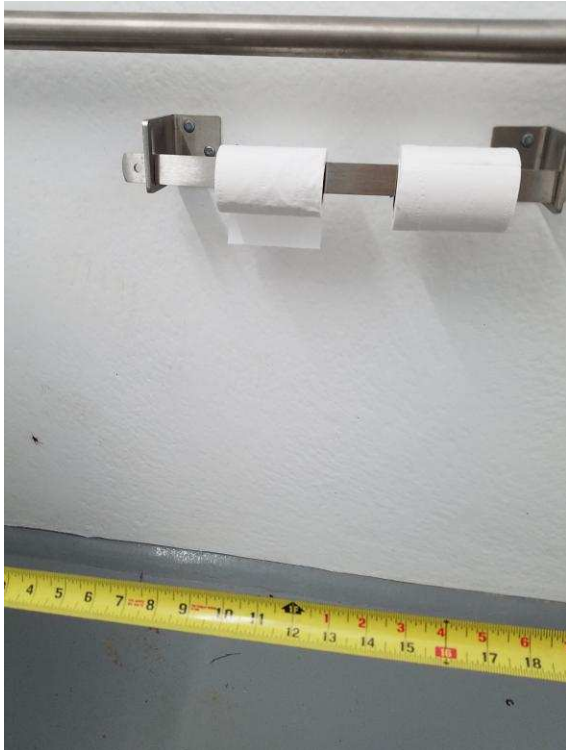
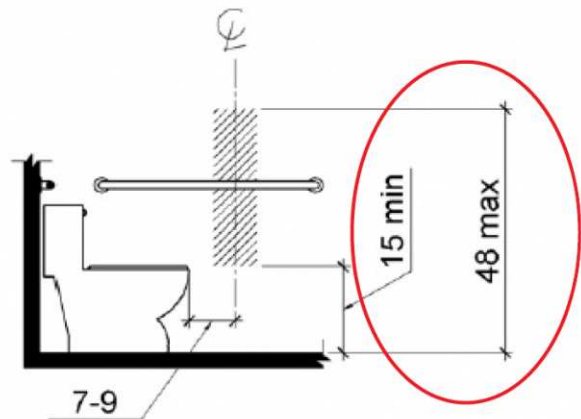
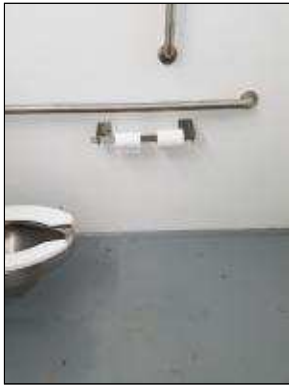
Finding: 15

The toilet paper is not installed within the compliant range.

toilet paper dispenser
is too far

Remount toilet paper dispenser max 7" to 9" from front of toilet, 15" to 48" aff and min 12" above or 1.5" below grab bar

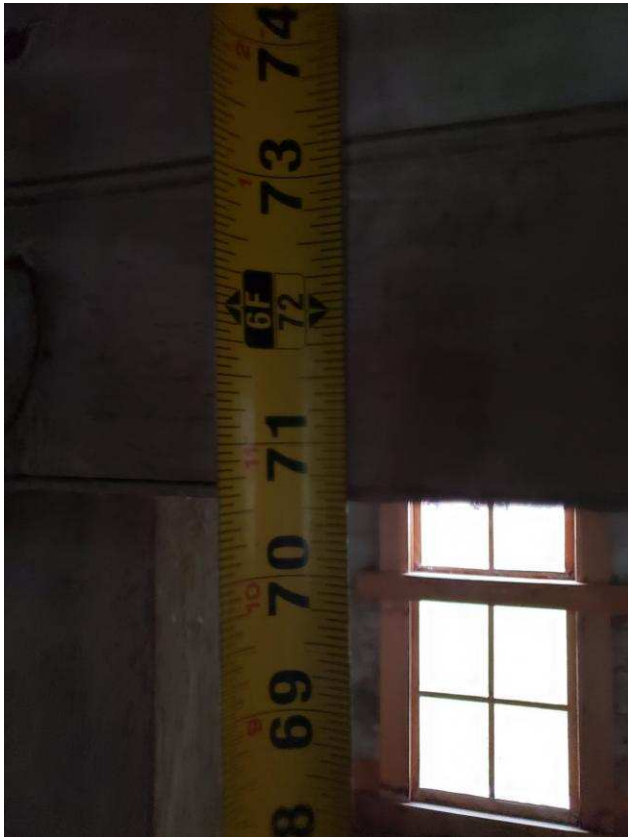
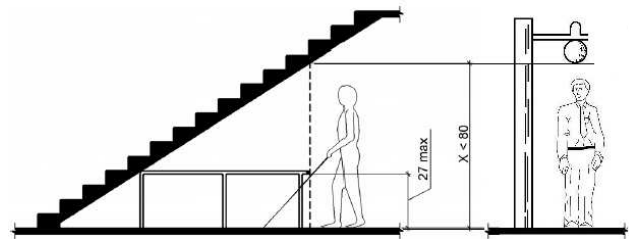
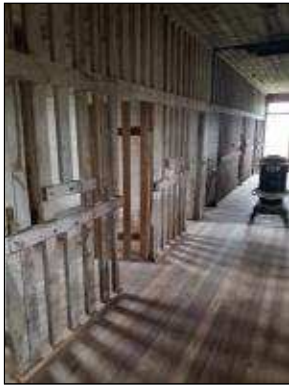
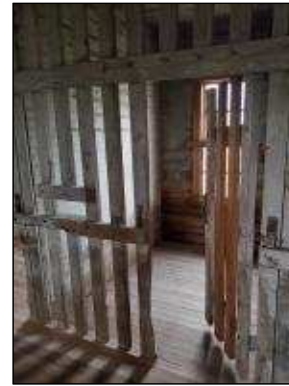
Finding: 16

The overhead support extends down too close to the route of travel.

70.75" into cells

Raise support to min 80", or pad object to prevent hazard in overhead clearance along AR

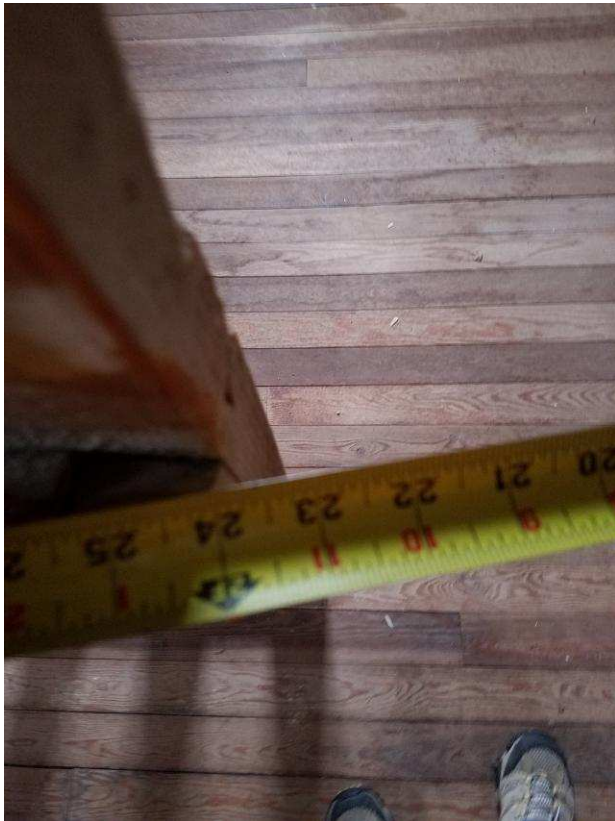
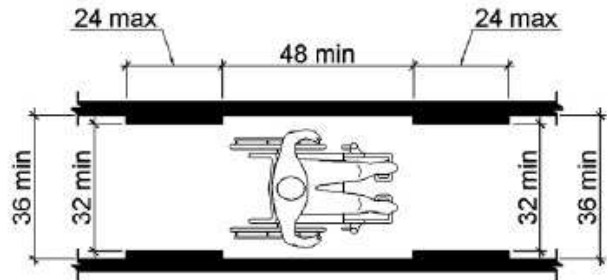
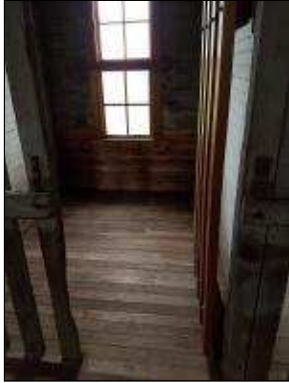
Finding: 17

The route of travel at this location does not provide a minimum width of 36 inches.

24" into cells in asylum

Widen AR to compliant 36" clear width

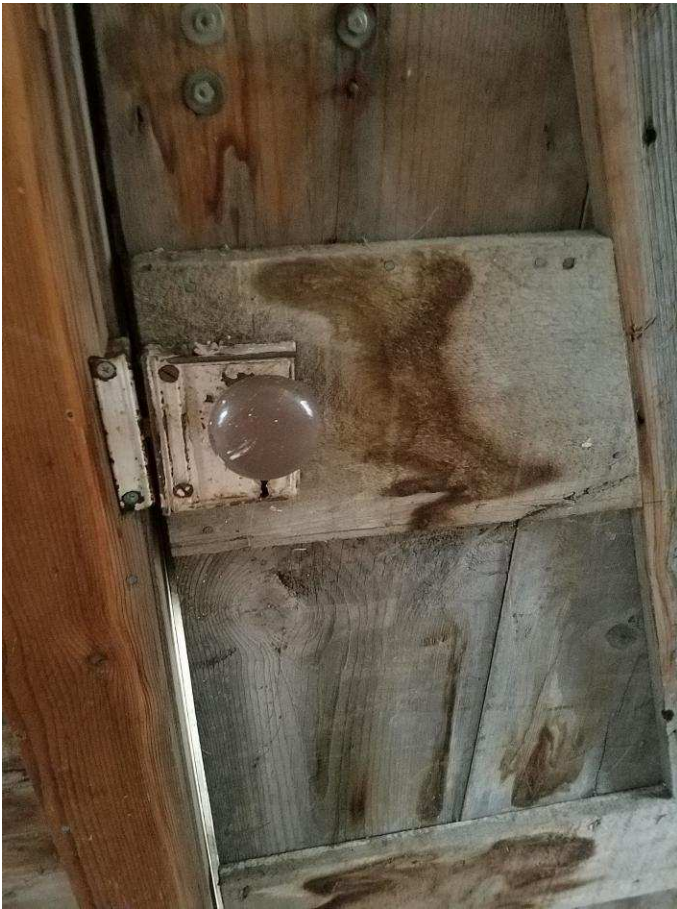
Finding #18 Continued

back entry, asylum - knob, too narrow, small ramp landing on exterior

For all doors along the public circulation route, provide required maneuvering clearance on push and pull side of doors

For all doors along the public circulation route, replace doors with doors having 80" overhead clearance and 32" clear width

Replace hardware with lever hardware or hardware operable without a tight pinch or grasp

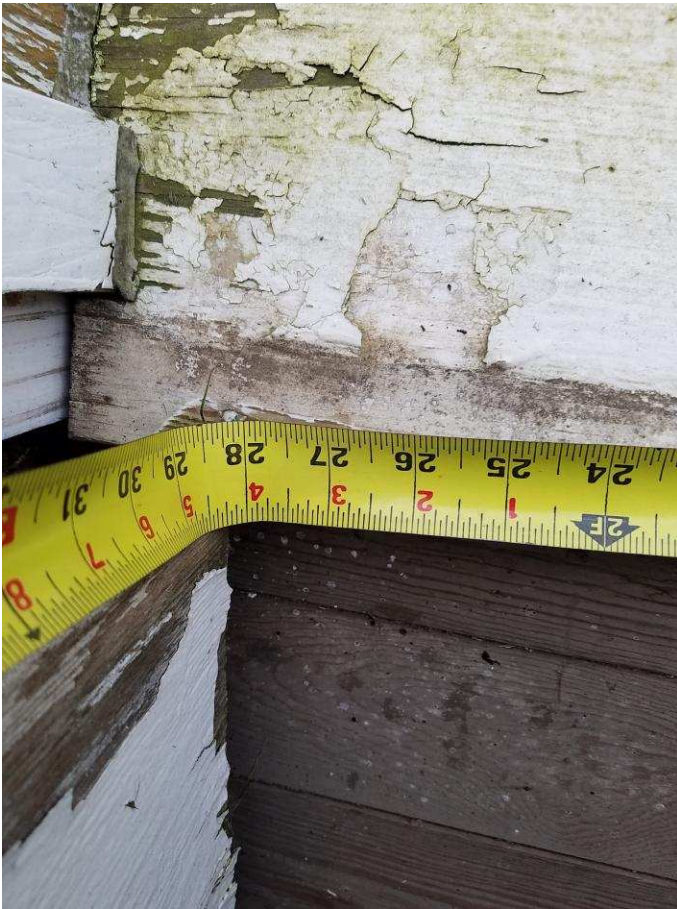
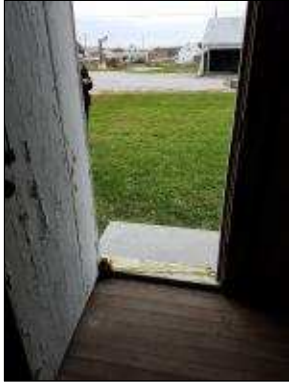
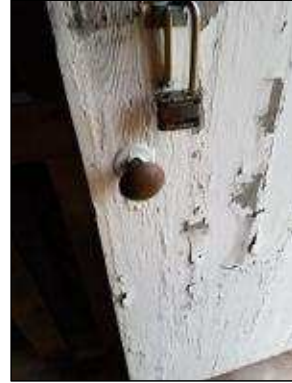
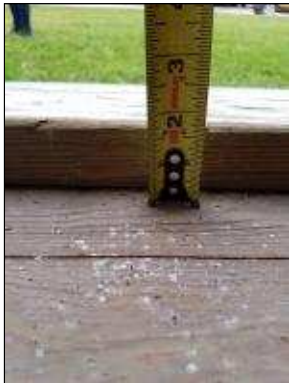
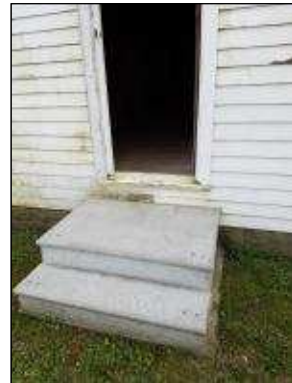
Finding #19 Continued

front entry, asylum -
knob, 28" wide, 1" CIL
interior, steps exterior

For all doors along the public circulation route, provide required maneuvering clearance on push and pull side of doors; ramp steps and correct CIL at doorway

For all doors along the public circulation route, replace doors with doors having 80" overhead clearance and 32" clear width

Replace hardware with lever hardware or hardware operable without a tight pinch or grasp

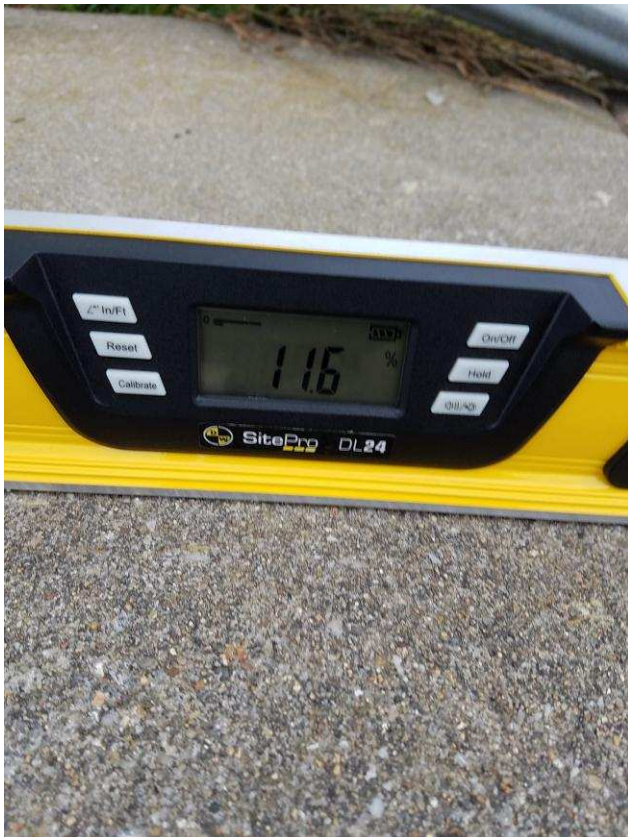
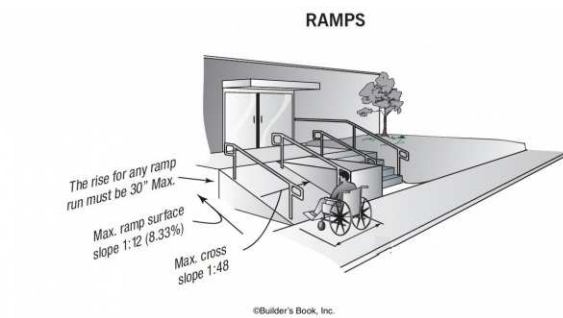
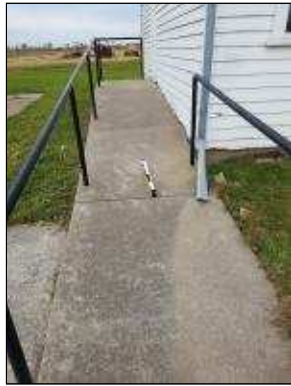
Finding: 20

The ramps slope exceeds the maximum running slope (direction of travel) allowable of 8.33%.

11.6% slope on ramp
to back asylum entry

Correct slope of ramp to max 8.33%

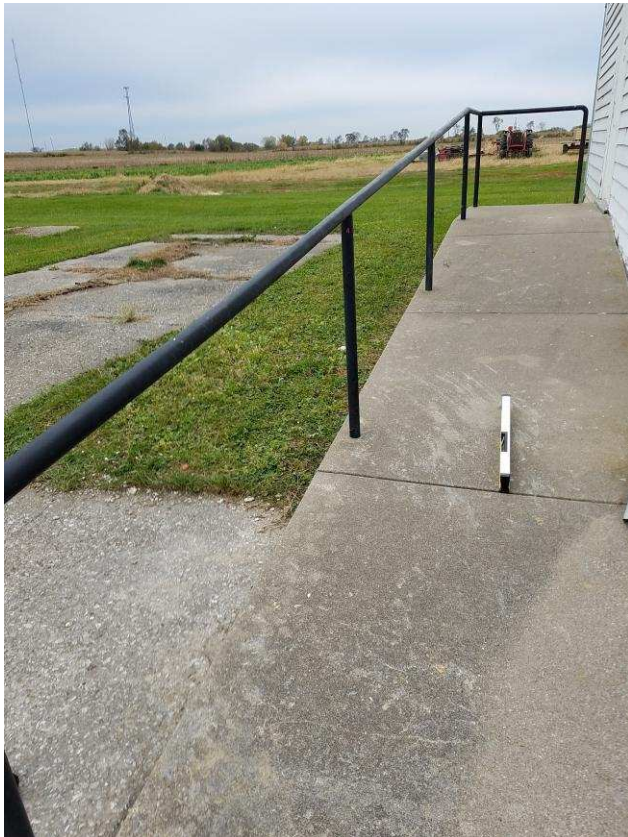
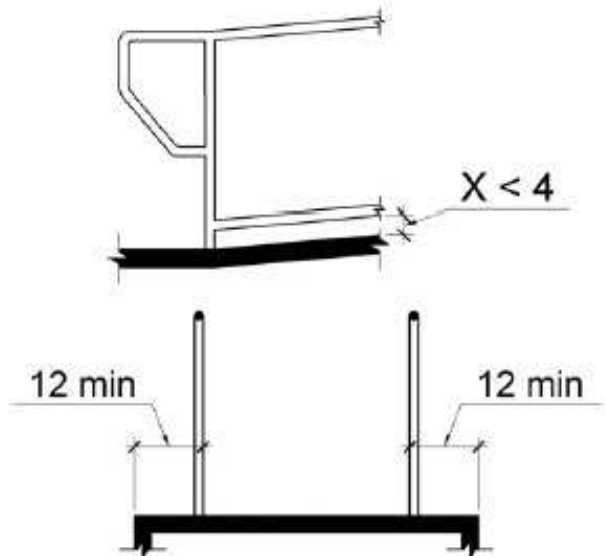
Finding: 21

The ramp run has not been provided with edge protection.

ramp lacks edge protection

Install rail along bottom edge of ramp that prevents a 4" sphere from passing through

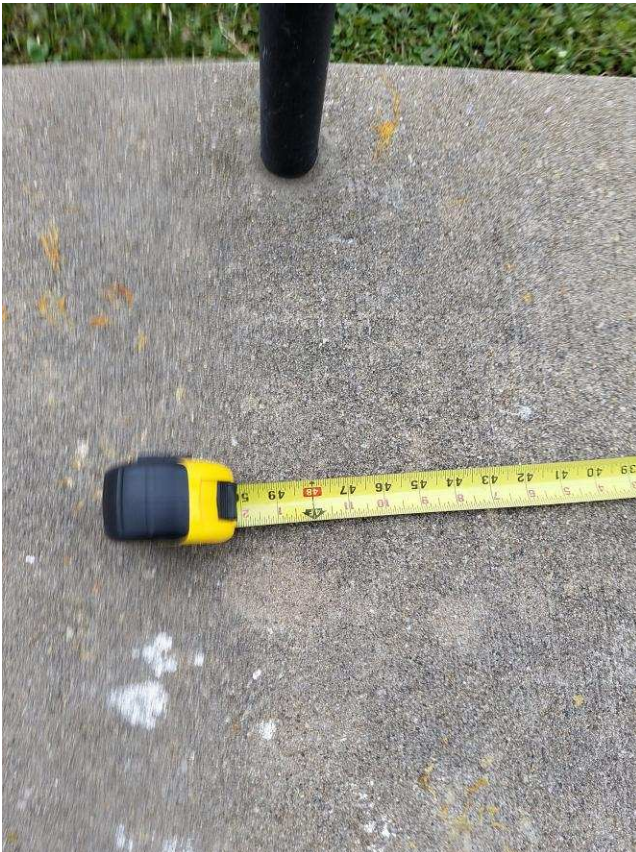
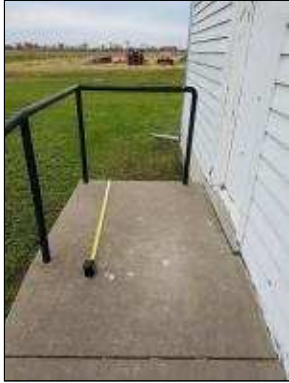
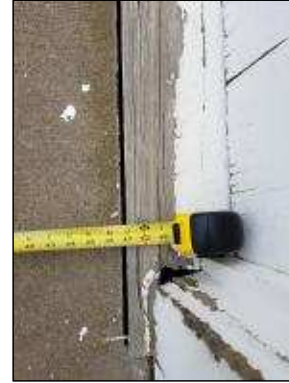
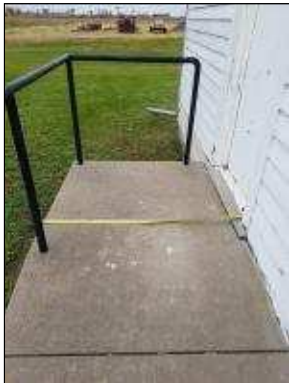
Finding: 22

The landing at the change of direction is not the correct size.

48" by 46.5"

Enlarge landing on ramp where directions change to 60" by 60"

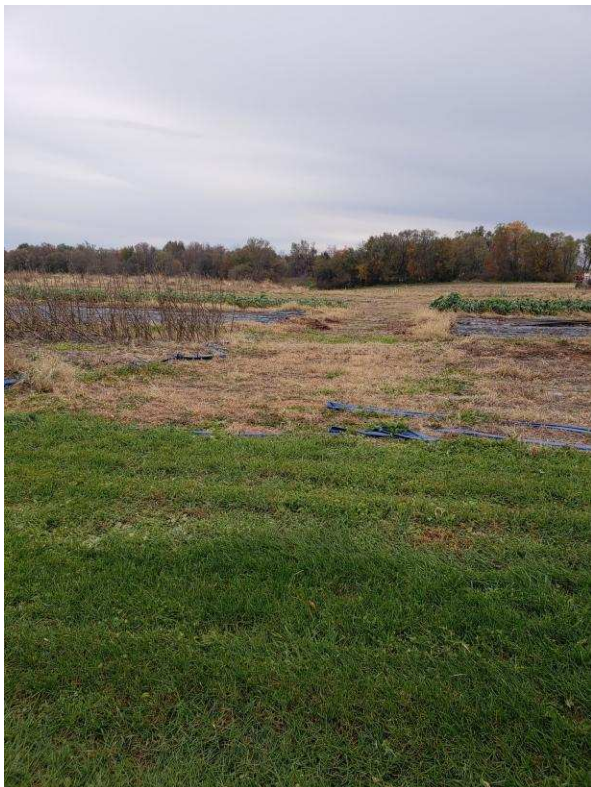
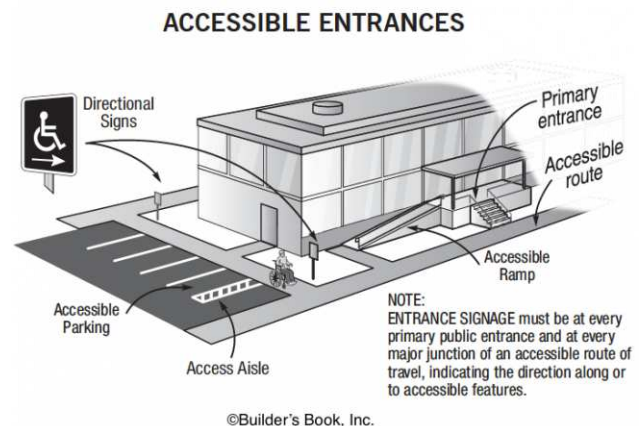
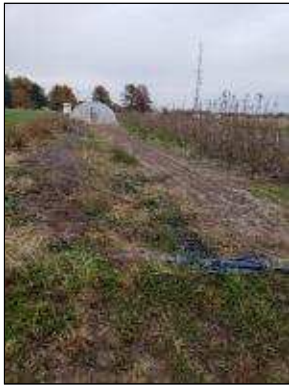
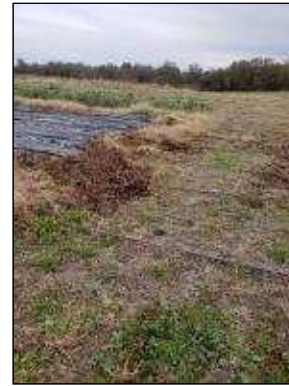
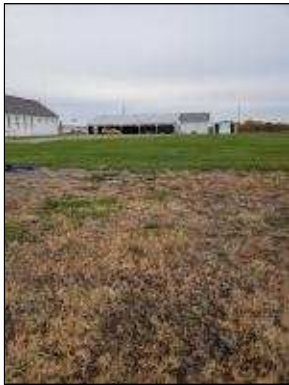
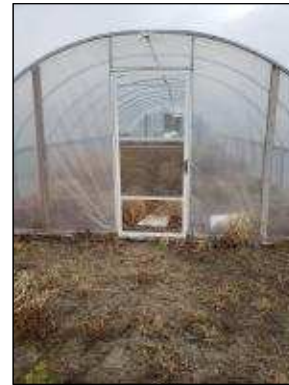
Finding: 23

There is no accessible route to the gardens.

gardens- grass, small greenhouse that is going to be revamped/torn down

Create an accessible route with crushed stone or other outdoor material from parking or walkway to community gardens.
