Site Accessibility Evaluation

SEATS and Secondary Roads

**4810 Melrose Ave
Iowa City, IA 52246**

***Inspection Date: 11/29/2018
Inspector: Shelley Zuniga***

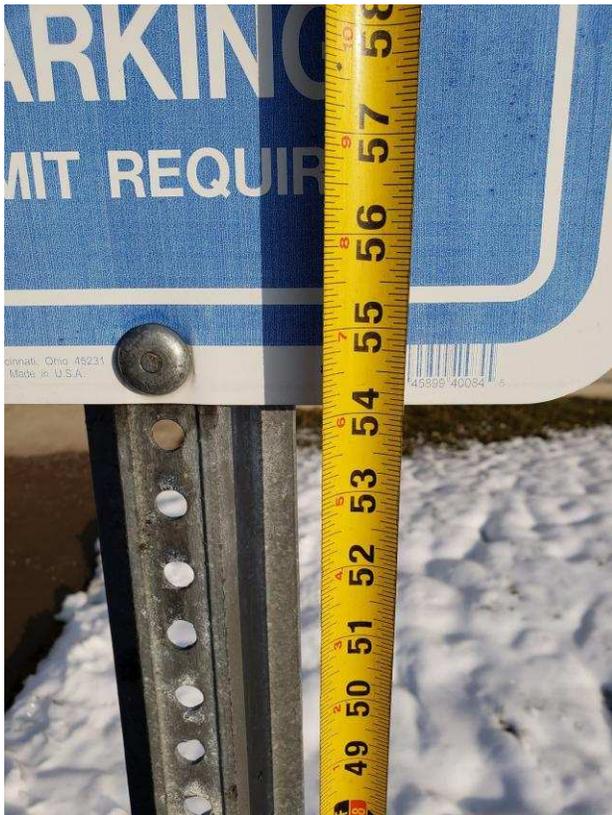
Finding #1 Additional Finding Photos

front- signs fail 54"
and 57"; back- both
58"

Raise existing accessible parking signs so lowest end of bottom sign is min 60" aff

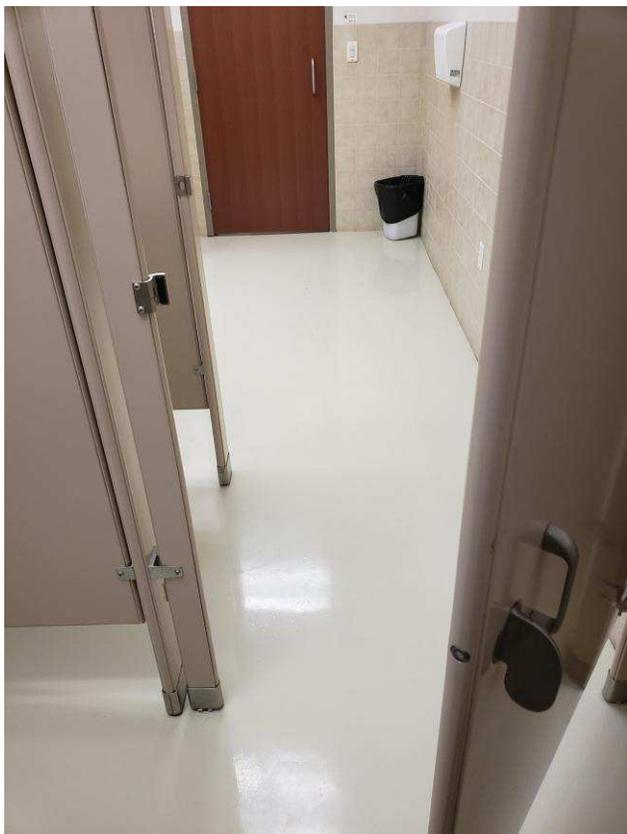
SEATS and Secondary Roads Men's Restroom

door fails to self-close

Replace or adjust stall door of accessible stall with one that is self-closing

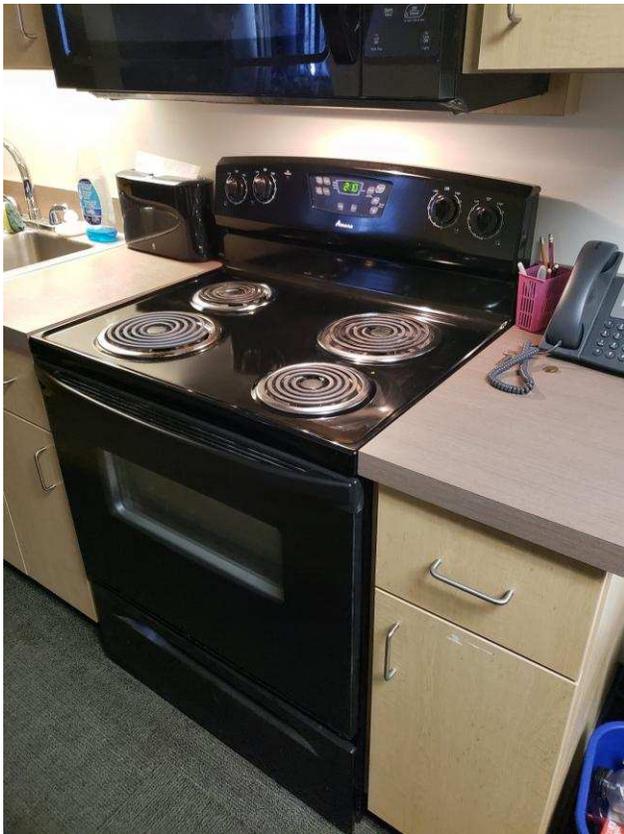
Ambulance Quarters

The controls are located such that operation require reaching across burners.

kitchen- stove fails

Replace oven with one having controls on the front panel

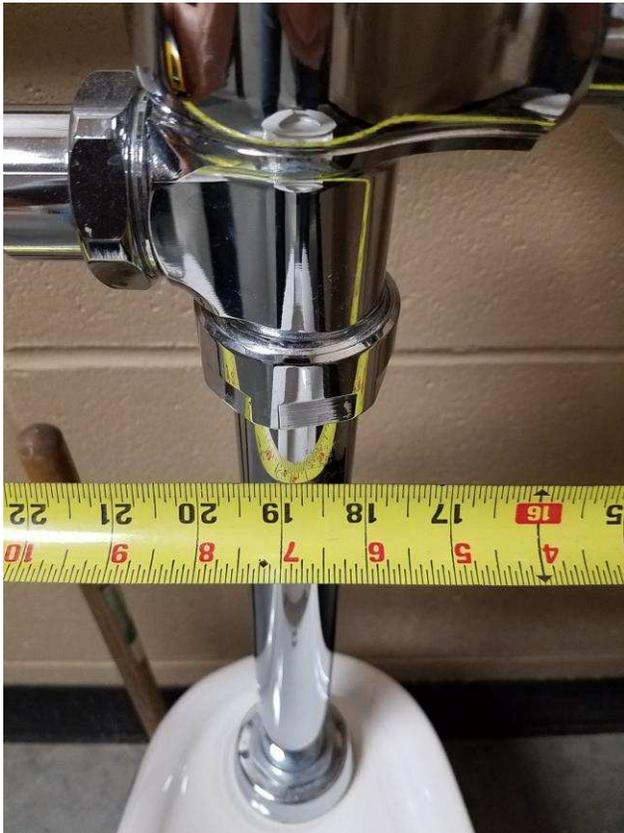
Finding #250 Additional Finding Photos

Center line of toilet is 18.75" from wall, should not exceed 18", leave as is citing construction tolerance
