STRUCTURAL CONDITION ASSESSMENT

Johnson County Sheriff's HQ and Jail

511 South Capitol Street

June 7th, 2024

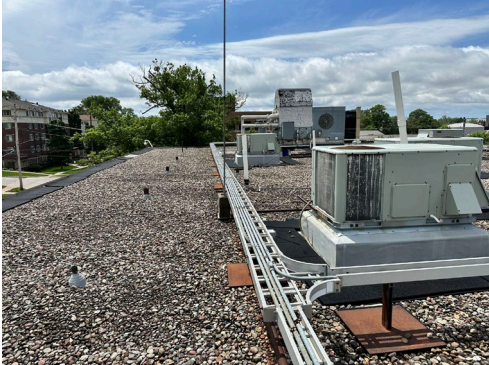
<p>A: General overview of the roof condition during this visit. The roof is in poor condition overall and should be scheduled to be replaced. It is older than 20 years according to stakeholders which is well outside of any warranty period. The roof shows serious signs of degradation and has active known leaks.</p> <p>While not the purview of this report – Axiom generally inspects mechanical and electrical equipment during a full PCA effort. The mechanical equipment noted during this structural inspection was in very poor condition and should also be replaced when the re-roofing is done as it will need to be removed regardless.</p>
2

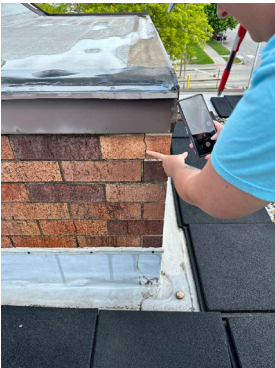
<p>S: This condition was noted last year at the North end of the building. The clay brick exterior fascia on the North stairwell's East end has settled and fractured. This is assuredly tied to the movement noted in the North stairwell on last years report. Interior elements within the stair show a slightly shifted hollowcore precast panel and some cracking in the CMU consistent with movement down and to the East.</p> <p>This condition should be monitored along with the interior conditions.</p> <p>A crack gauge will be placed at this location.</p>

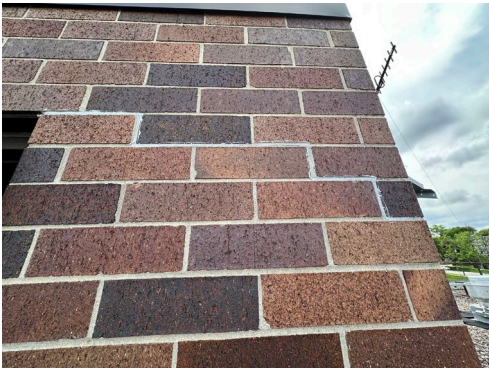
<p>S: Another view of settled and cracked brick detailed in Item 2 above showing additional cracking of the stairwell brick fascia.</p>

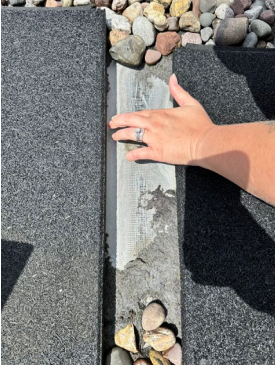
<p>A: Membrane roofing areas which are visible between walkway pads/ballast show heavy signs of degradation. The membrane is not only old and worn, it is actually showing the fibrous integral material and is raveled/fraying. This is indicative of heavy wear and age and is likely worse across the roof than is visible. The roof is a ballasted system meaning that most areas are not visible. This is concerning and should be corrected immediately for safety, occupant conditions, and preservation of the interior building elements.</p> <p>A new membrane roof would require removal of the existing MEPT elements on the roof. New roofing would not require ballasted installation and we recommend its removal.</p>
5	 	<p>A: Membrane roofing areas which are visible between around roof edges show heavy signs of degradation. The membrane is not only old and worn, it is actually showing the fibrous integral material and is raveled/fraying. This is indicative of heavy wear and age and is likely worse across the roof than is visible. The roof is a ballasted system meaning that most areas are not visible. This is concerning and should be corrected immediately for safety, occupant conditions, and preservation of the interior building elements.</p> <p>A new membrane roof would require removal of the existing MEPT elements on the roof. New roofing would not require ballasted installation and we recommend its removal.</p>

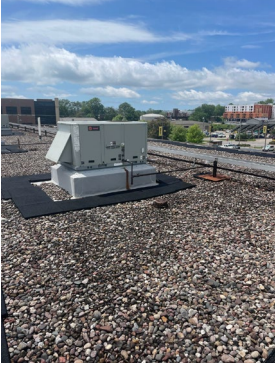
<p>A: A low area located around the North 1/3 of the roof on the Western half shows an obvious low area. Ballast here was still wet after the rest of the roof had dried out. Sheriff Kunkel noted that a permanent bucket is installed in the hallway directly below this point in the upstairs West hall. This area consistently holds water and frequently leaks. Tapered insulation in this area is likely in very poor condition and may not have been installed properly. Area should be installed with a positive drainage pattern/cricket when the new roofing is installed.</p>

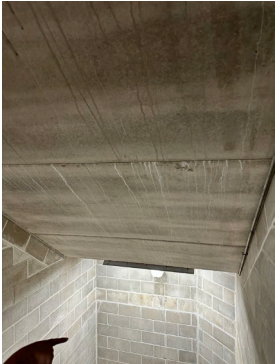
<p>S: Angled precast ceiling in the North stairwell. (This item was examined and identified in last years report as well.) Precast roofing shows prior signs of water infiltration and movement. Movement is not extreme and could have occurred during construction. The water infiltration lines can clearly be seen in the picture running away and down. This movement is indicative of some of the general building issues Axiom has noted occurring towards the outsides of the building. This should be monitored for worsening.</p> <p>A crack gauge will be placed here.</p>
2

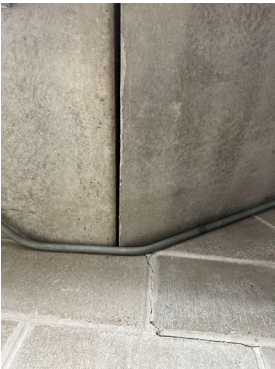
<p>S: In conjunction with the issues noted in Item 1 above are corresponding cracks in the CMU wall directly in line with the panel gaps. The fact that the cracks line up almost directly with the gap in the precast panel is unlikely to be circumstantial. The cracking in the CMU blocks is occurring both on joint lines and through members. This should be monitored annually for worsening.</p> <p>Cracks in the brick stairwell fascia are located directly above this area. These were detailed in the previous section above.</p>

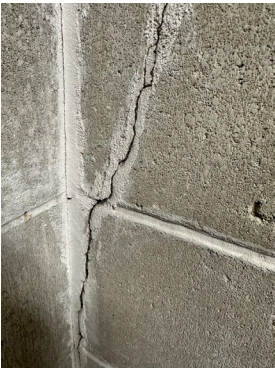
<p>S: This crack was noted in the NE corner of the North stairwell, near the upper floor on the landing to the roof. This crack has been previously patched but has since separated. Cracking is active and gappy – starting to show a little bit of material loss. This is located in the Northern portion of the building which shows the most significant signs of fatigue (compared to the South.) This area should be monitored and may be a candidate for repair depending on wear over time.</p> <p>A crack gauge will be placed here.</p>

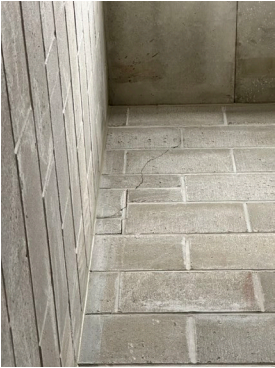
<p>S: Additional cracking noted in the North stairwell, NE corner near the roof. Cracking is directly below the roofing issues described above and is related to Item 3 on the previous page. This cracking should be noted as it is breaking through the CMU blocks not just on the joints. This is indicative of greater strain/movement than simple settlement might show.</p> <p>This area should be monitored and may be a candidate for repair depending on wear over time.</p>
5

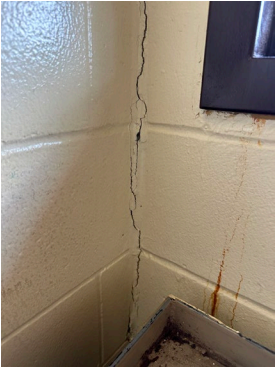
<p>S: Corner cracking in Block A – typical of nearly every corner interface within all cell blocks on the East side of the building. Very few corners did <u>not</u> show this condition. This example is worse than most and shows active cracking and movement.</p> <p>This should be monitored for worsening condition when time and access allows and we will continue to examine these conditions on the annual inspections.</p> <p>These cracks are mapped later on in this report for locational tracking.</p> <p>Most of the corner cracking does not split through CMU units.</p>

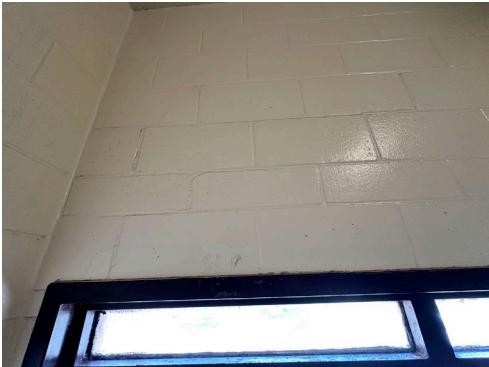
<p>S: Additional typical cracking in cells shows stair-step cracking noted elsewhere in the building. This type of cracking is present in many of the cells on the East side and some cells on the West. This cracking is not generally as significant/gappy as the corner cracking noted in the previous item.</p> <p>Monitor these for worsening, further separation, and/or material loss.</p>

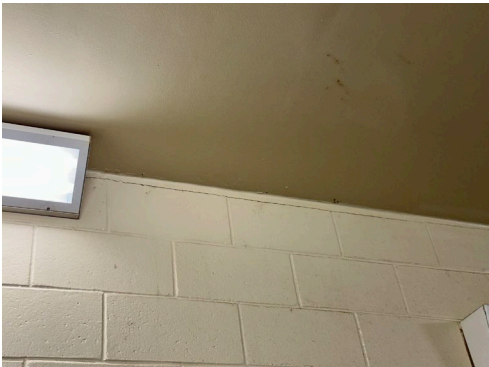
<p>S: Ceiling/outer wall interface cracking noted in many of the cells on both sides of the upper floor. These cracks were noted on both the outer walls and the inner walls of day-rooms. As noted elsewhere in this report, the ceiling hollowcore precast panels have shown some signs of movement and/or pull towards the outsides of the building. These cracks would be consistent with such a condition. While not incredibly large or particularly active in appearance they should be monitored for worsening or changing conditions.</p> <p>These cracks will be examined on an annual basis.</p>
8

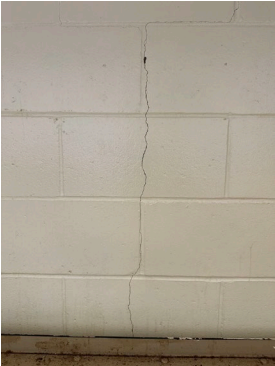
<p>S: A number of cells on the East side of the building, and some on the West, show cracking near the middles of the cells, often directly centered on the bunk beds or above/below steel window frames. These cracks – like the one in the picture at left – show cracking that splits the structural CMU and are somewhat active/clean. These are more concerning than the more hairline and/or stair-stepped cracks and should be monitored closely and during the annual inspection.</p> <p>These may be a candidate for repair in the future pending changing conditions to the building.</p>

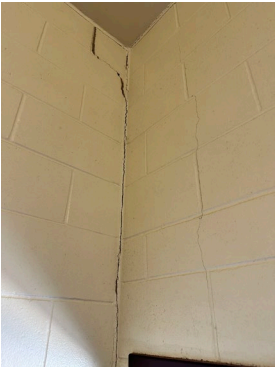
<p>S: A few of the corner cracks described in Item 5 above display additional cracking that includes the beginnings of some spalling of the CMU resulting in plate-type fractures. When considering outward movement of the West or East walls that are tied into the demising walls in the jail cells – this type of fracture is what would be expected should such movement continue. Because the walls are tied together, they will spall/split when moving apart. Most cells do not show this condition but it is occurring in 1-2 places along the E side (mostly on N half) as well as in Block E in the NW part of the building.</p> <p>These areas should be closely monitored and evaluated during the annual inspections.</p>

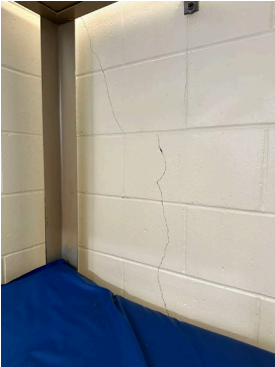
<p>S: A few cells on both sides of the building, show corner cracking that is splitting away and bisecting blocks. This is similar to Items 4, 8, and 9 above. These areas are more concerning than the simple corner-only cracks and should be closely examined and reevaluated during the annual inspections. Some of the crack gauge placements will be on cracks of this type.</p> <p>These may be a candidate for repair in the future pending changing conditions to the building.</p>
11

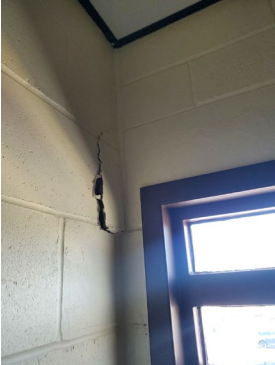
<p>S: Cell block E shows the worst overall cracking of any interior section of the building. This upper corner shows a significant spall similar to that in Item 9. This area was noted last year as an area of concern although the exterior portions of the building associated with this area aren't in as bad a condition as those on the NE and E portions of the exterior. These particular cracks were noted in Room 218 which serves as a small office.</p> <p>A crack gauge will be placed in this location.</p>

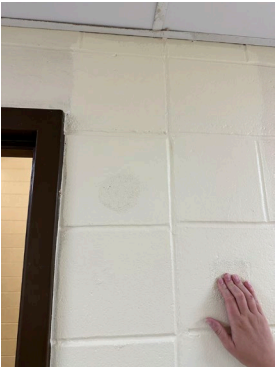
<p>S: Door jamb in the West hallway, North end where McComas-Lacina recently completed a CMU repair. Repair area can be noted by the new paint. Steel pins were drilled and epoxied horizontally from the door frame outward, and the CMU cells were grouted solid.</p> <p>Additional doors are slated for similar repairs.</p>

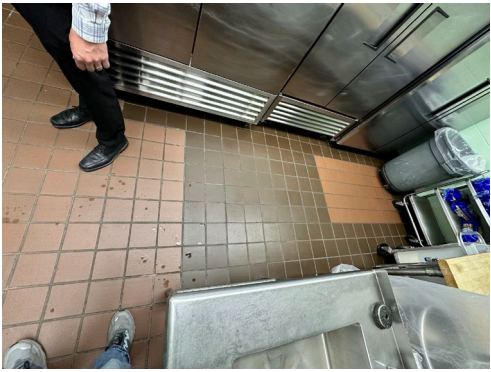
<p>S/A: Flooring in the kitchen area was previously repaired according to Sheriff Kunkel. This area has been noted as buckling at least two (2) previous times during the Winter months – reason unknown. According to Sheriff Kunkel, the area did not experience any movement or shifting during this past Winter season.</p> <p>This area will continue to be evaluated.</p> <p>The previous Winter was noted as the warmest on record.</p>
1 4

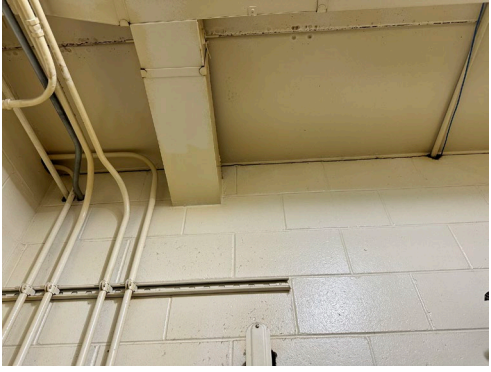
<p>S: Storage areas on the upper floor which are located more towards the core of the building (inside of the two hallways) also show signs of movement/separation. In the inner areas, this more often at the ceiling/wall interface which would be consistent with the outer walls pulling on the hollowcore slabs away from the building.</p> <p>Continue to monitor these areas. They will be examined during the annual inspections.</p>
1 5

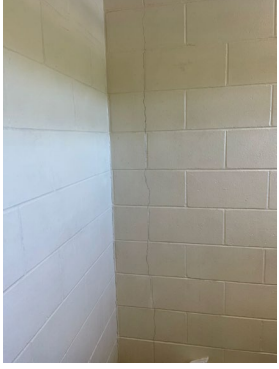
<p>Internal rooms do show some wall cracking but at much less common frequency. This area does show a vertical crack that splits through the individual CMU. This area was located in the core of the building towards the South end – in the 232-234 area.</p> <p>This area should be monitored moving forward and will be examined during annual inspections.</p> <p>This particular location showed a hairline fracture only.</p>

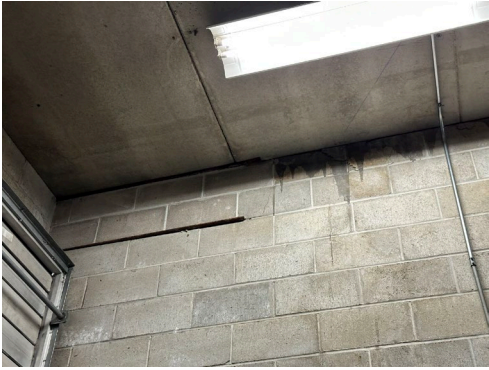
<p>S: This area was noted during the inspection last year and sits directly within some very bad exterior areas. This is located at the SE corner of the building. The angle which is embedded two (2) courses down from the roof has both pulled (1-2") and shifted (inward.) While not necessarily different in condition from last year, this area should be monitored on a periodic basis for worsening conditions/cracking.</p> <p>Poor conditions on the exterior are likely tied to this issue in the mechanical/equipment space in the sub-basement.</p>
1 7

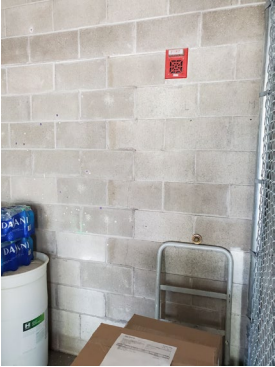
<p>S: This area is located in the sally port and includes a hairline crack on the interior (W) all. This crack is not as concerning as many of the others but is likely tied to issues along the E side of the building. This wall is the first interior wall inside of some of the worst exterior conditions on the structure detailed in the next section.</p> <p>Monitor this crack.</p> <p>This will be examined during the next annual inspection.</p>

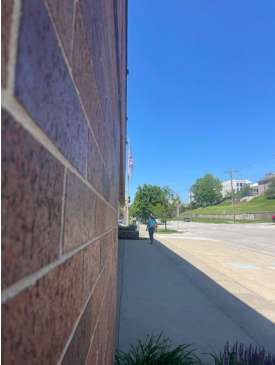
<p>S: Siting down the East face (looking North) to do a cursory check for wall plumb and observable shifting. None noted.</p> <p>It should be noted that siting is simply a quick and simple way to examine obvious defects in a building façade. This in no ways should minimize the other issues showing outward “pull” on the building.</p>
2

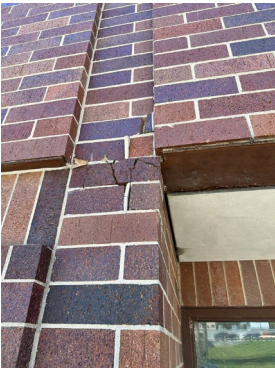
<p>S: Exterior entryway inset/jamb near the main entrance to the building. This particular location is nearest to gridline D.3 for reference with original plans. The clay brick fascia in this area is crushed and fracturing and the end of the opening lintel. This is likely close to the demising wall between cells 262A and 262B within Block C where cracking was noted.</p> <p>Cracking this significant is indicative of movement outside of normal settlement of a building.</p>
3

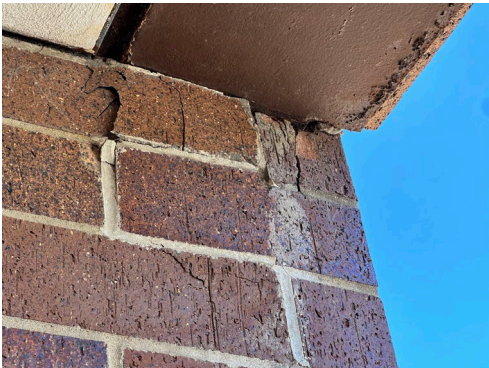
<p>S: Interior view of Item 2 above showing shifting gaps, crushing brick, and rusted steel (poor drainage condition.)</p>

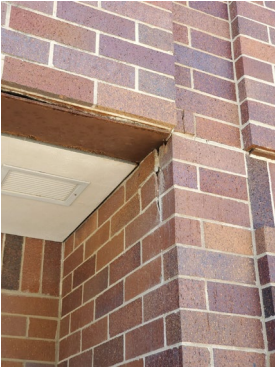
<p>S: North side of main entry point showing similar shifting and crushing issues to item #2 and 3 above within the same opening. Additional brick cracking can be seen to the right of the lintel.</p>
5

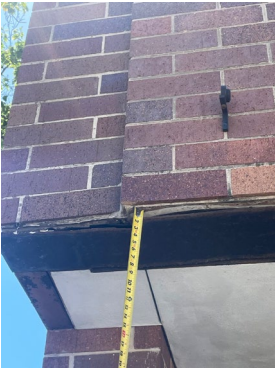
<p>S: SE corner of the building – exterior lintel shows very poor drainage condition, water damage, buckling/warping of the lintel and gapping measured at near 2". Shifting and movement here have not translated into cracking/breaks in the brick above but the shifted angle on the inside of the building combined with conditions in the East side cells help form an overall picture of issues with the building exterior pulling/settling to the outsides.</p>

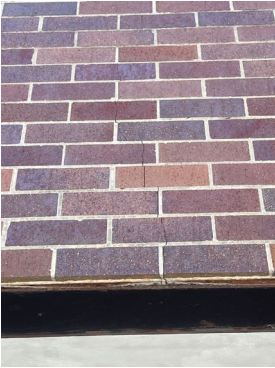
<p>S: In addition to the issues described above, the settled and shifted lintel is causing vertical cracking within the brick walls which is traveling regardless of jointing. This is likely translating into the wall cracks within the cells which are directly above this.</p> <p>This area is likely below the 260A-D cells.</p>
9

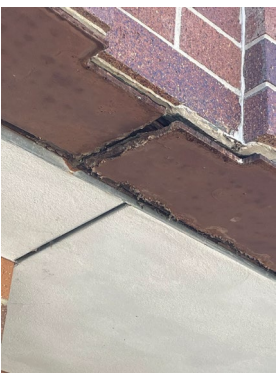
<p>S: Additional examples of lintel damage (shown for the next 3 items including this one.) All lintels show a significant water problem – indicating water buildup and corrosion due to lack of drainage and poor design. The lintels are heavily rusted and are pulling and twisting away from their installed positions.</p> <p>Gaps measured at these locations ranged from 1-2" which is significant and is allowing further moisture intrusion and potential freeze/thaw condition. Over time these areas will worsen including the lintels, soffit material, and surrounding brick.</p> <p><i>These areas will require repair to stabilize the building – along with the roof.</i></p>
11

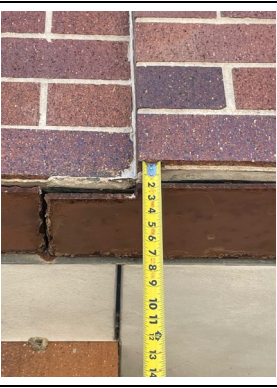
<p>S: Secondary example of Item 10 above – this is on the West side of the building as is Item 10.</p>
12

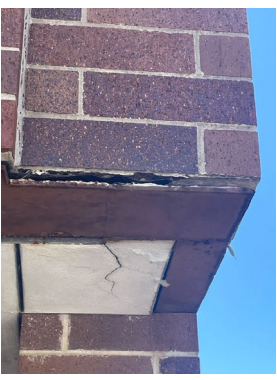
<p>S: Tertiary example of Item 10 above – this is on the South side of the building.</p>
