Office of Johnson County Sheriff and Jail

Facility Condition Assessment Report

Prepared for:
Johnson County

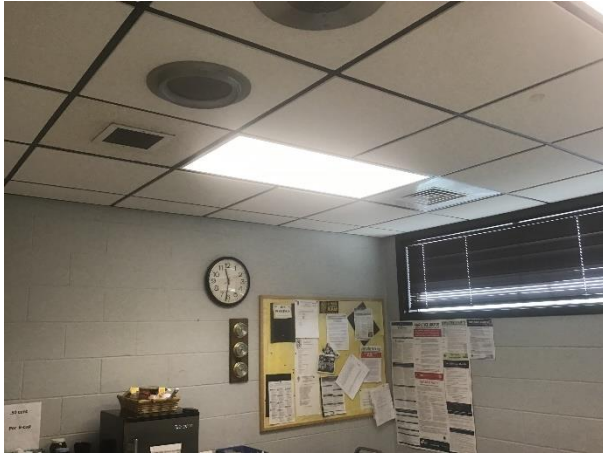
Acoustic Ceiling System — Standard

The ceiling finishes were observed to be in fair to good condition. Based on the condition of the finishes, no replacement is anticipated during the study period.

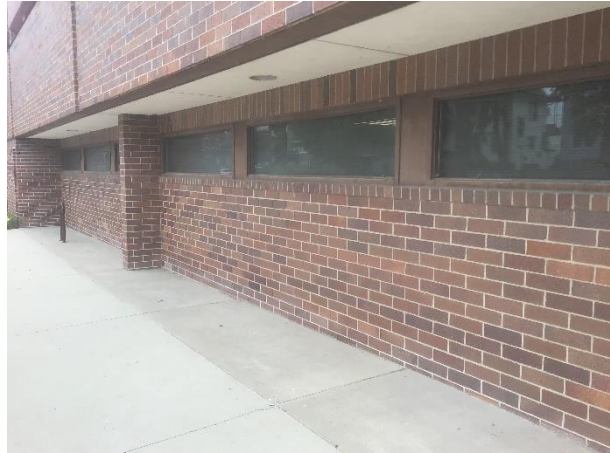
Aluminum Window Units — Fixed or Single Hung

The exterior windows were observed to be in poor to fair condition and are assumed to be original to the facility. Based on the age and condition, we recommend upgrading the windows early in the study period.

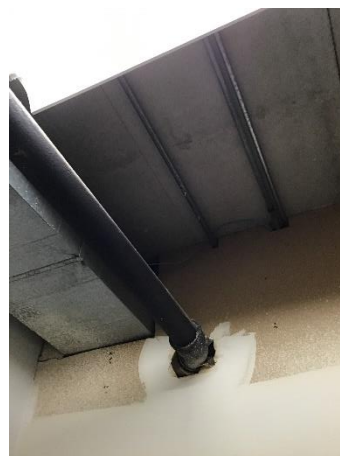
Cast in place Concrete Beams and Floor Slab

The upper floor was observed to be in generally fair condition, with no significant cracking or failure observed. No actions will be generated during the study period.

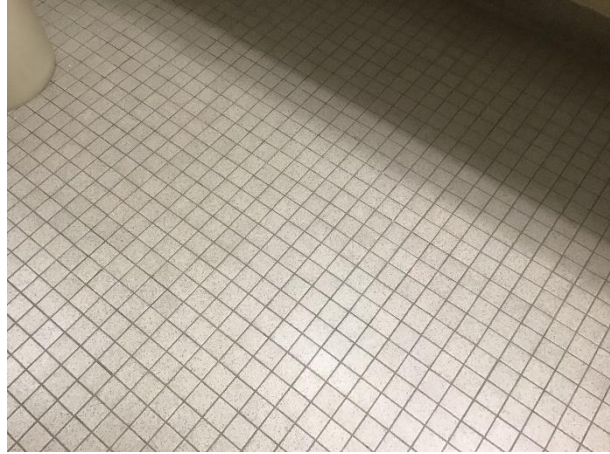
Ceramic Tile

The floor tile in the restrooms and locker rooms appeared to be in poor to fair condition. Based on the age and condition we recommend replacement early in the study period.

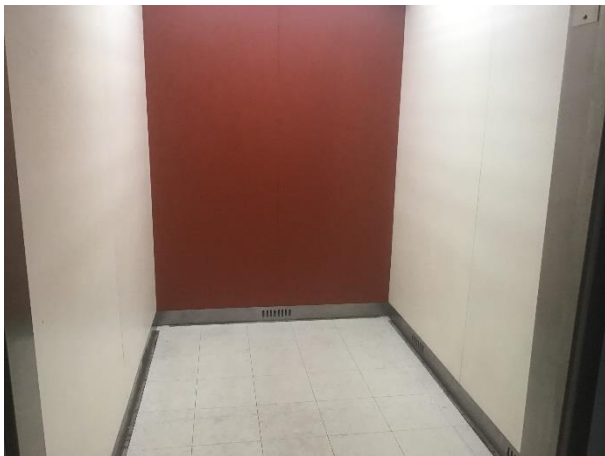
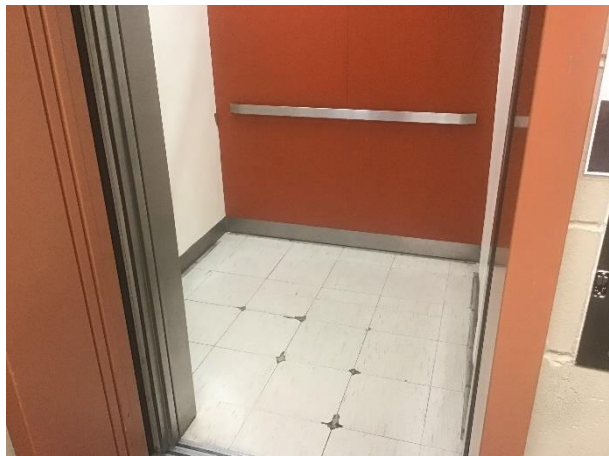
Elevator Cab Renovation

The elevator cab finishes were observed to be in poor to fair condition and dated in appearance. Based on the condition we recommend replacement early in the study period.
