Site Accessibility Evaluation

Hills Access

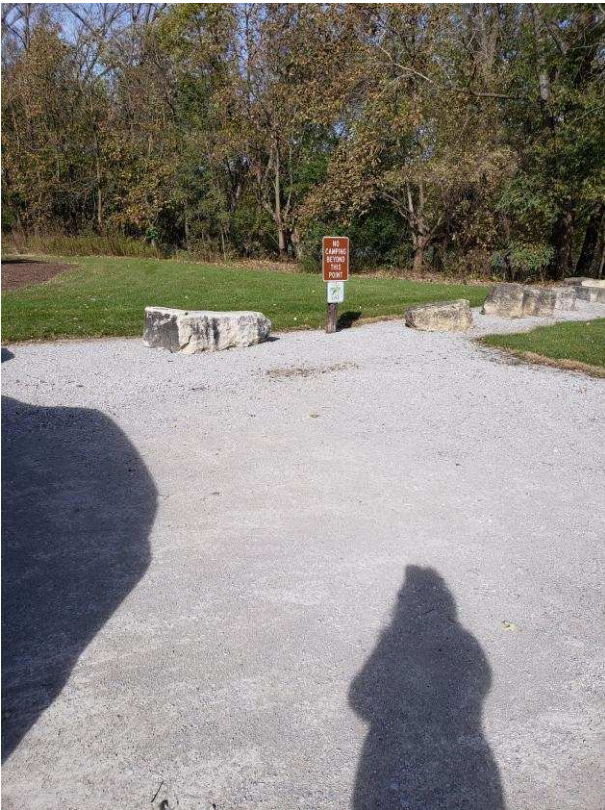
Total Number of Parking Spaces Provided in Parking Facility	Minimum Number of Required Accessible Parking Spaces
1 to 25	1
26 to 50	2
51 to 75	3
76 to 100	4
101 to 150	5
151 to 200	6
201 to 300	7
301 to 400	8
401 to 500	9
501 to 1000	2 percent of total
1001 and over	20, plus 1 for each 100, or fraction thereof, over 1000

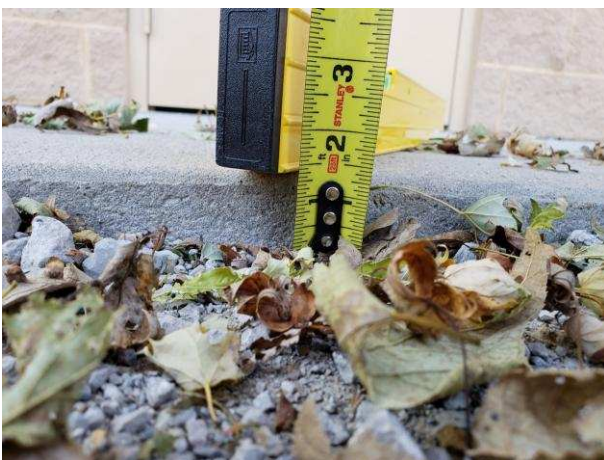
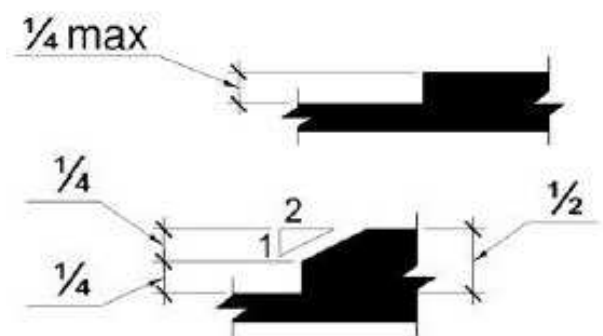
Finding #2 Additional Finding Photos

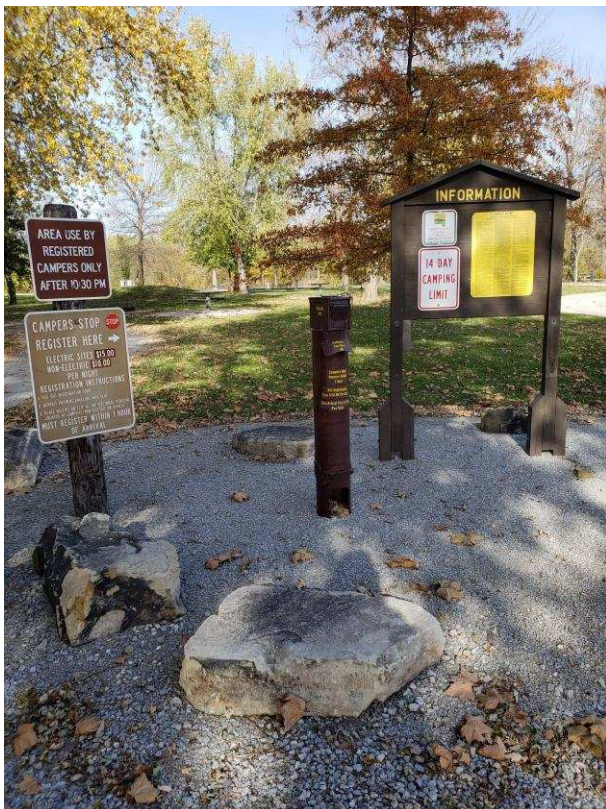
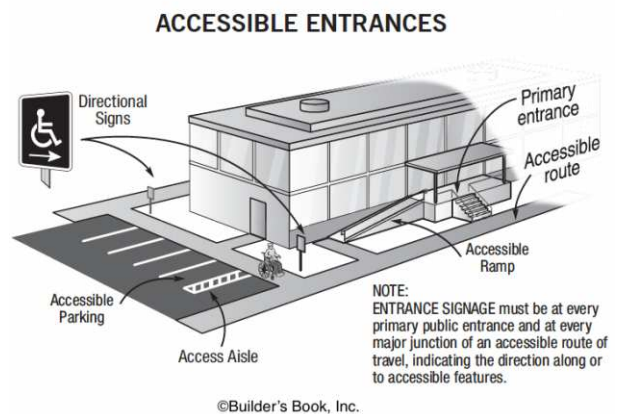
Create an accessible route with crushed stone or other outdoor material from parking or walkway to registration.

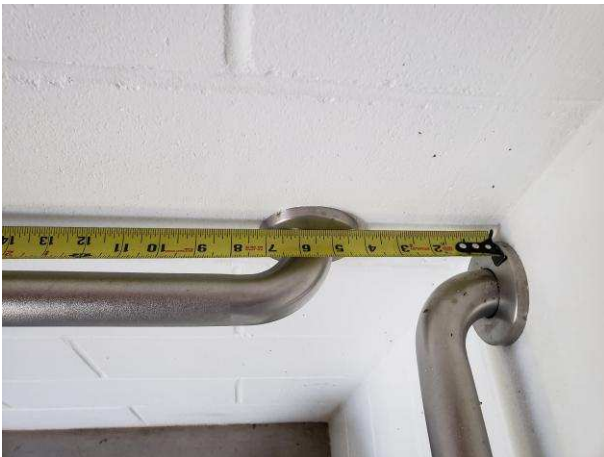
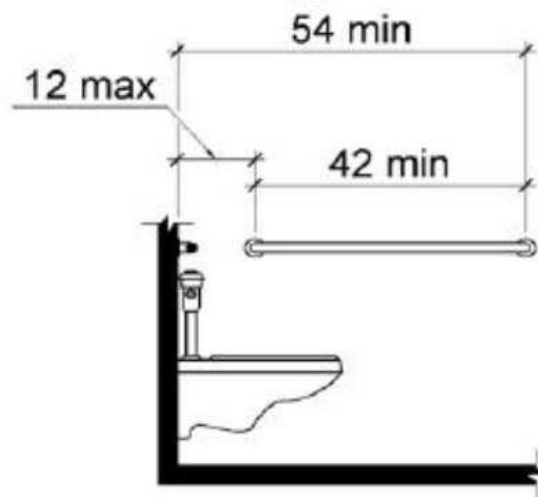
Finding #6 Additional Finding Photos

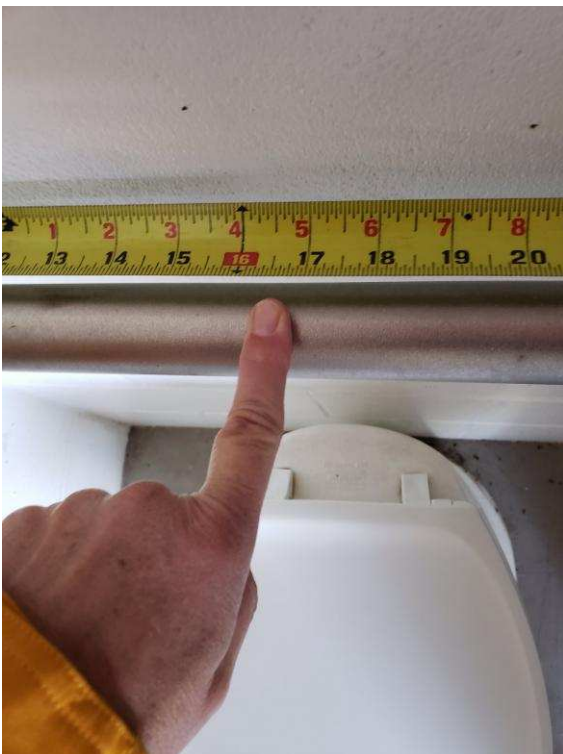
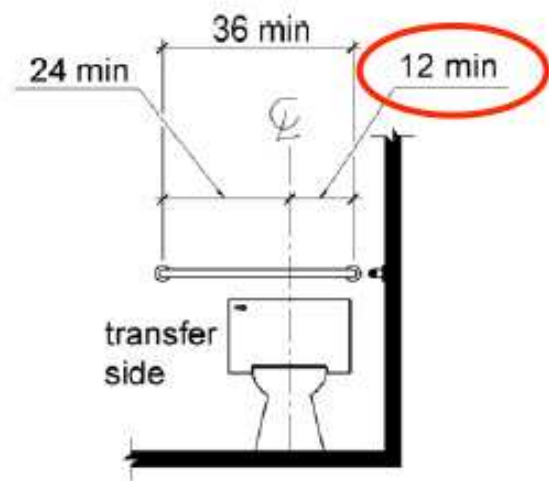
Finding #7 Additional Finding Photos

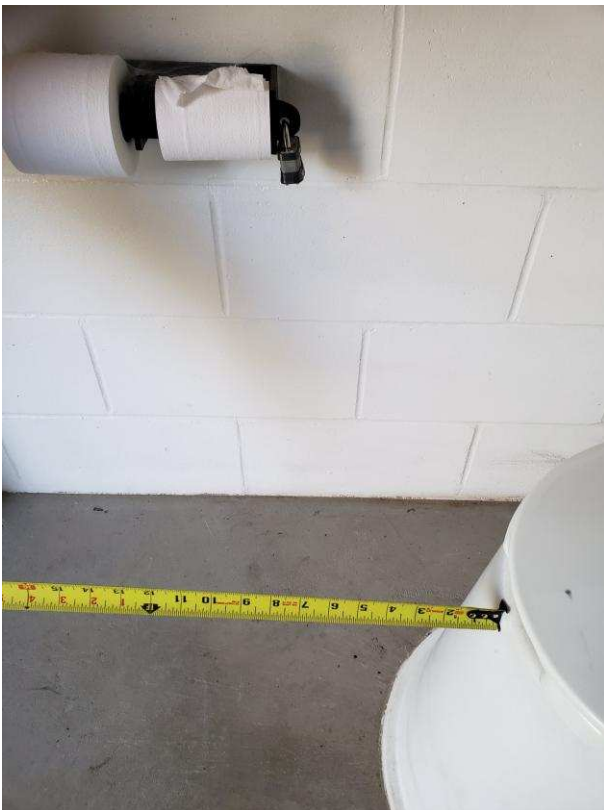
Remount toilet paper dispenser max 7" to 9" from front of toilet, 15" to 48" aff and min 12" above or 1.5" below grab bar

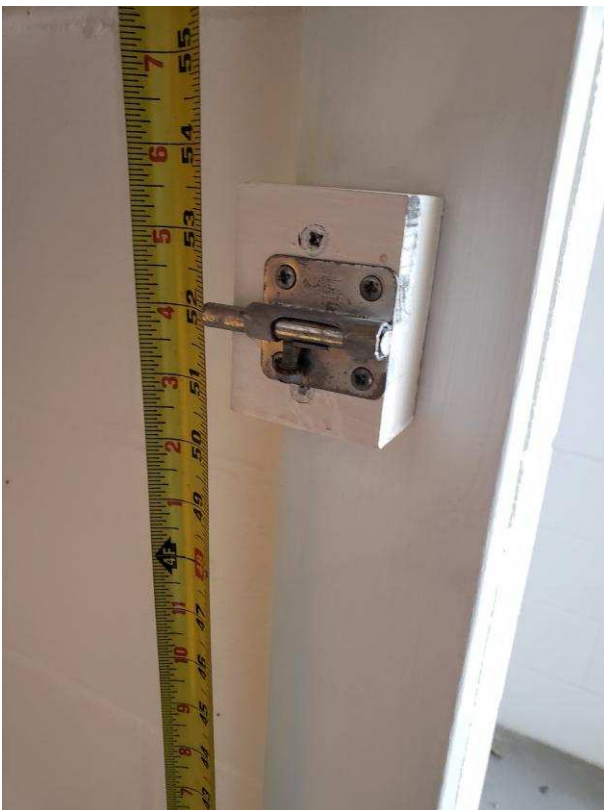
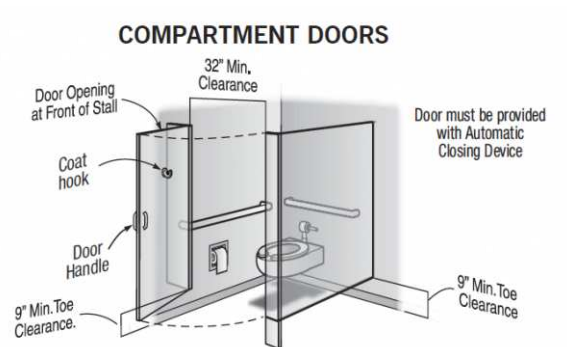
Finding #9 Additional Finding Photos

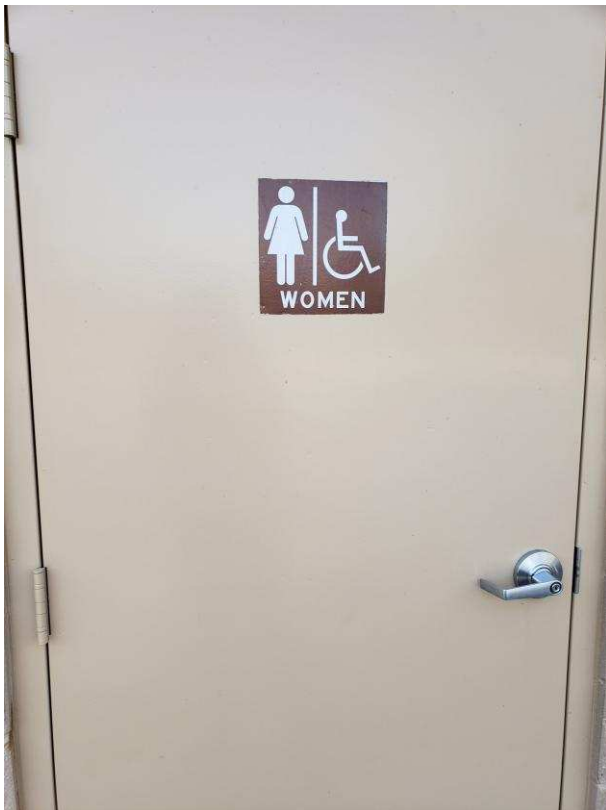
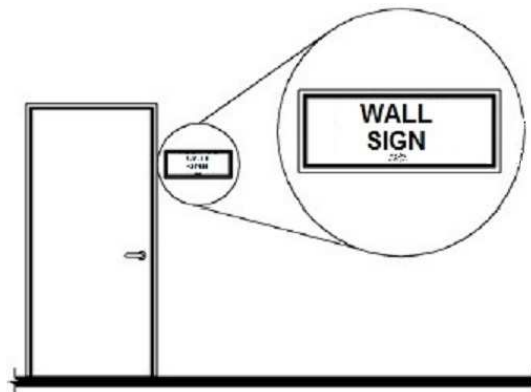
Mount signage at all permanent rooms/spaces having Braille and the international symbol of accessibility, mounted 48" to baseline of lowest character and 60" to the baseline of the highest character sign and on the latch side of the door

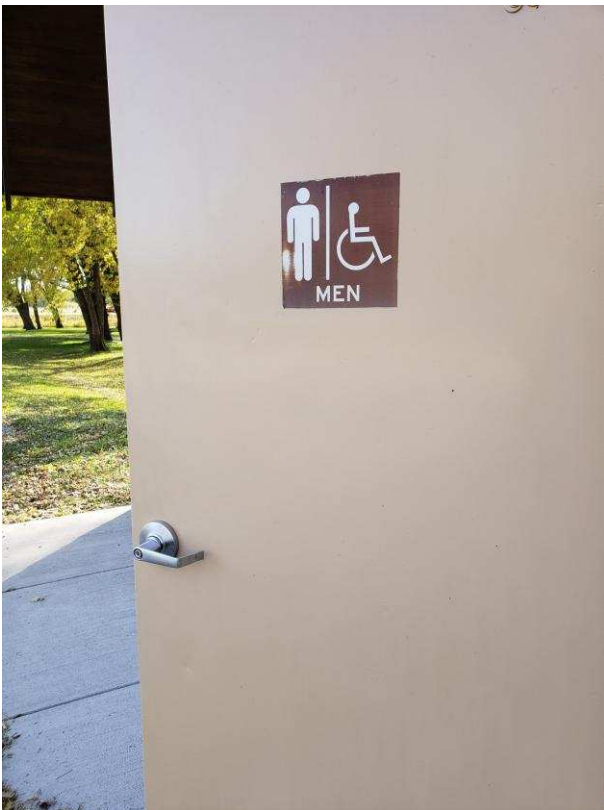
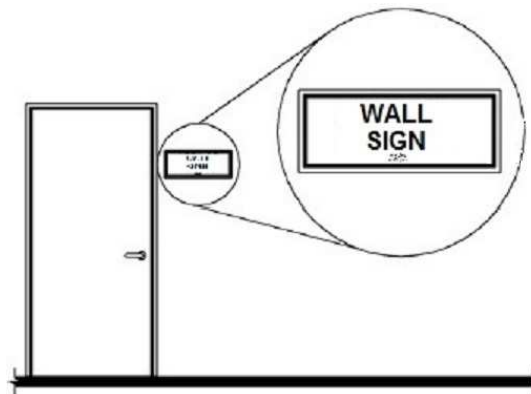
Mount signage at all permanent rooms/spaces having Braille and the international symbol of accessibility, mounted 48" to baseline of lowest character and 60" to the baseline of the highest character sign and on the latch side of the door

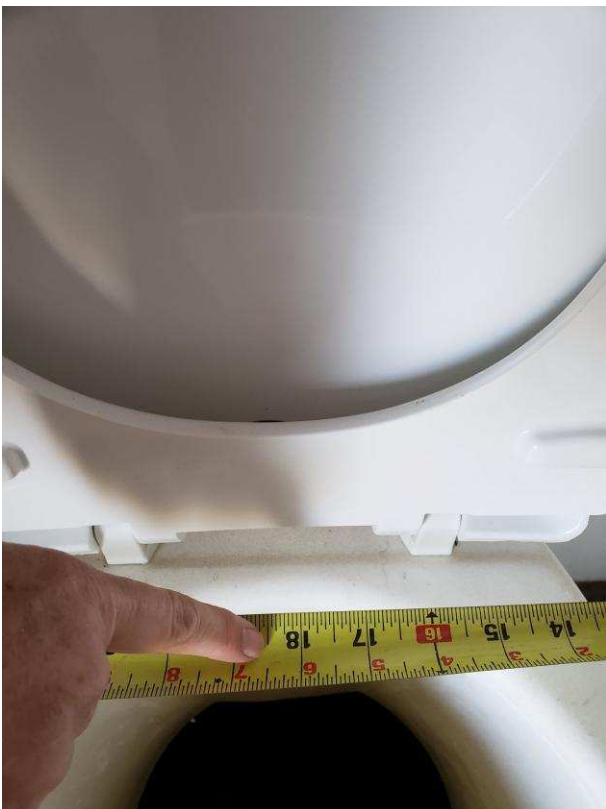
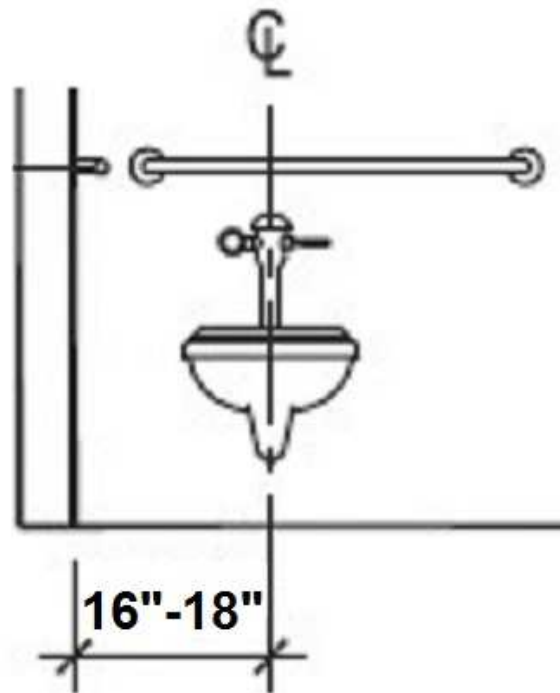
Finding #13 Additional Finding Photos

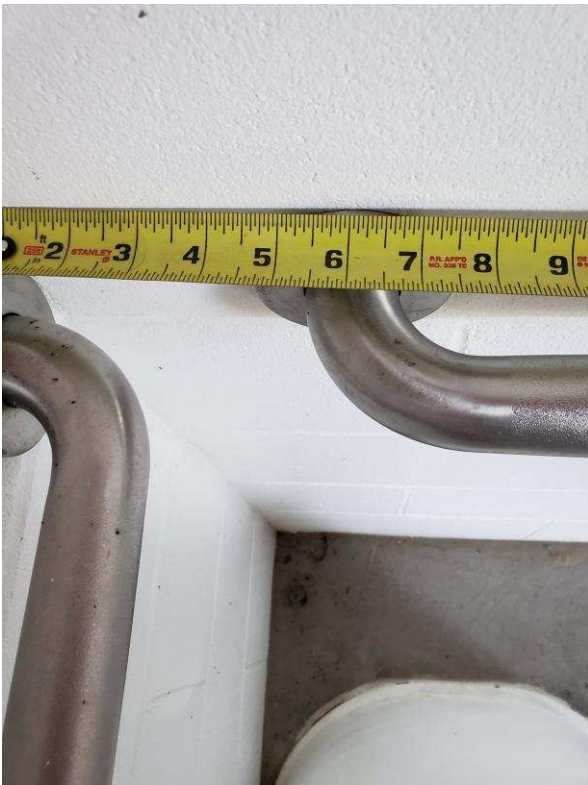
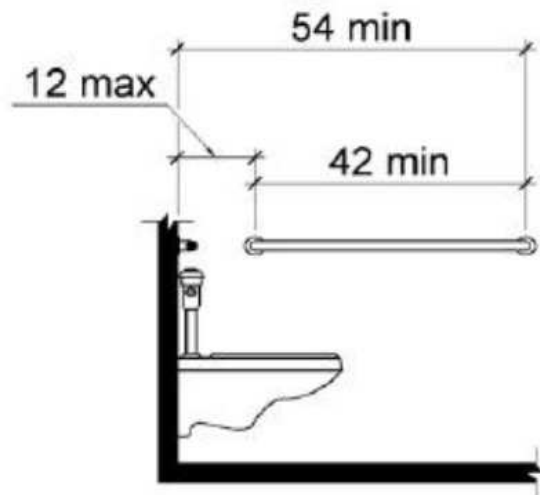
Finding #14 Additional Finding Photos

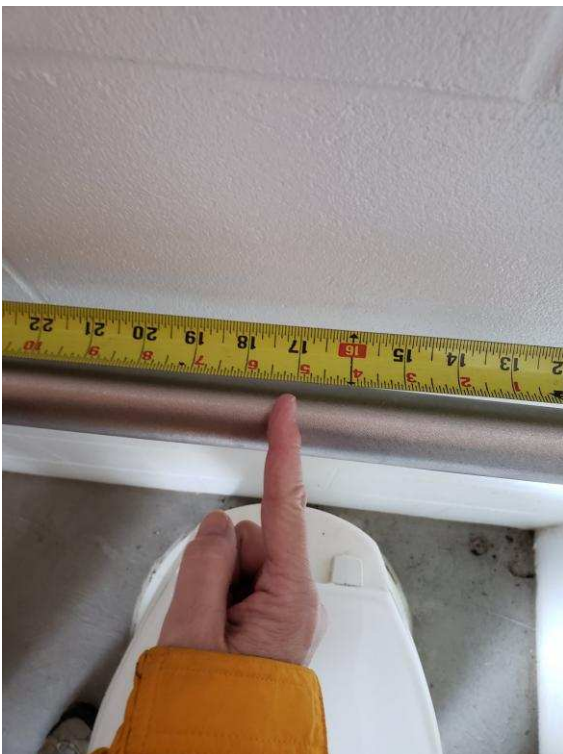
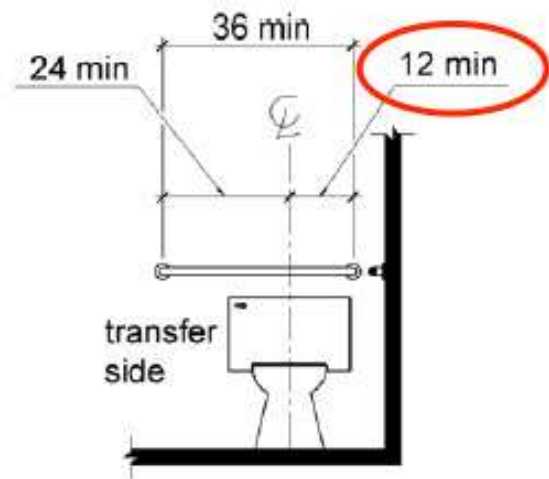
Finding #15 Additional Finding Photos

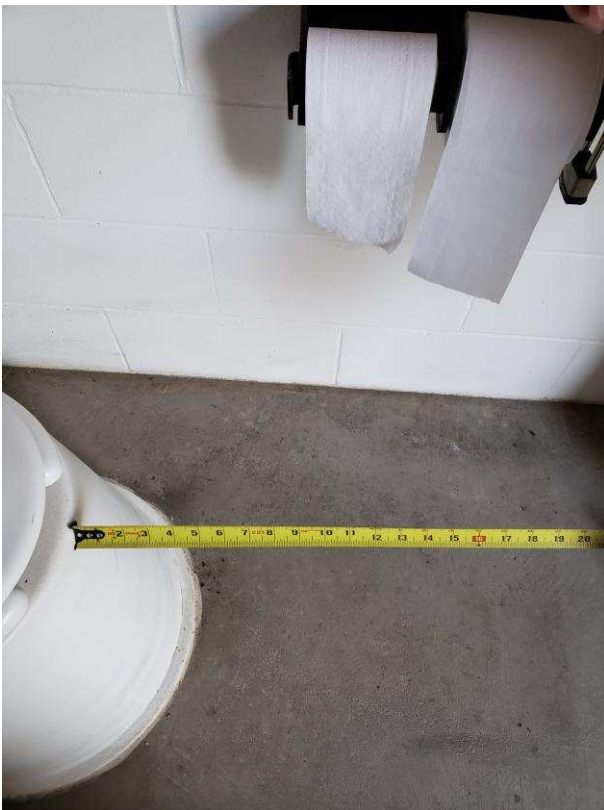
Remount toilet paper dispenser max 7" to 9" from front of toilet, 15" to 48" aff and min 12" above or 1.5" below grab bar

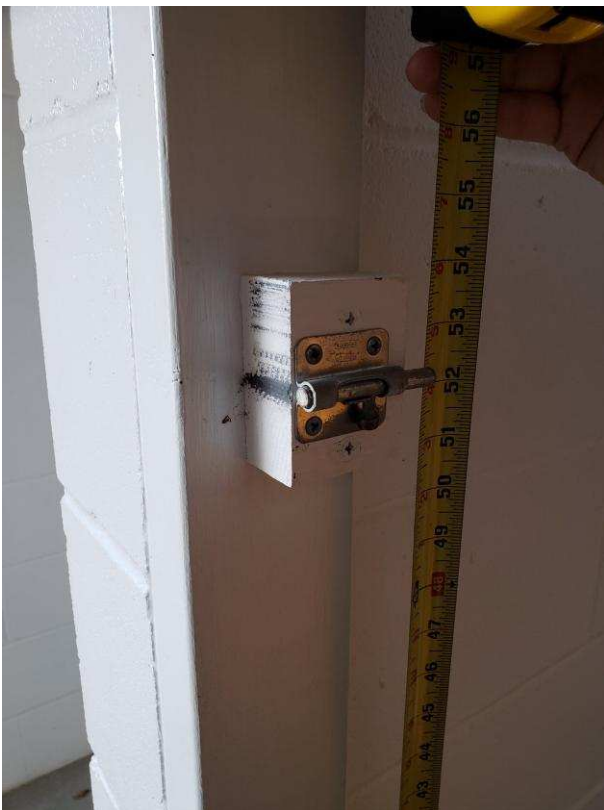
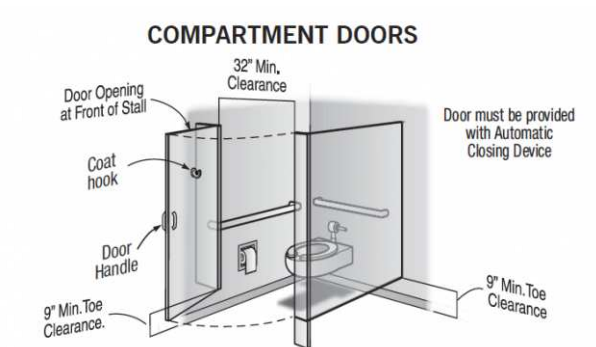
Finding #17 Additional Finding Photos

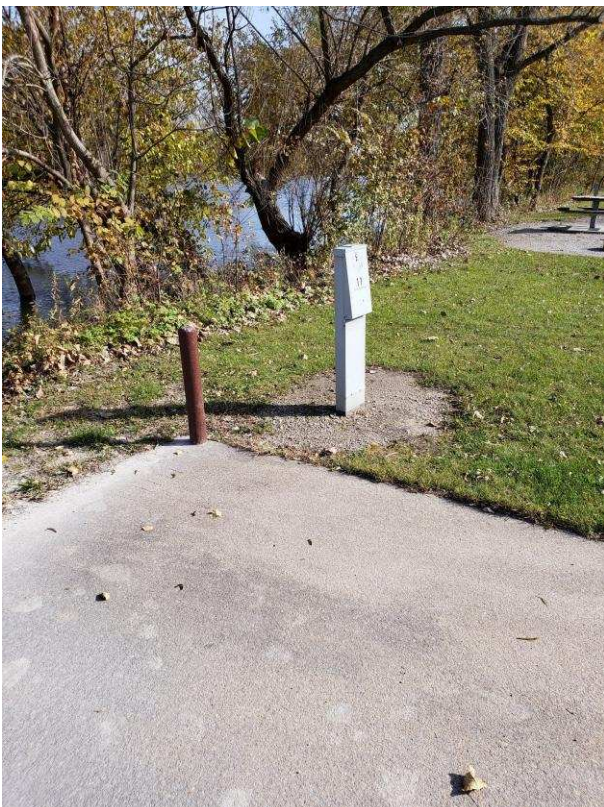
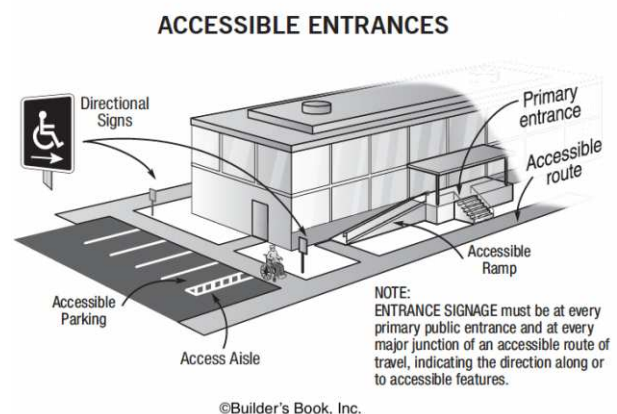
Create an accessible route with crushed stone or other outdoor material from parking or walkway to electrical hook up

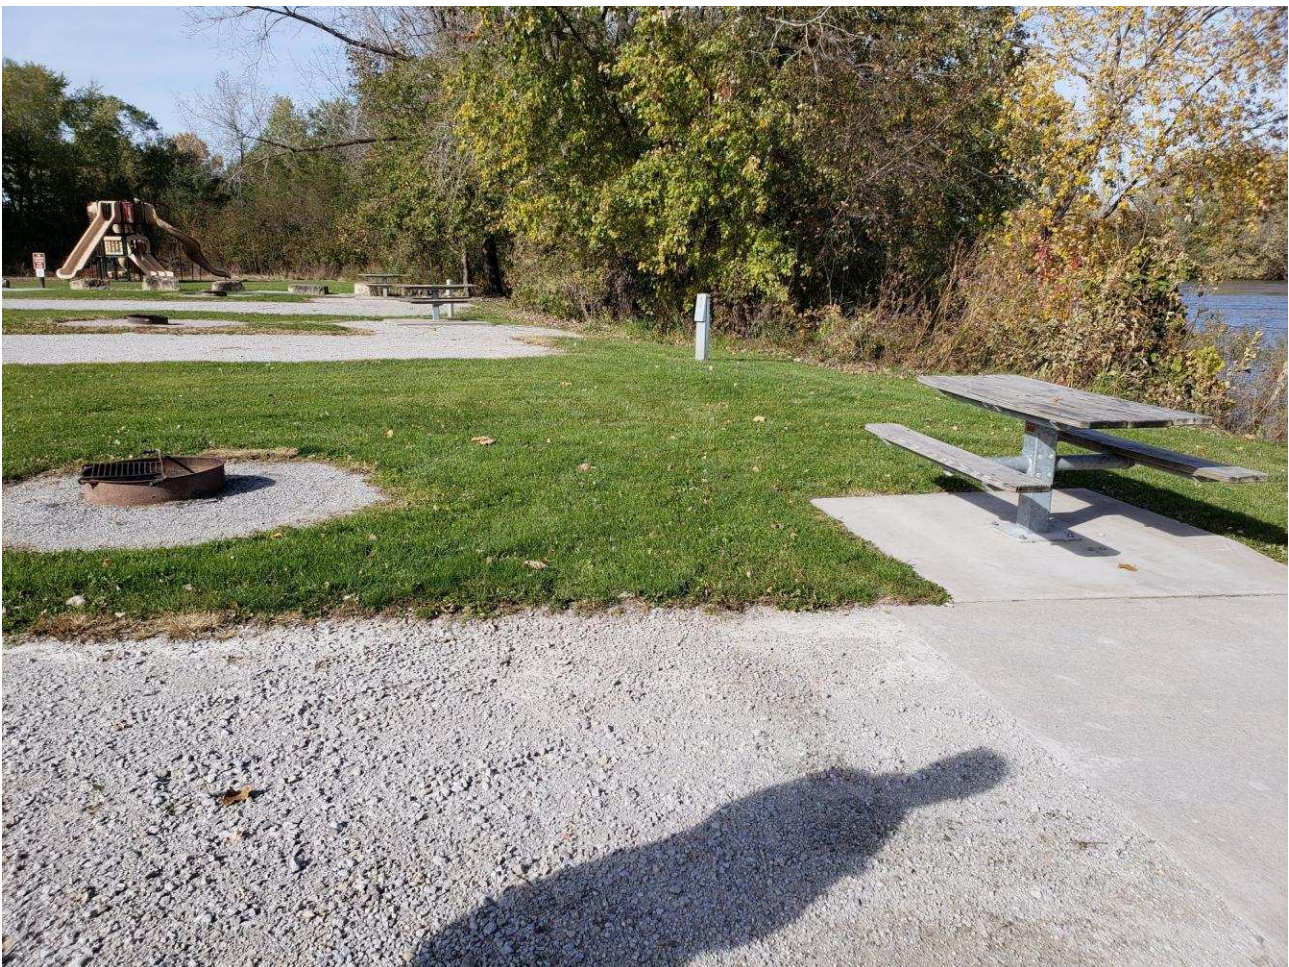
Provide required 48" clear ground space centered along usable side of fire ring, grill, fireplace, or woodstove as a smart practice

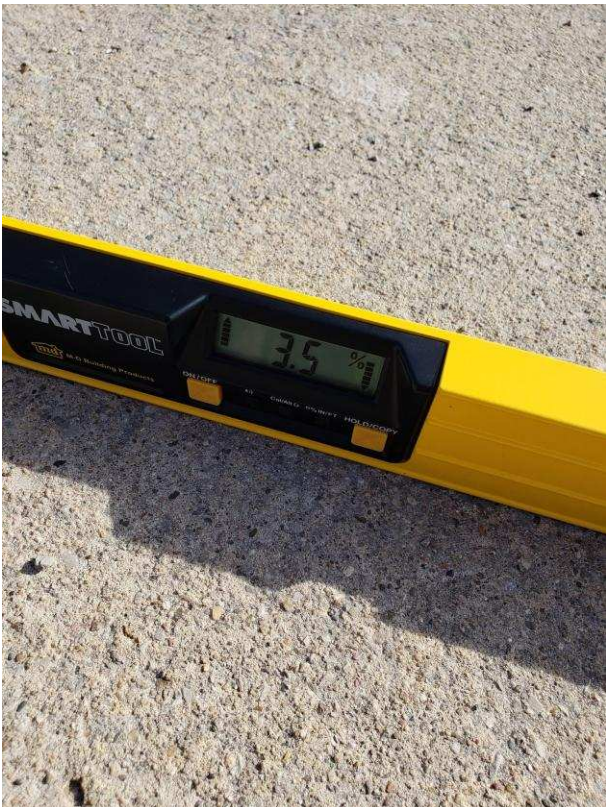
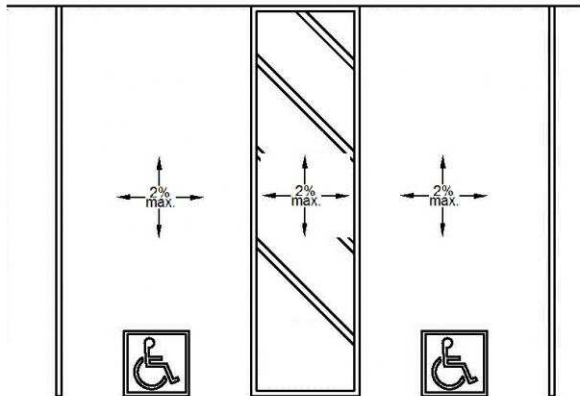
Finding #22 Additional Finding Photos

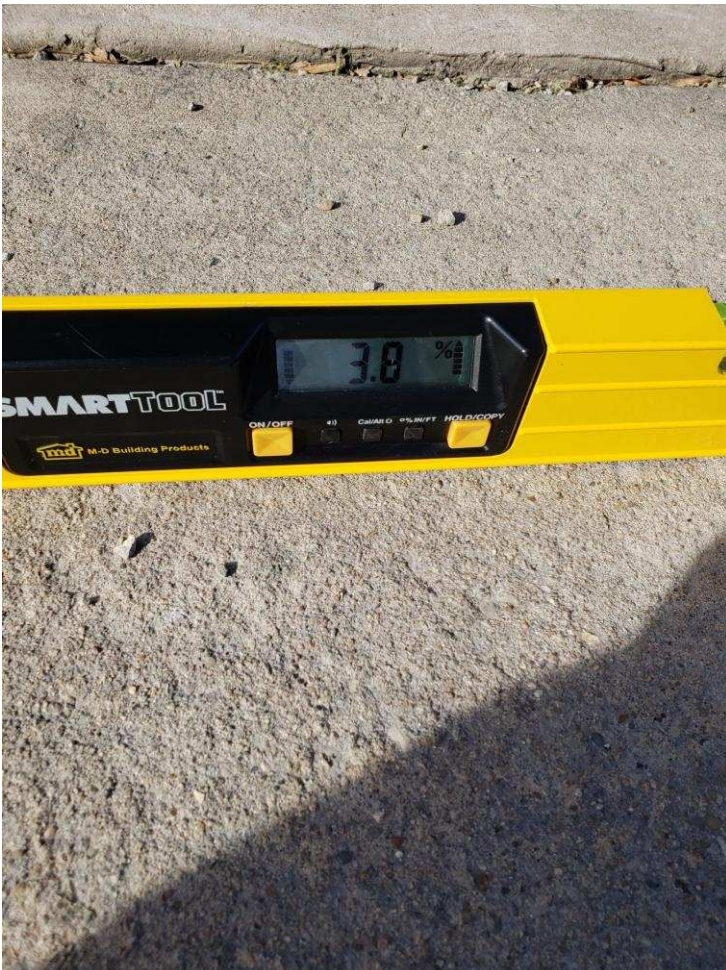
Finding #23 Additional Finding Photos

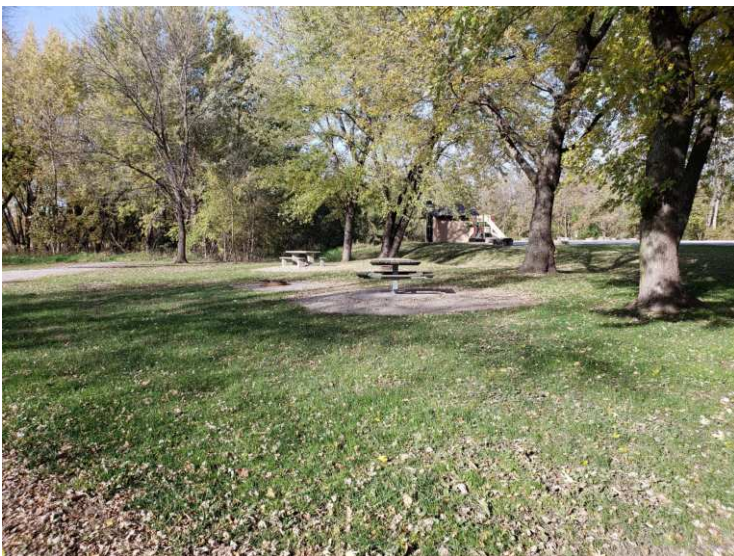
Create the required number of accessible camp sites per table F244.2 as a smart practice; leave as is primitive sites.

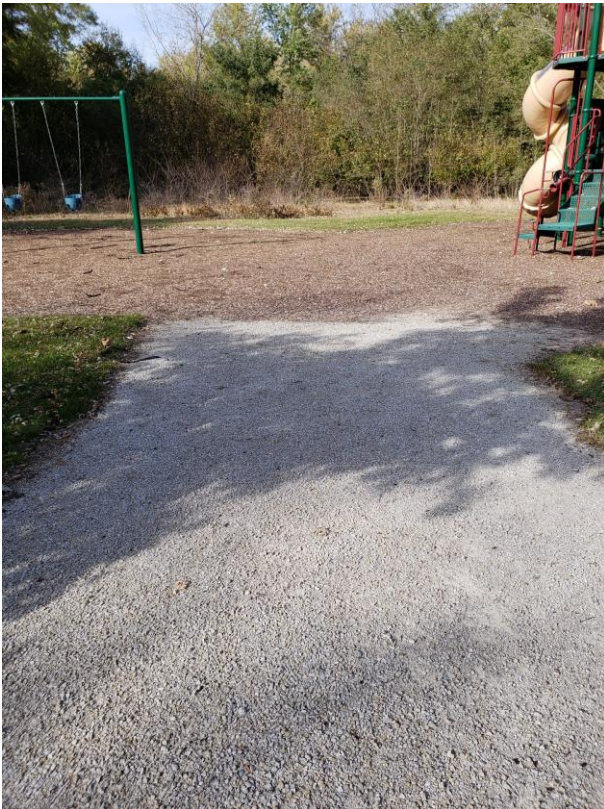
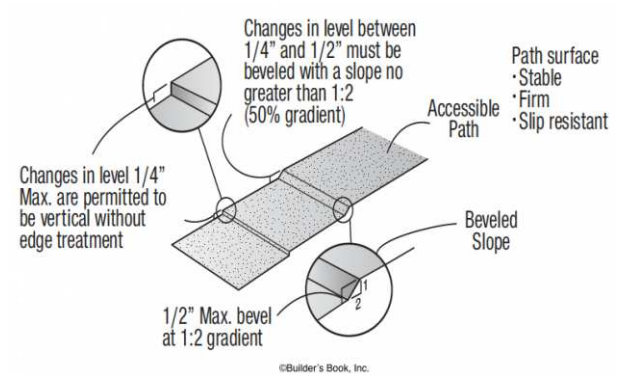
Resurface AR where deterioration occurs

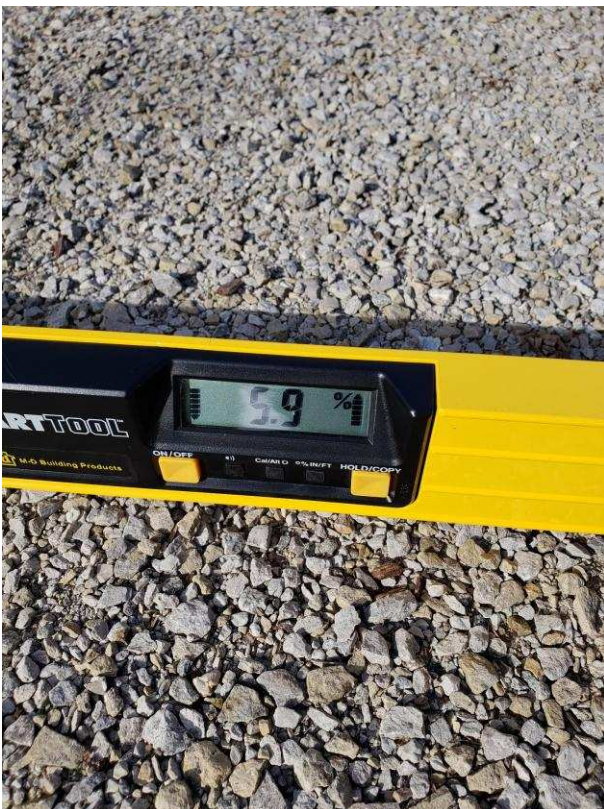
Finding #26 Additional Finding Photos

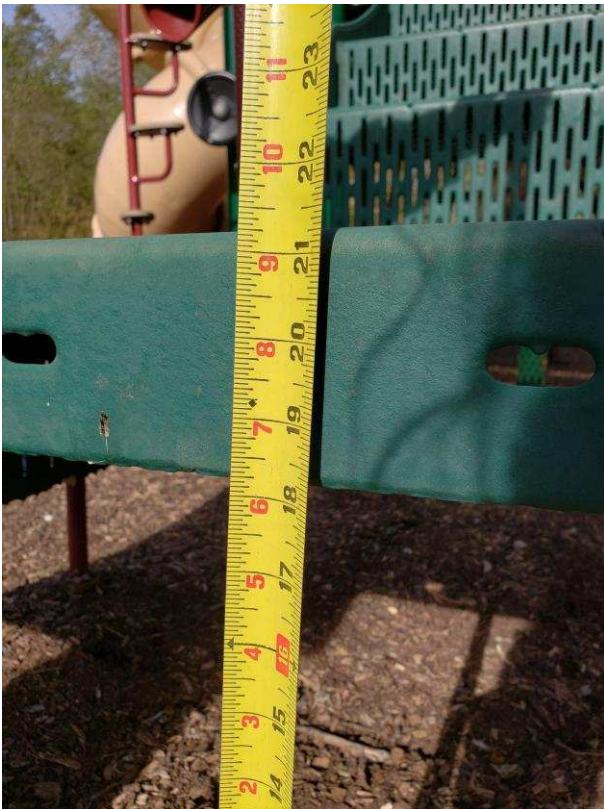
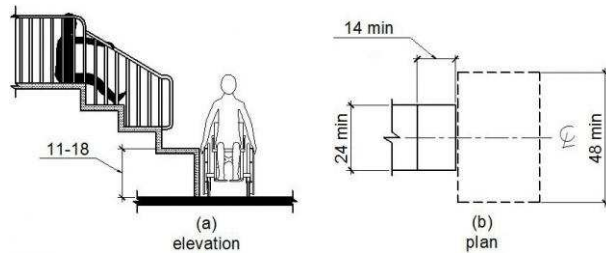
Finding #28 Additional Finding Photos
