Site Accessibility Evaluation

Schwab-Burford

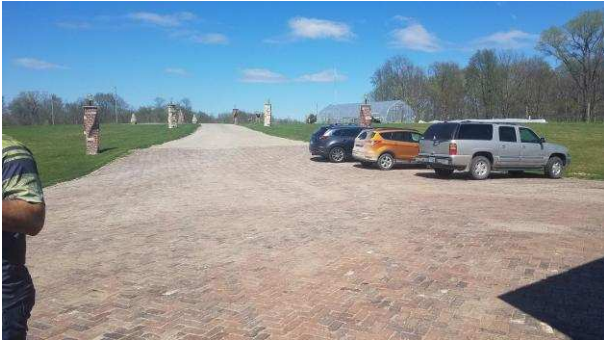
Total Number of Parking Spaces Provided in Parking Facility	Minimum Number of Required Accessible Parking Spaces
1 to 25	1
26 to 50	2
51 to 75	3
76 to 100	4
101 to 150	5
151 to 200	6
201 to 300	7
301 to 400	8
401 to 500	9
501 to 1000	2 percent of total
1001 and over	20, plus 1 for each 100, or fraction thereof, over 1000

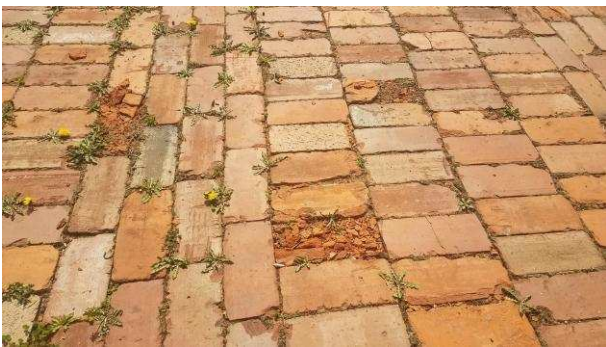
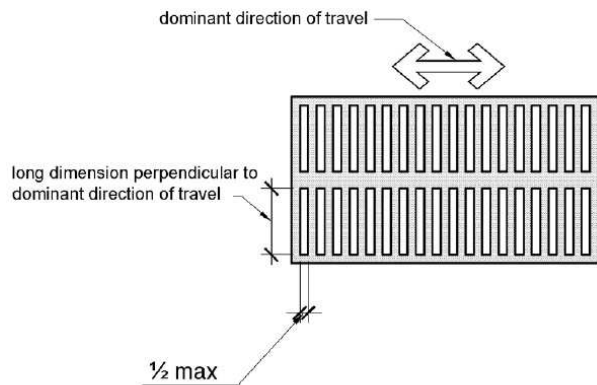
Finding #2 Additional Finding Photos

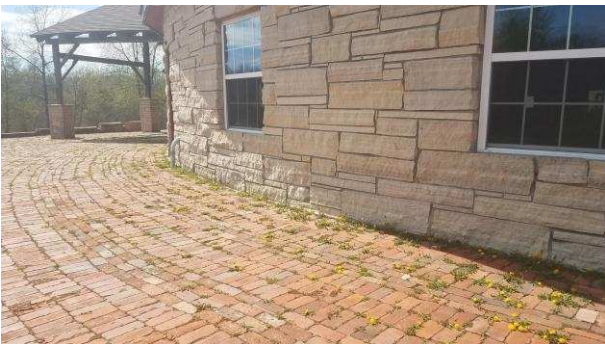
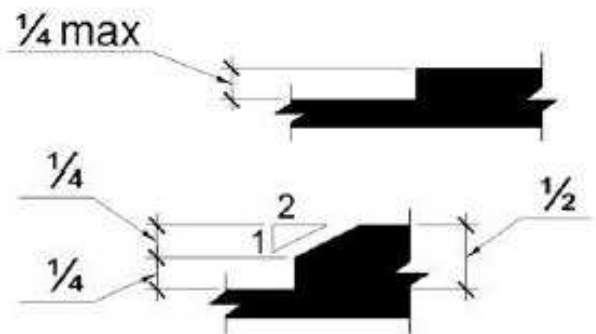
Repair or reset pavers to eliminate CIL

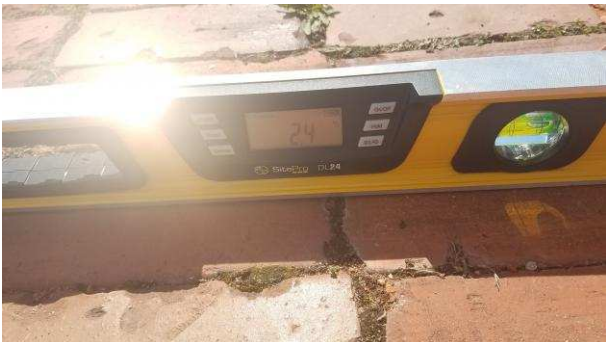
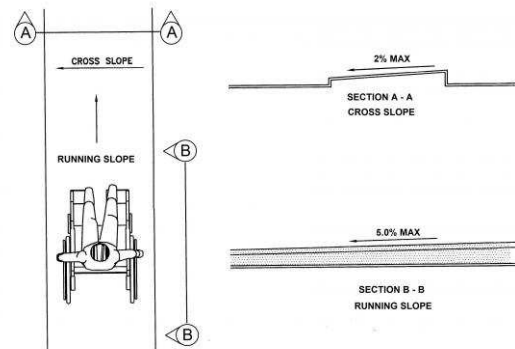
Finding #4 Additional Finding Photos

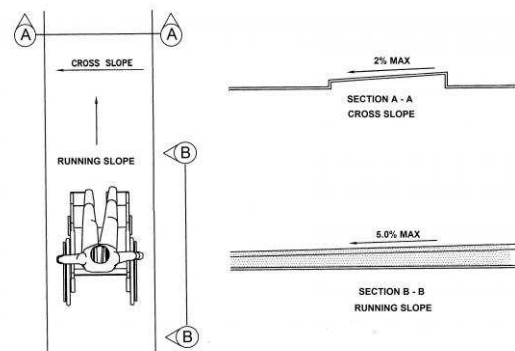
Correct or repair cross slope along AR to max 2.08%

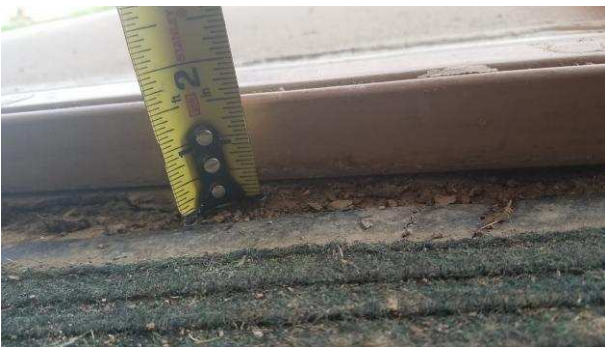
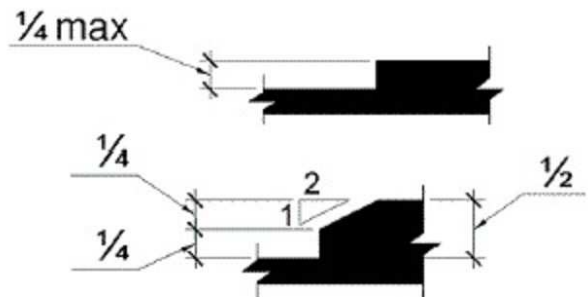
Finding #6 Additional Finding Photos

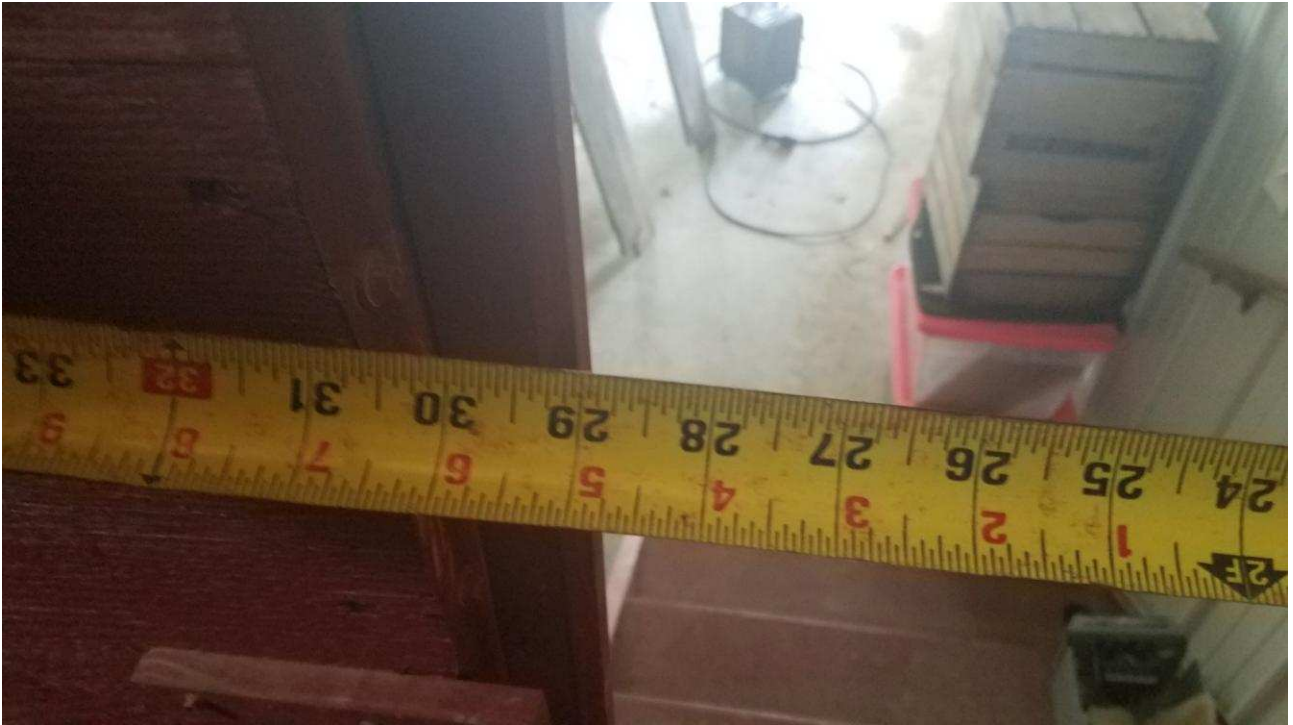
Finding #7 Additional Finding Photos

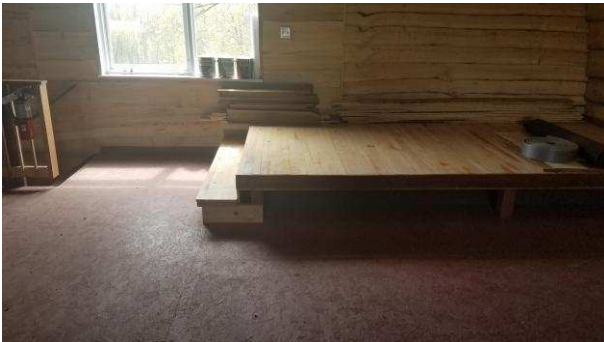
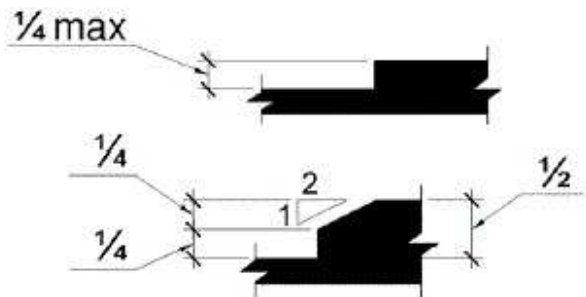
Repair, bevel or ramp CIL along AR to max .25"

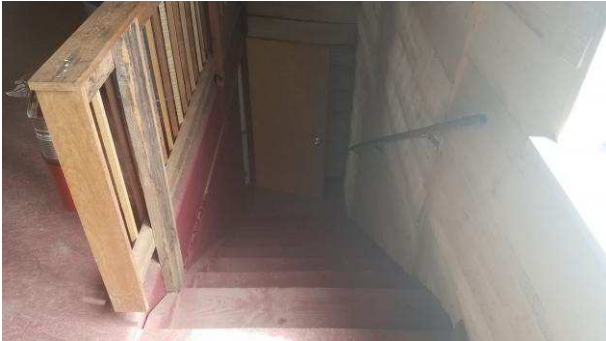
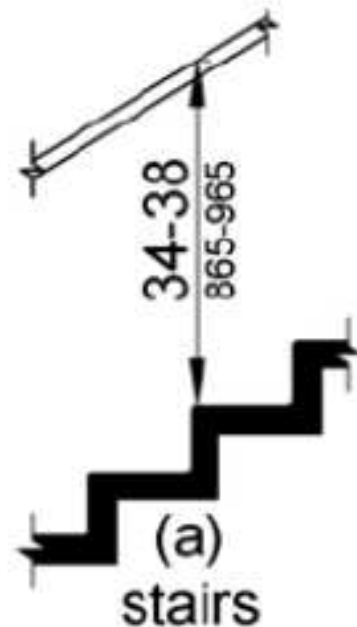
Finding #9 Additional Finding Photos

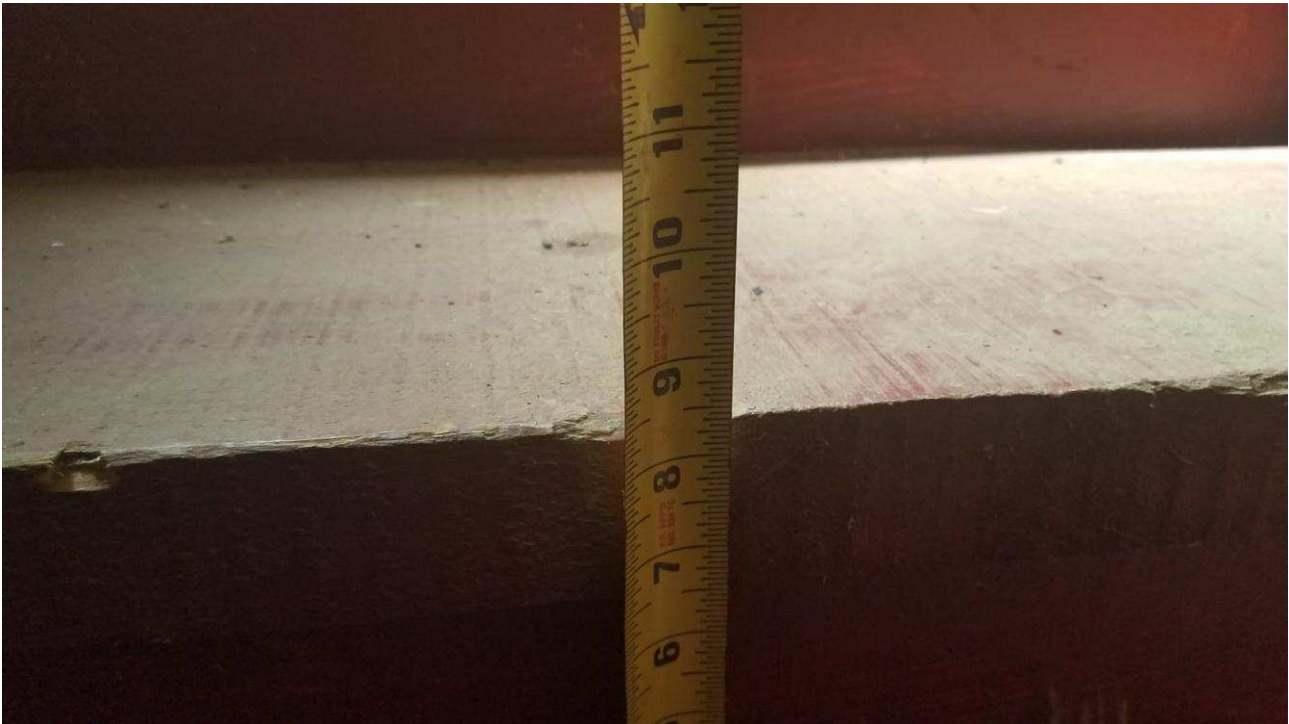
Finding #10 Additional Finding Photos

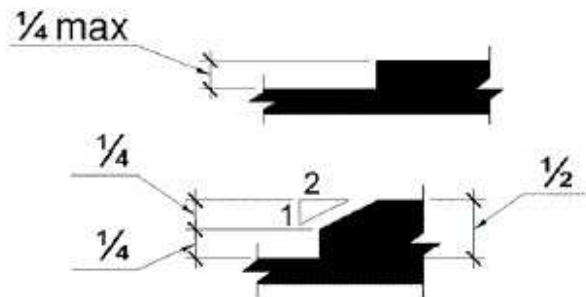
Leave as is, and provide alternate if activity is schedule for this space

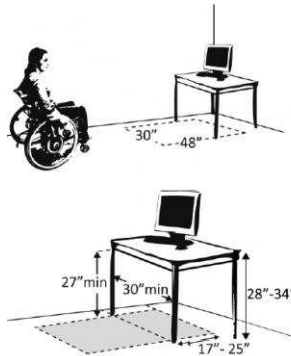
Replace 5% of the tables with ones providing required knee and toe clearances

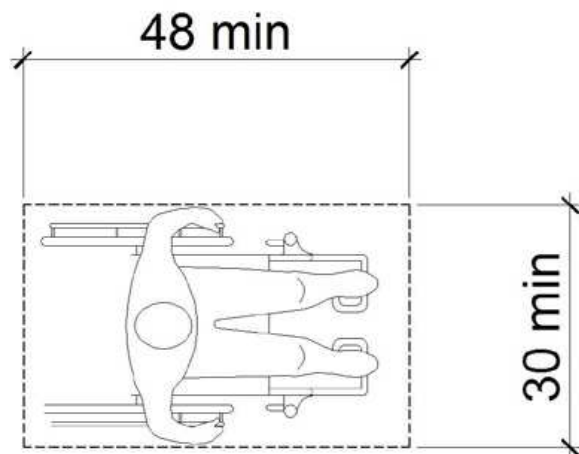
Remove, or relocate storage in CFS at fixtures and operable parts along the AR

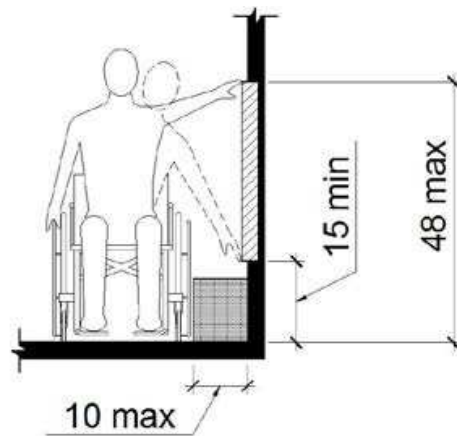
Lower operating mechanisms to max 48" aff to highest operable part; leave as is if employee only operated

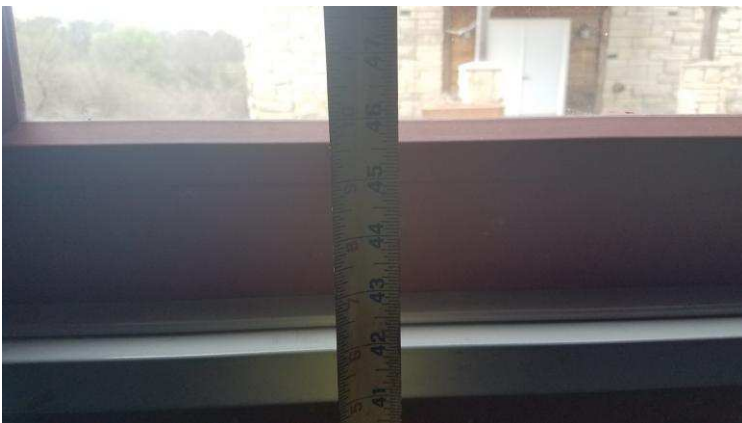
Finding #15 Additional Finding Photos

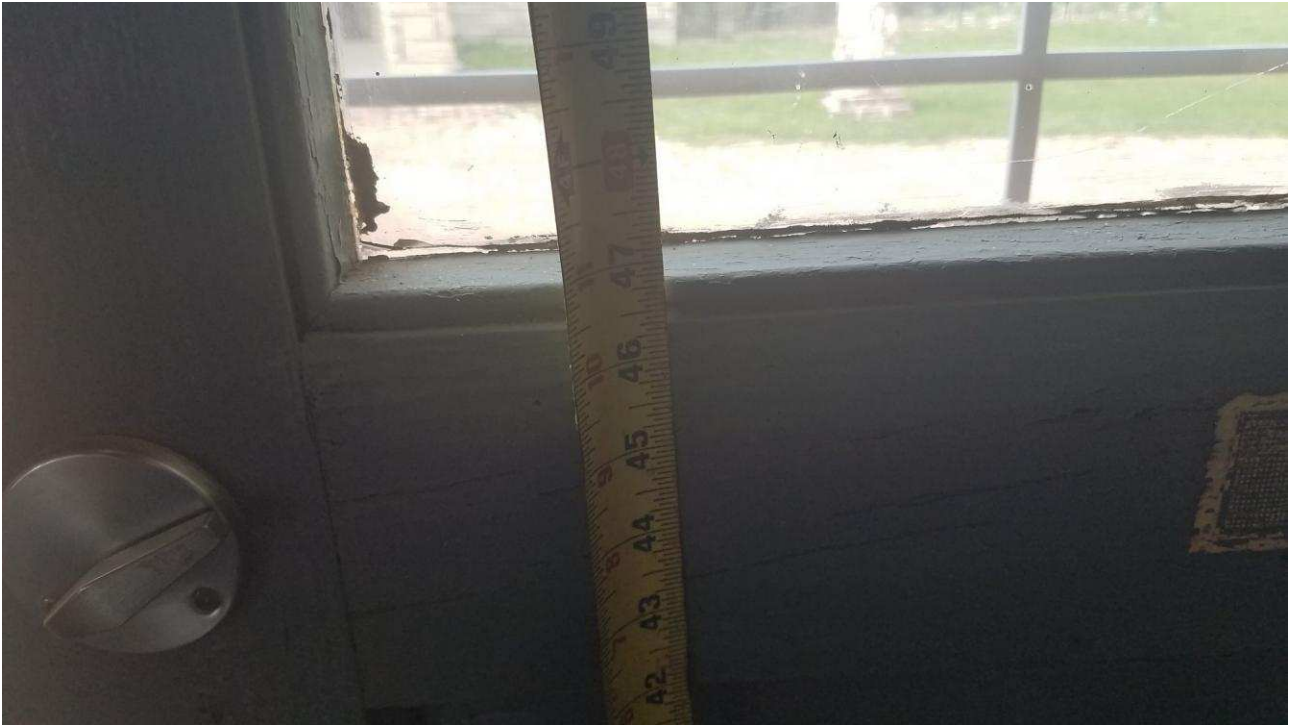
Finding #16 Additional Finding Photos

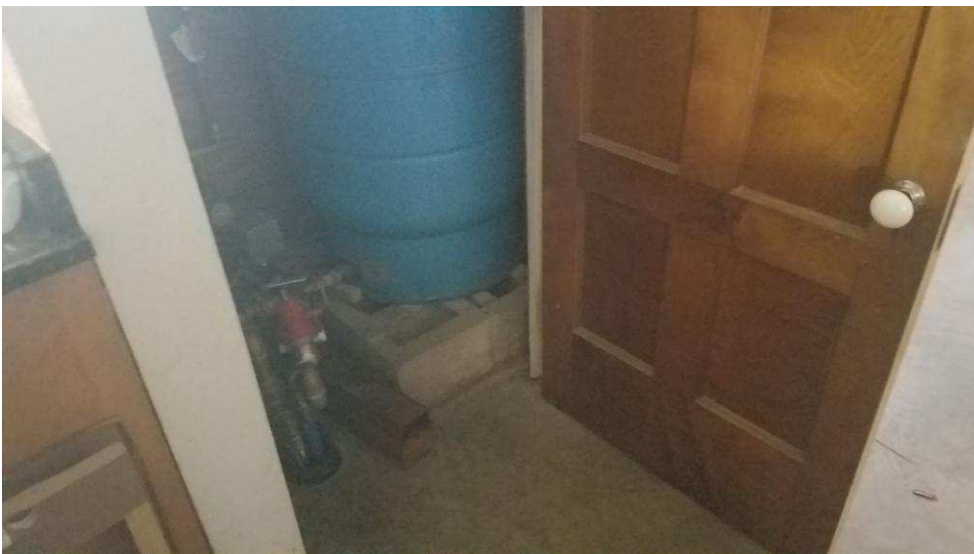
Finding #17 Additional Finding Photos

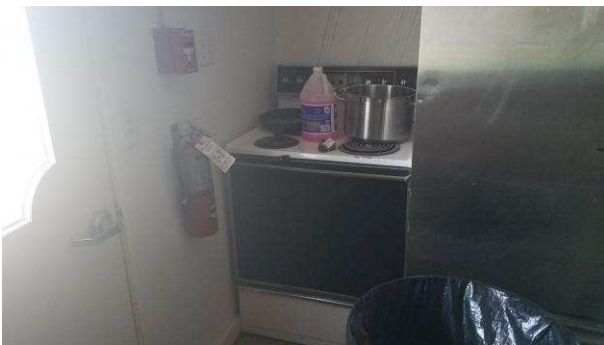
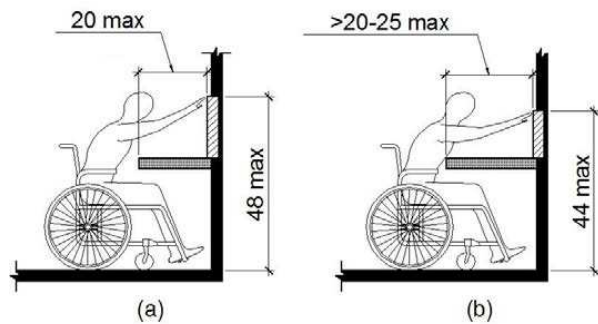
Replace oven with one having controls on the front panel

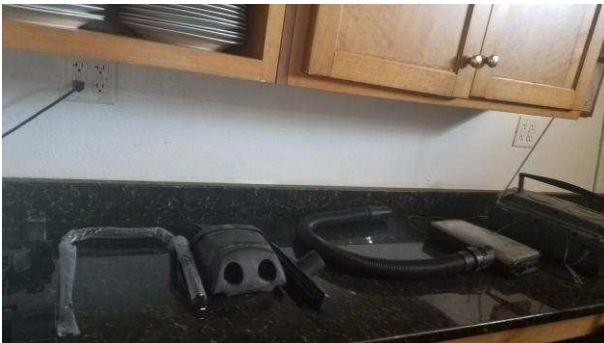
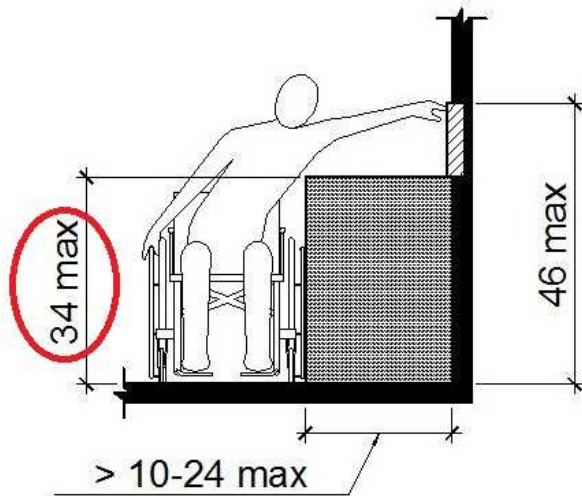
Lower outlets to max 46" for a side reach over counter

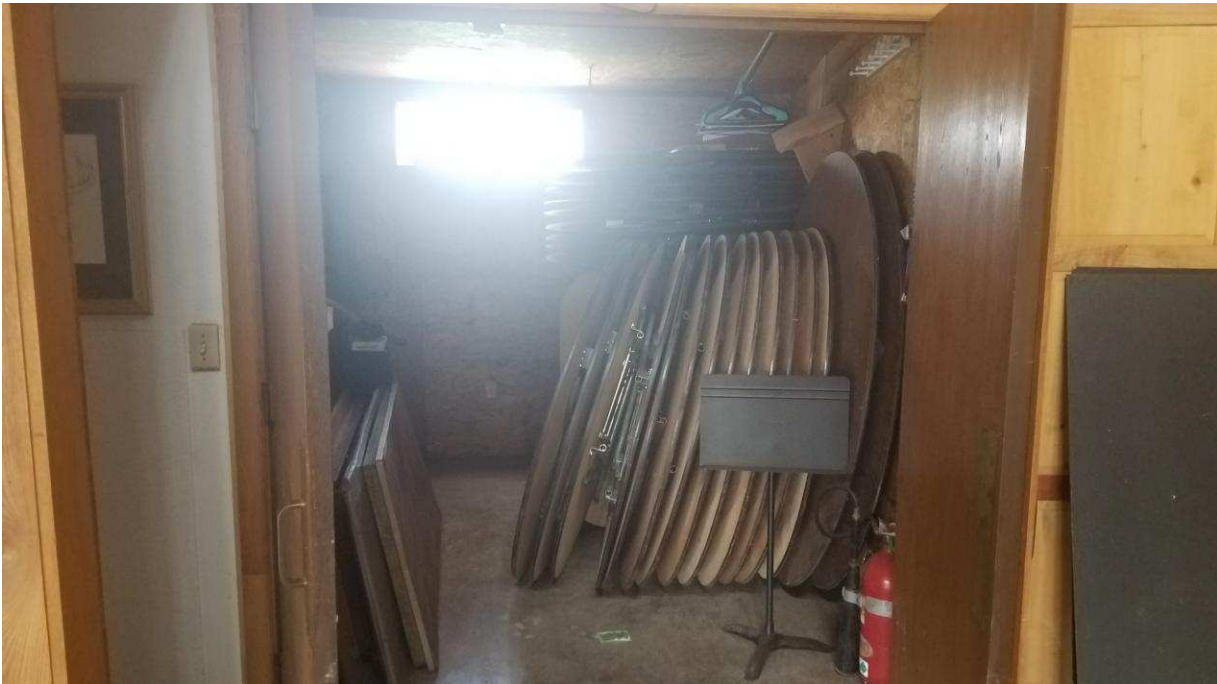
Finding #22 Additional Finding Photos

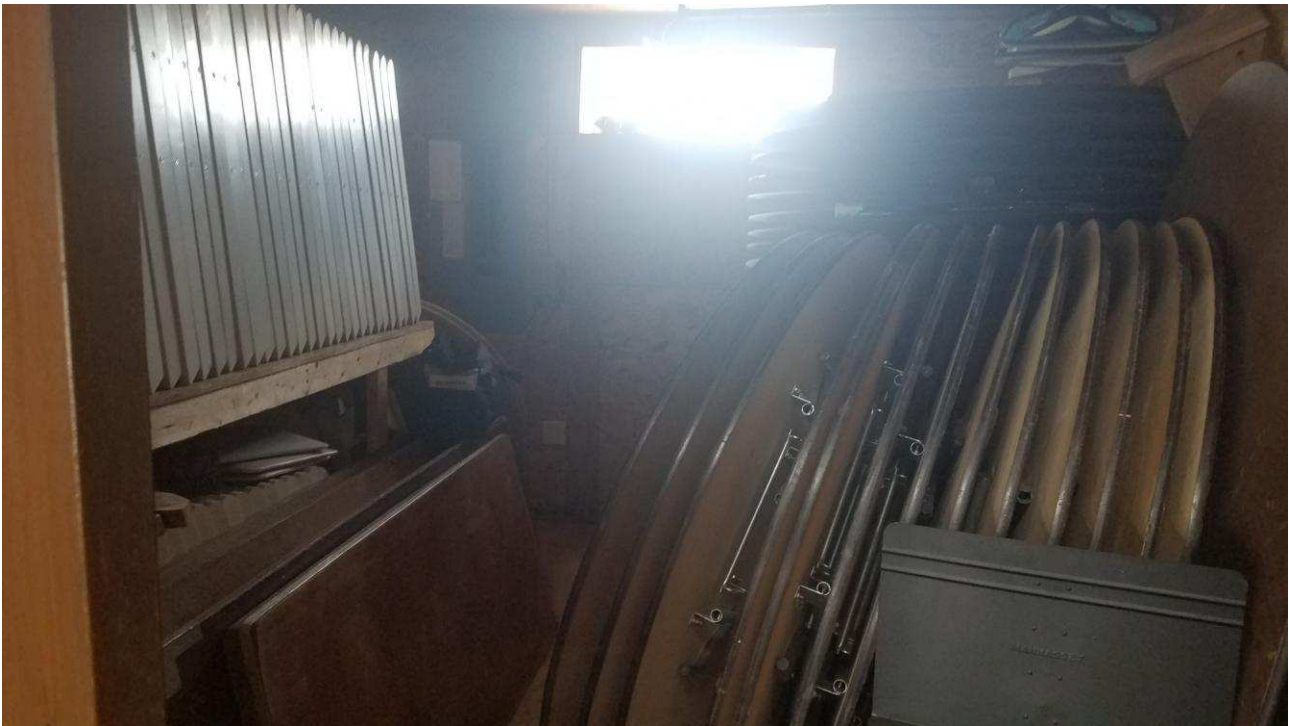
Relocate storage for 36" clear path through room

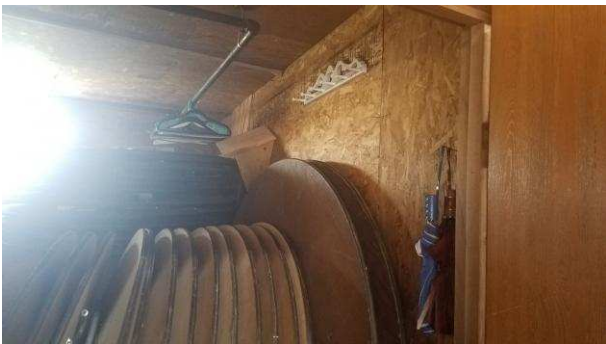
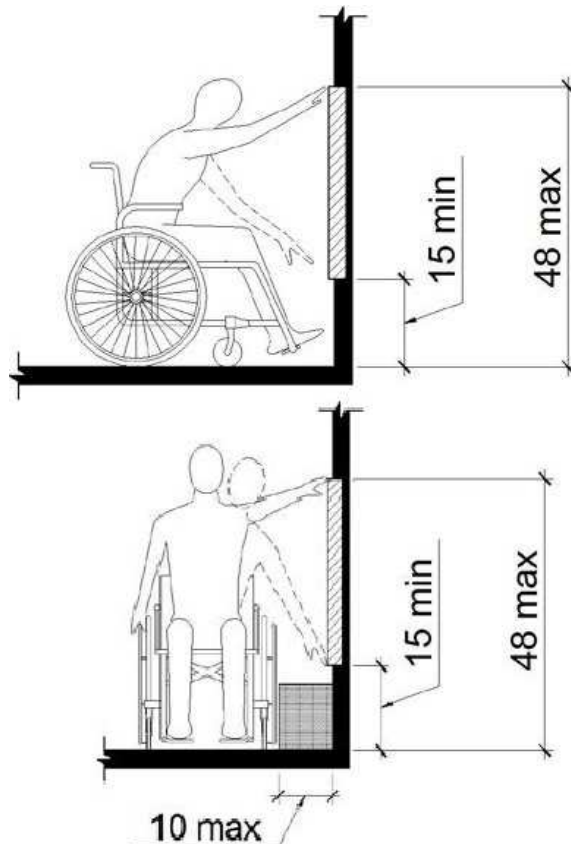
For deficit, leave as is, employee work area pursuant to 2010 Standards 106.5 Defined Terms, until an employee with a disability works here

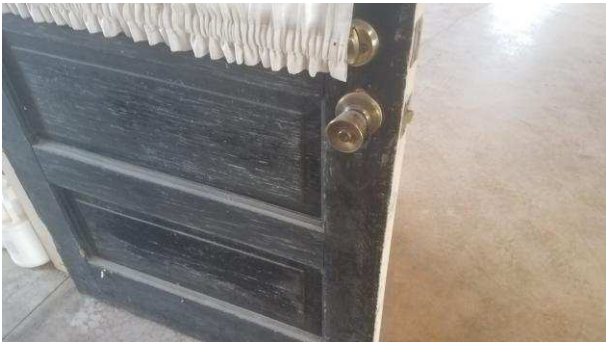
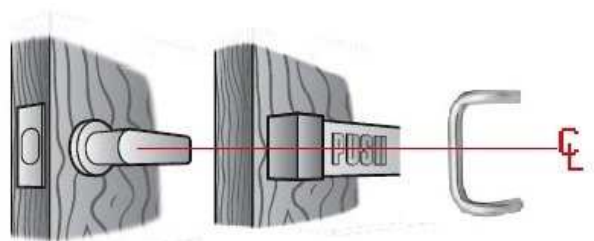
Lever Panic Bar Loop Handle

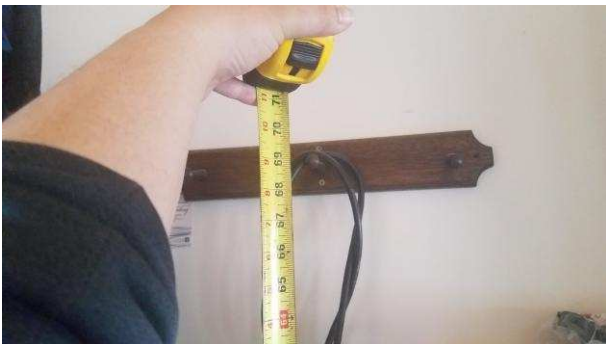
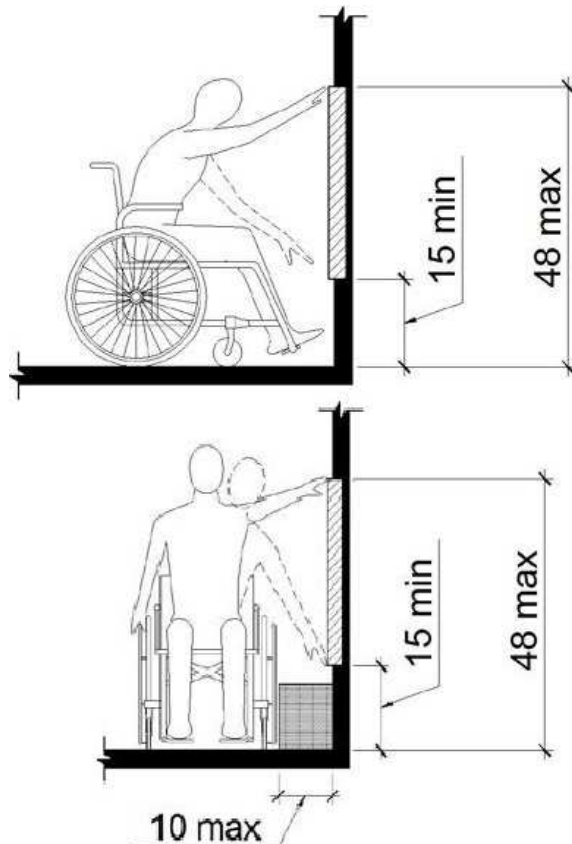
Finding #26 Additional Finding Photos

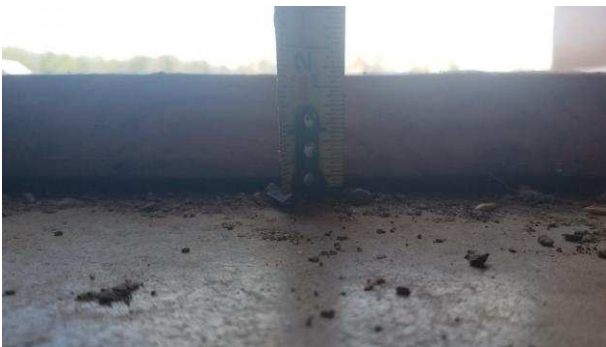
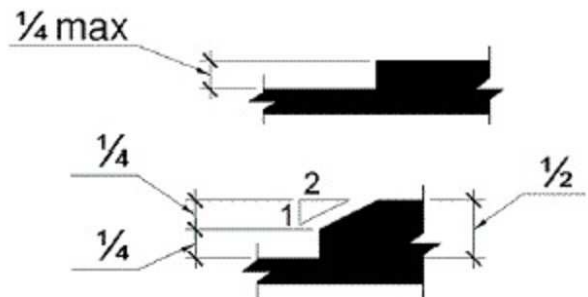
Repair, bevel, or ramp CIL at door entries to max .25"; or provide beveled threshold

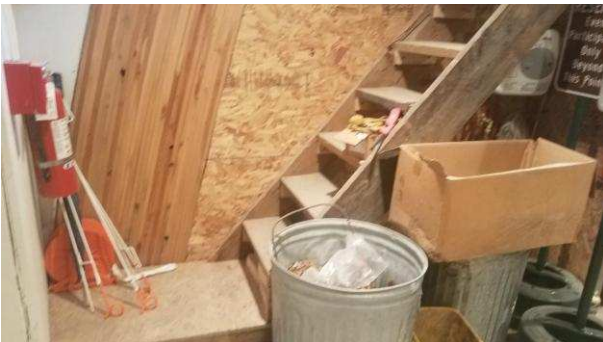
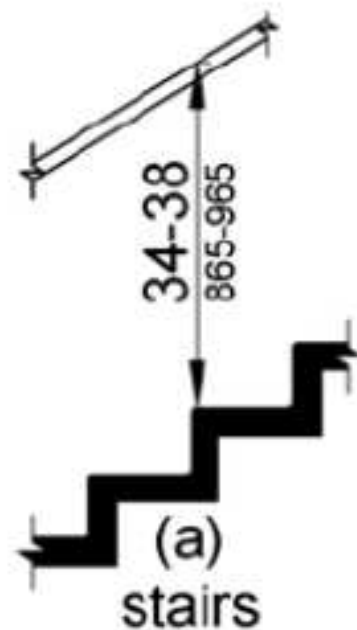
Finding #29 Additional Finding Photos

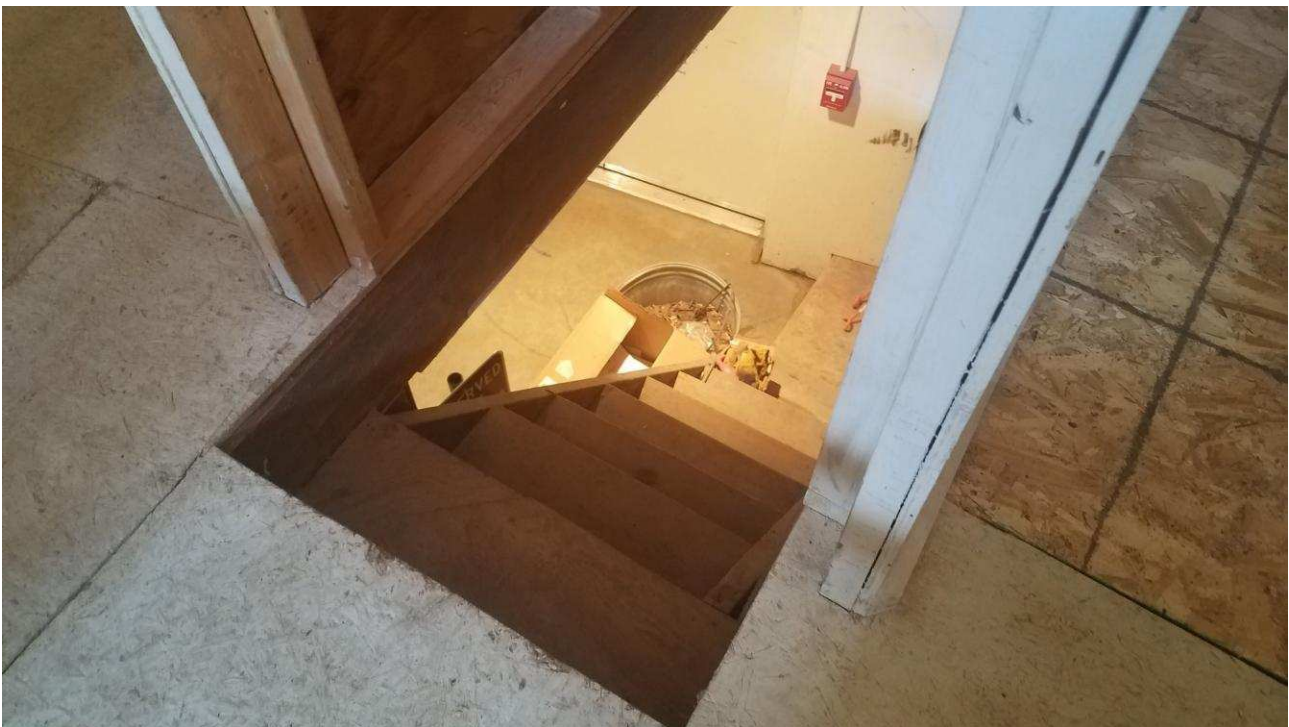
Instill kick plates or replace stairs with ones having closed risers

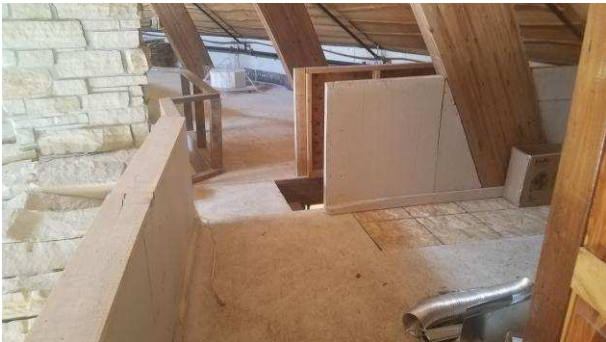
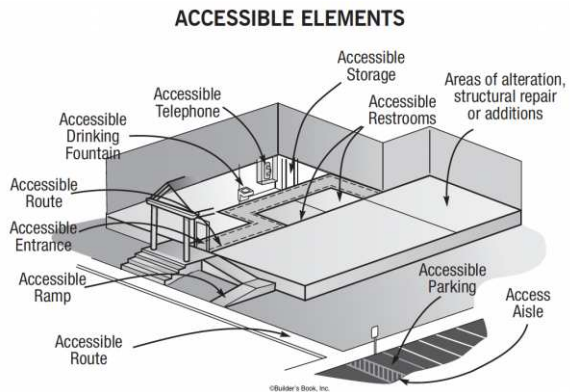
Leave as is, employee area only

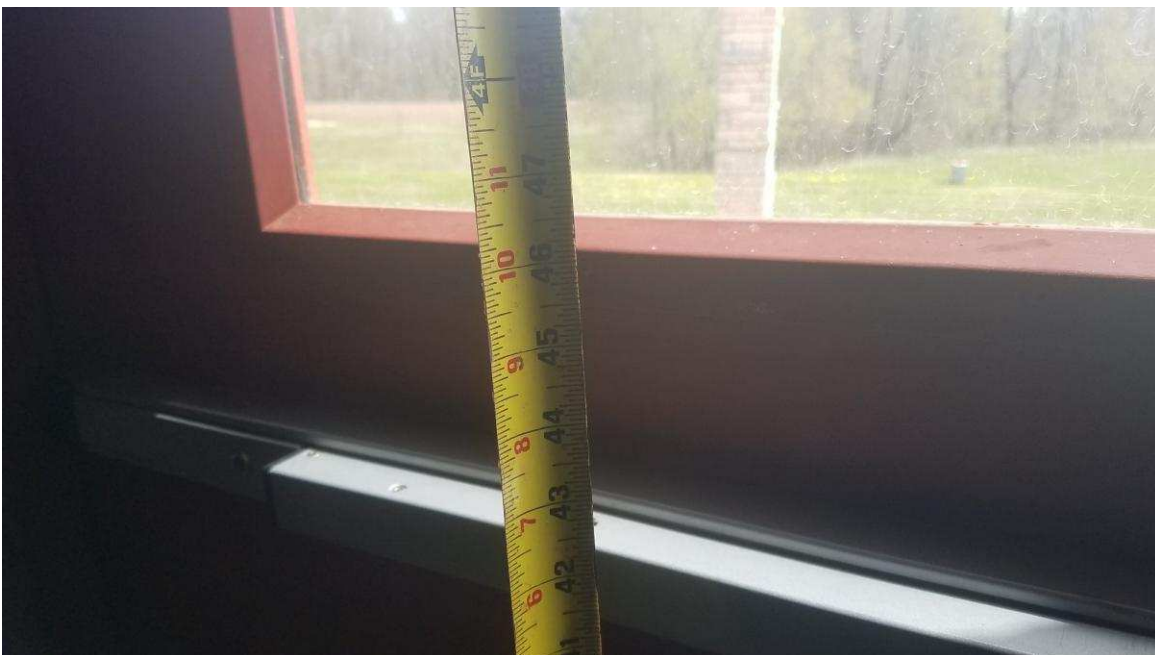
Finding #32 Additional Finding Photos

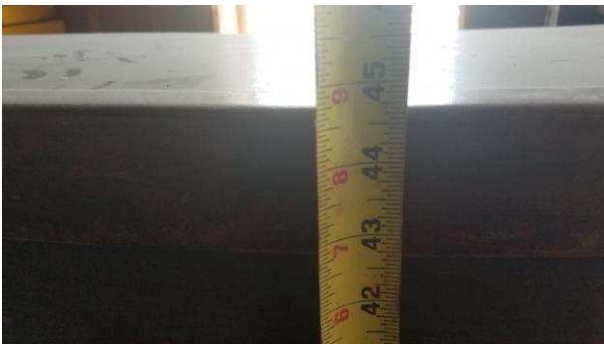
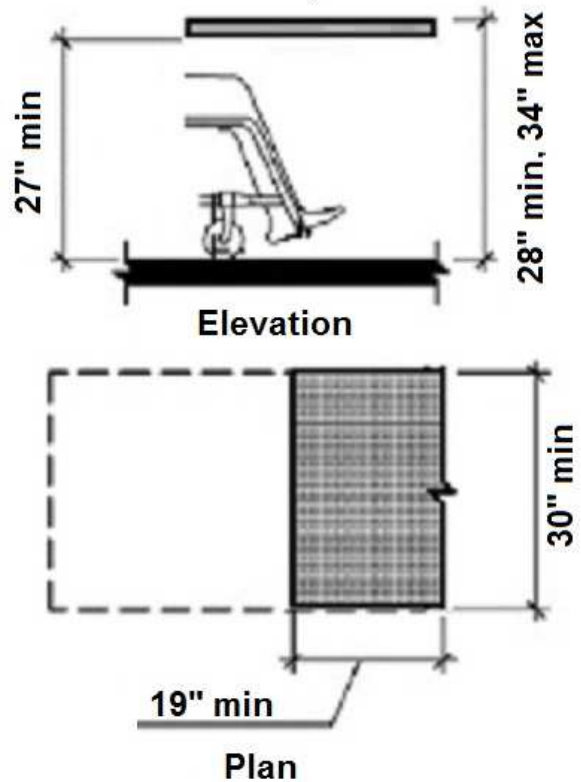
Finding #33 Additional Finding Photos

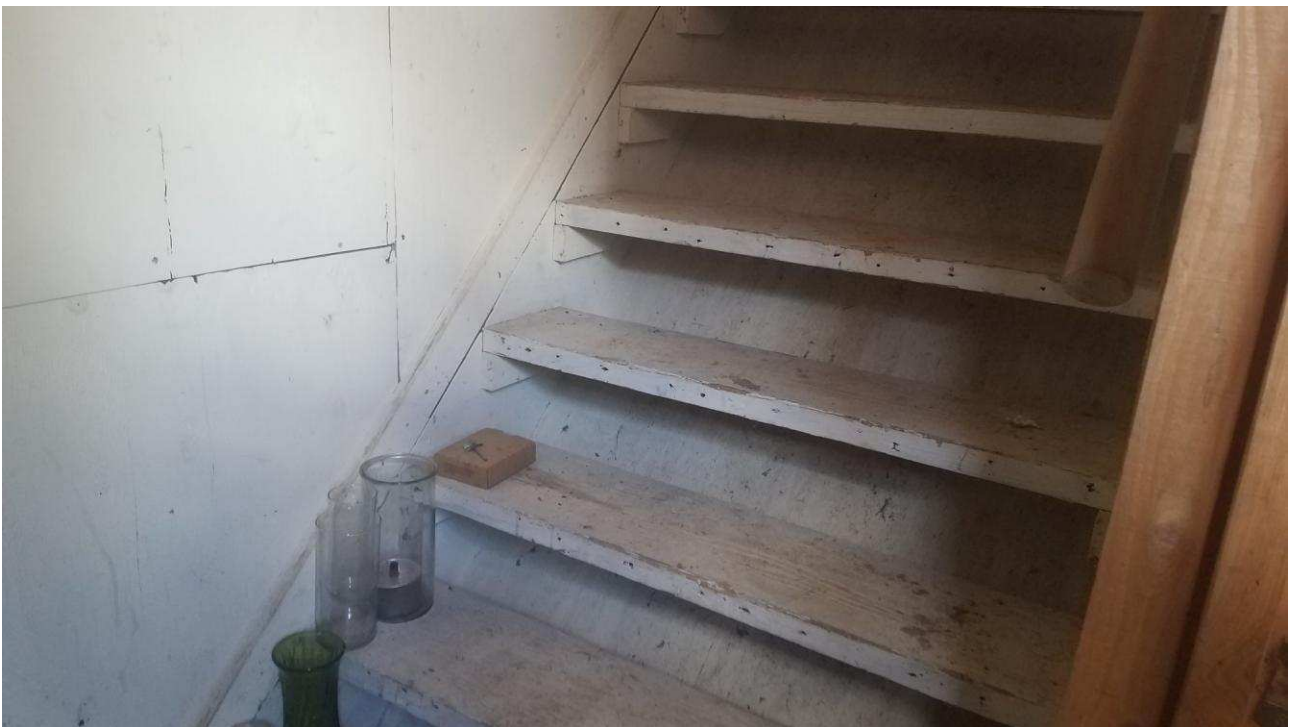
Finding #34 Additional Finding Photos

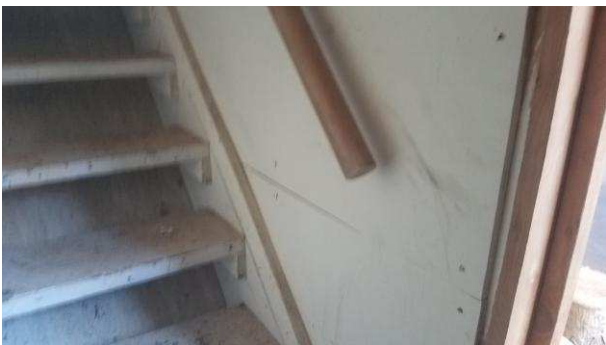
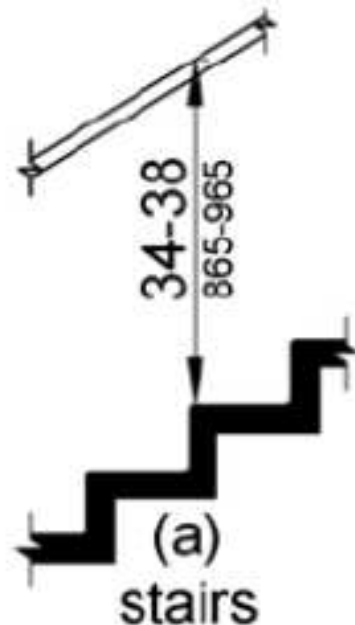
Finding #35 Additional Finding Photos

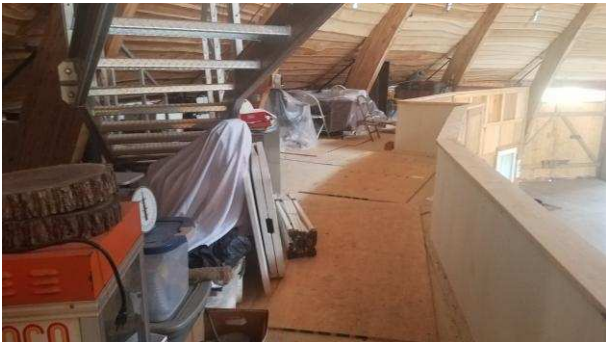
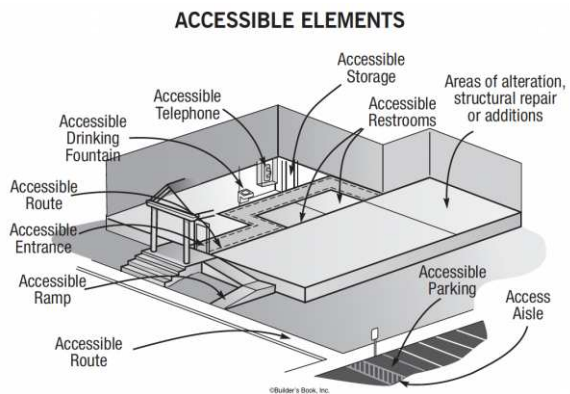
No AR to upper level employee area, leave as is, and reassign duties if an employee with disabilities requires access here

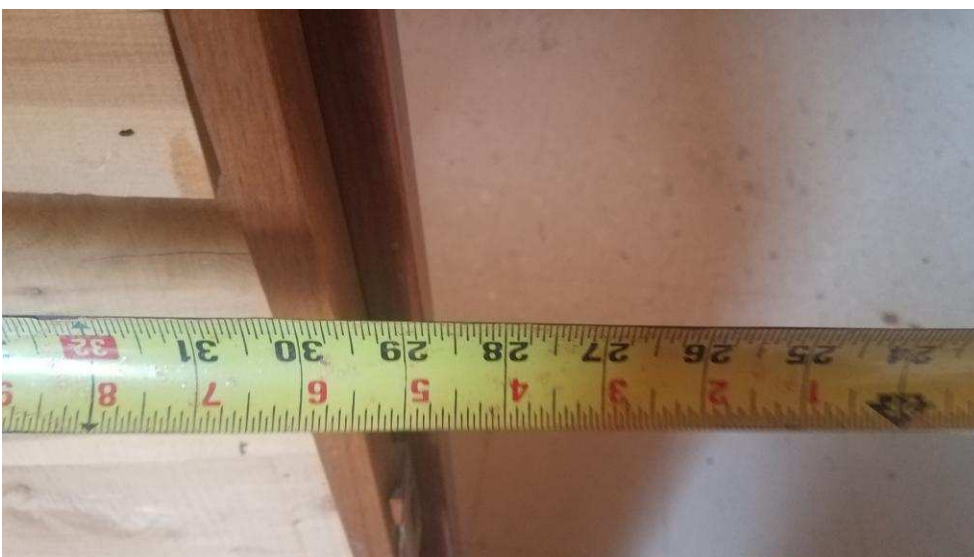
Finding #37 Additional Finding Photos

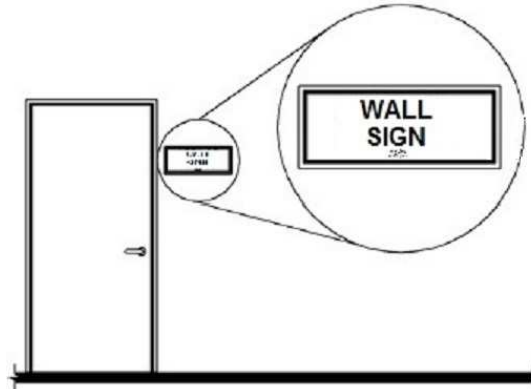
Mount signage at all permanent rooms/spaces having Braille and the international symbol of accessibility, mounted 48" to baseline of lowest character and 60" to the baseline of the highest character sign and on the latch side of the door

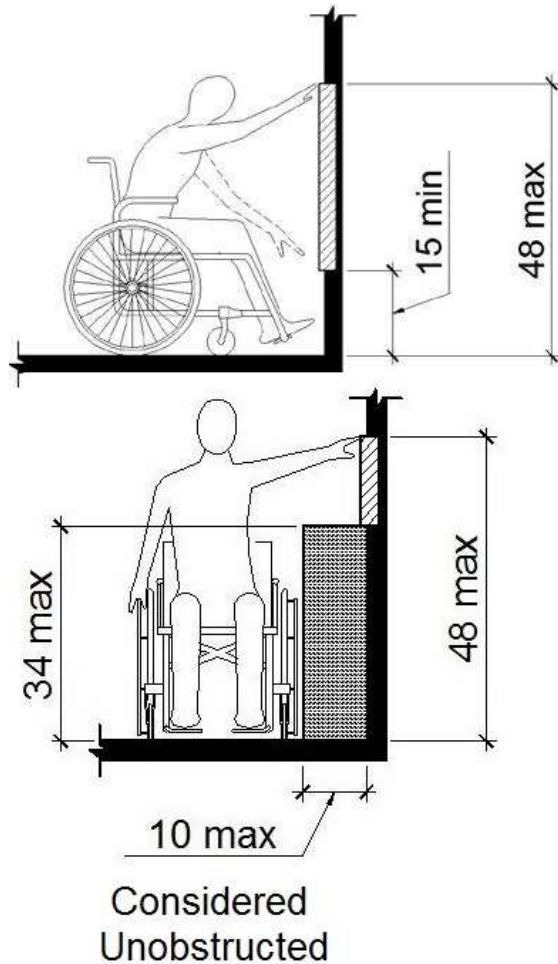
Remount the coat hook to be in reach range of 15" min to 48" max above the finished floor.

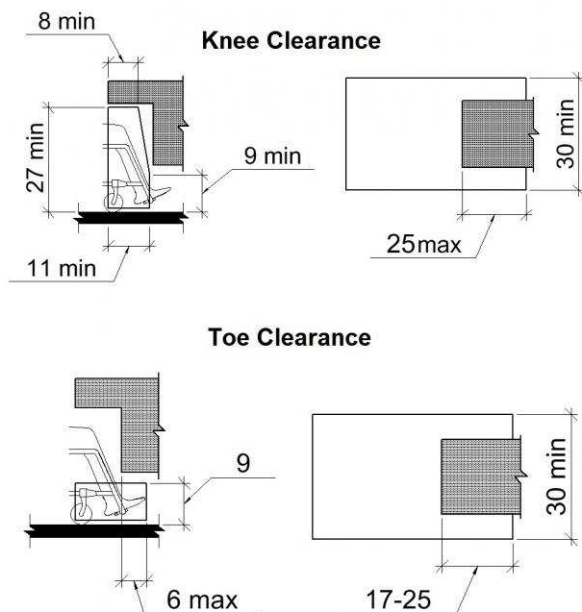
Remove under sink cabinets to provide knee and toe clearances under sinks and insulate exposed pipes

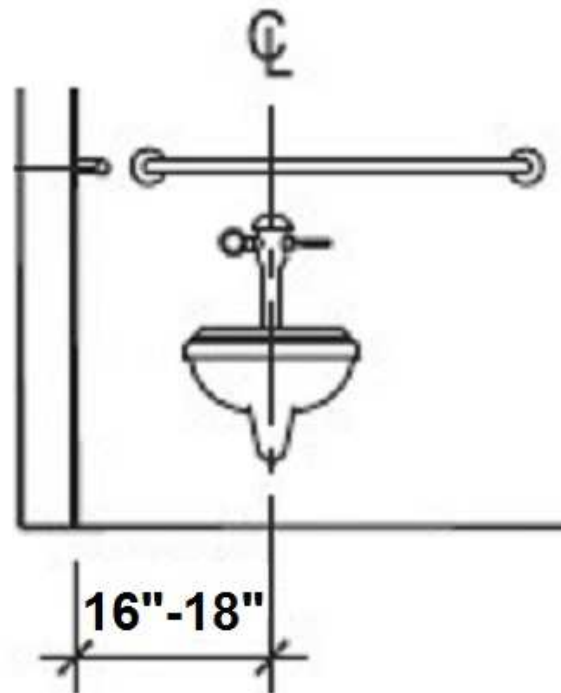
Remount toilets to 16" to 18" from the side wall to centerline

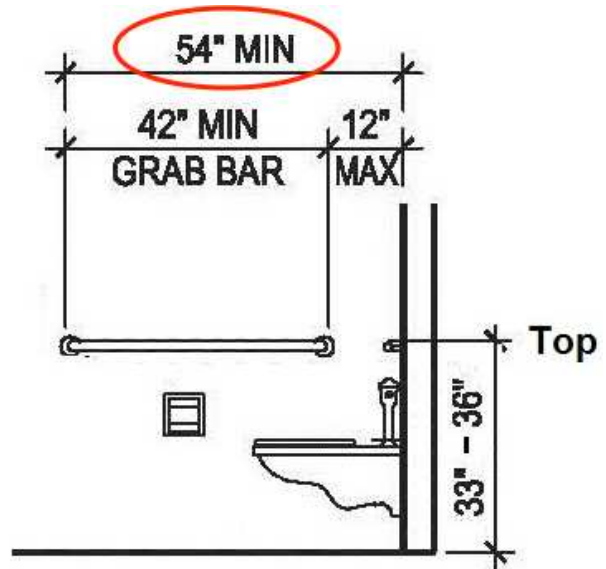
Remount side grab bar to max 12" from the rear wall at the close end and min 54" on the far end, and 33" to 36" aff

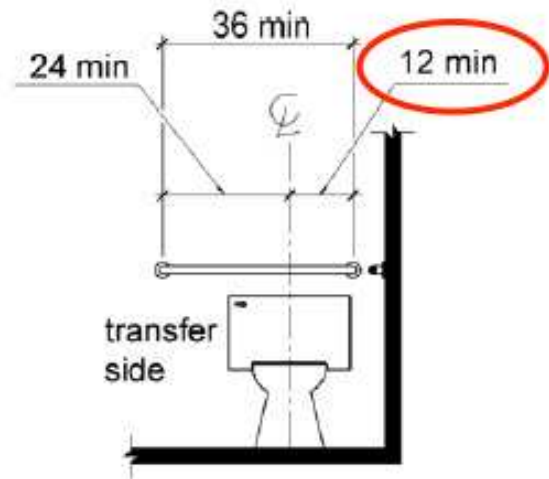
Remount rear grab bar to behind the toilet, 12" to one side of center and 24" to the other and 33" to 36" aff

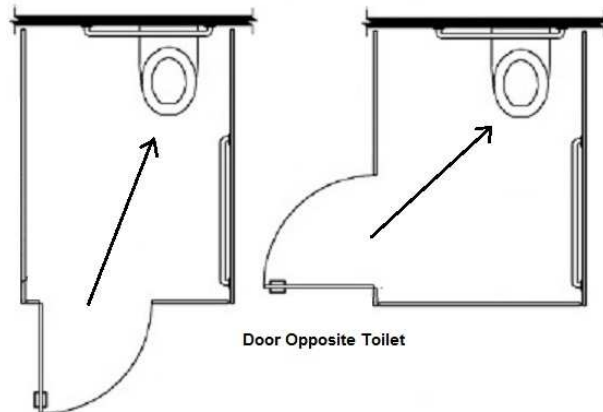
Remount stall door to be opposite toilet and on wall farthest from the toilet, adjust to be self-closing

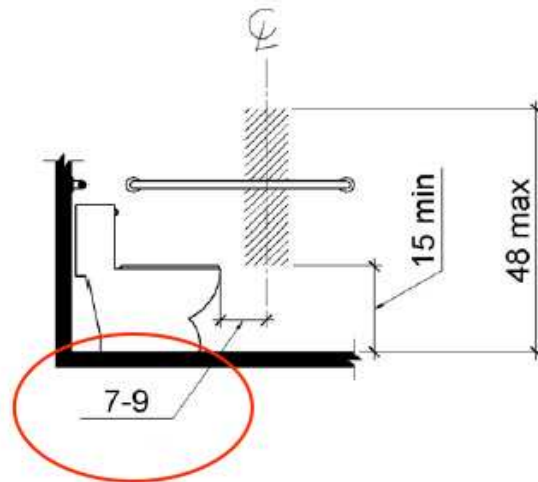
Remount toilet paper to 7" to 9" from the front of the toilet to center of dispenser and 15" to 48" aff

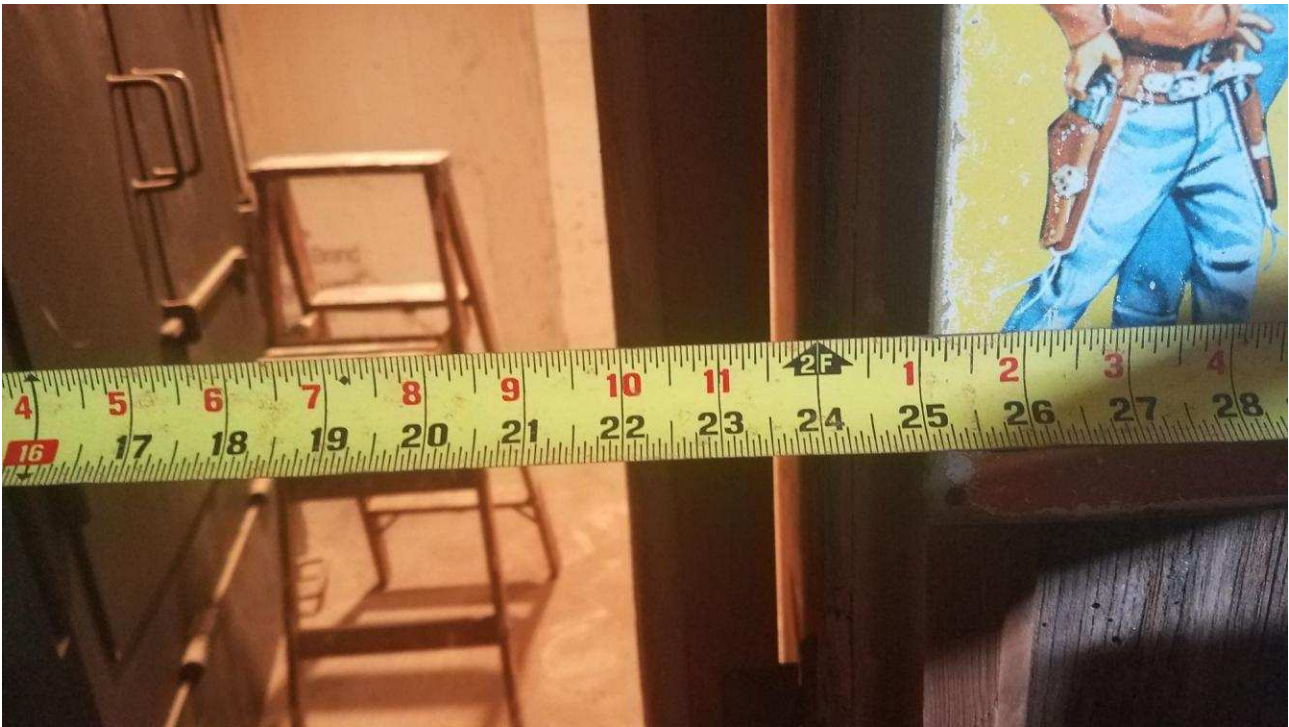
Finding #47 Additional Finding Photos

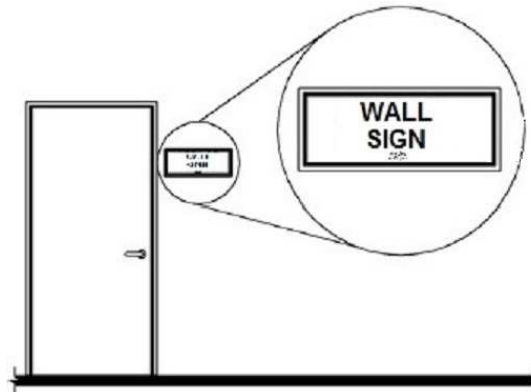
Mount signage at all permanent rooms/spaces having Braille and the international symbol of accessibility, mounted 48" to baseline of lowest character and 60" to the baseline of the highest character sign and on the latch side of the door

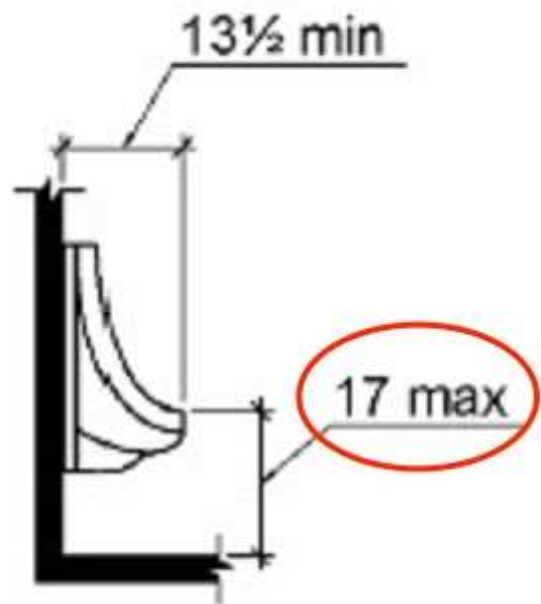
Lower urinal so that rim height is max 17" aff

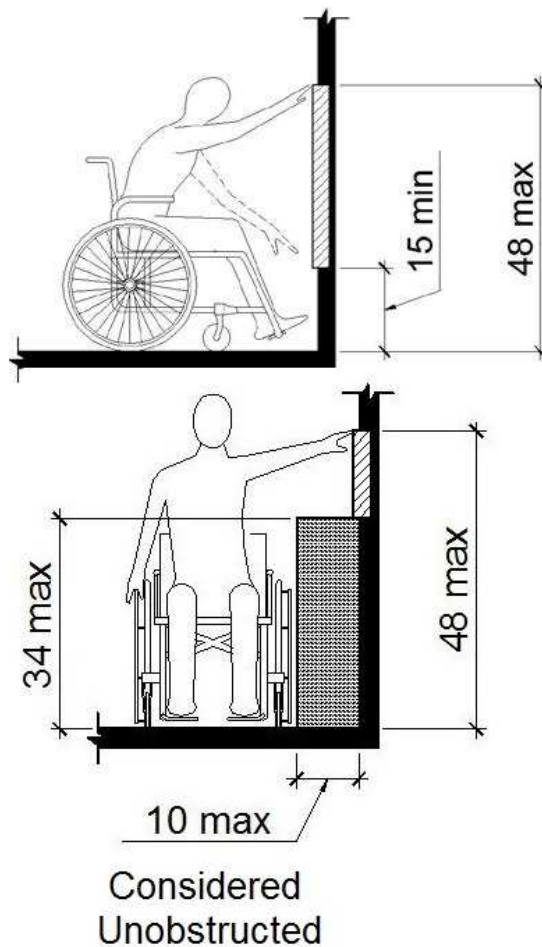
Remount the coat hook to be in reach range of 15" min to 48" max above the finished floor and relocate storage for CFS

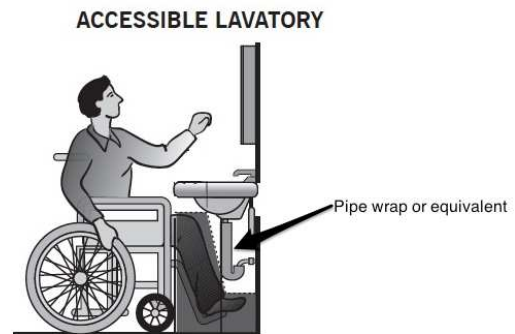
Insulate exposed pipes under one sink and removes storage for CFS
