Site Accessibility Evaluation

Schwab-Burford

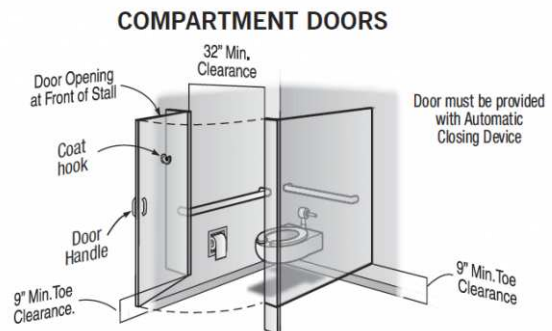
Widen stall doors to 32" when opened to 90 degrees

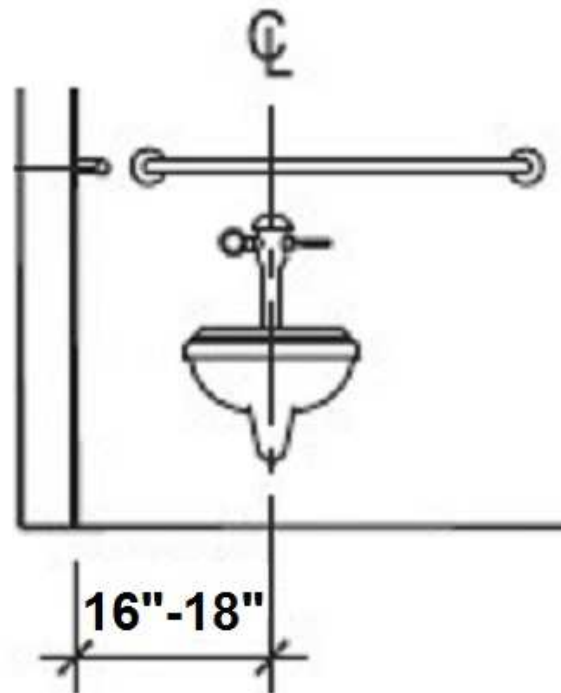
Remount toilet to 16" to 18" from the side wall to centerline

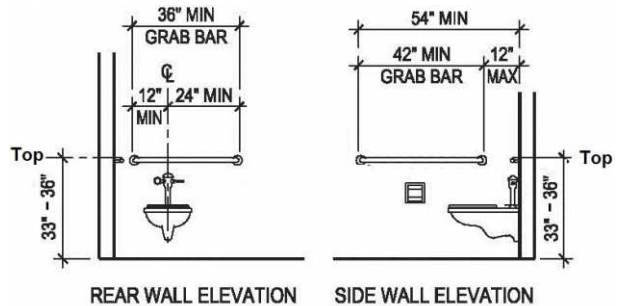
Install required side and rear grab bars in wheelchair accessible stall

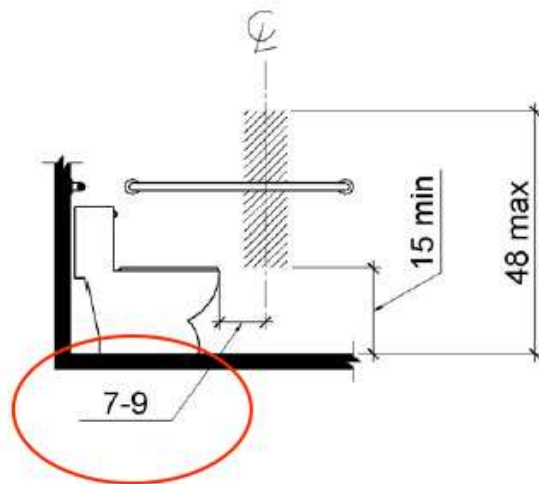
Remount toilet paper dispenser 7" to 9" from toilet and 15" to 48" aff

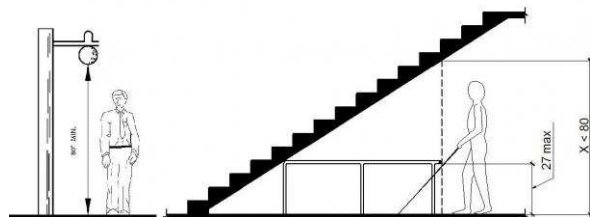
Relocate protruding objects in toilet compartment

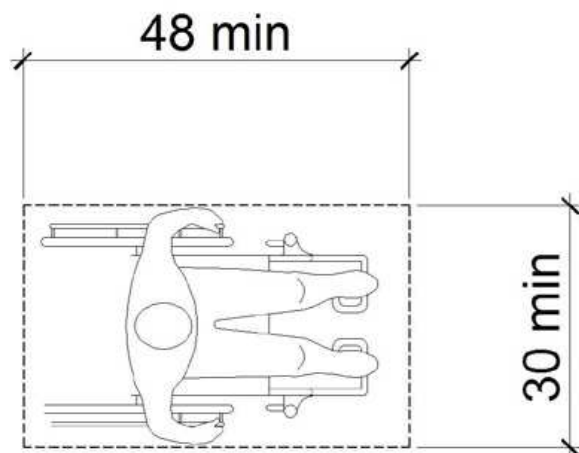
Relocate items under paper towels to provide CFS

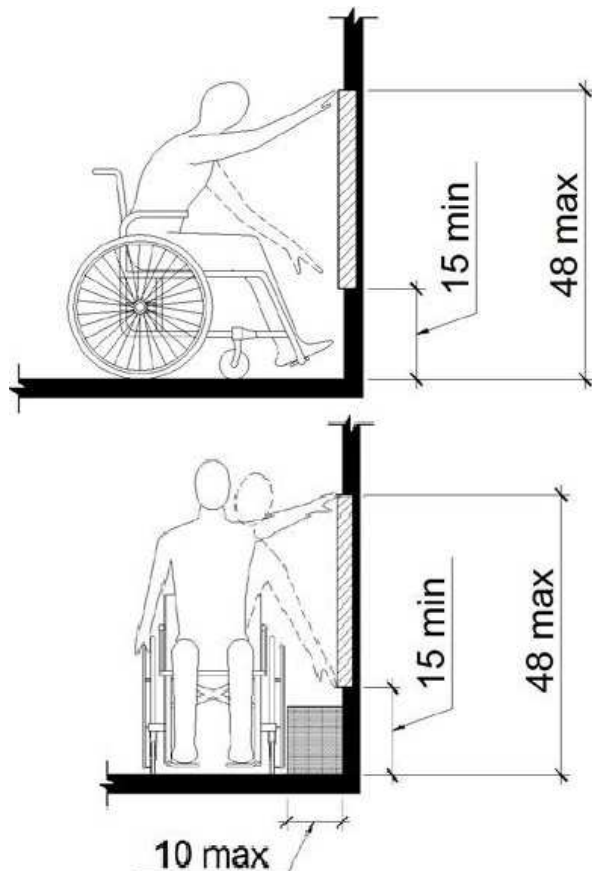
Remount operable parts to be in reach range of 15" min to 48" max and relocate storage for access

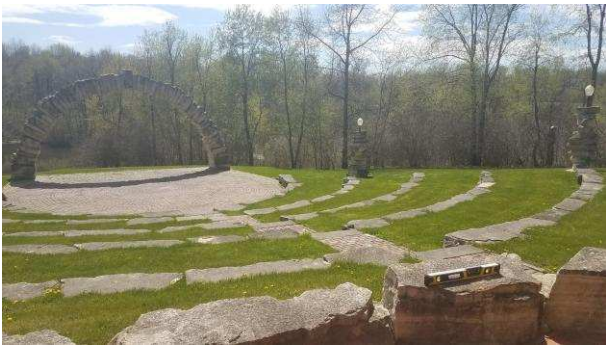
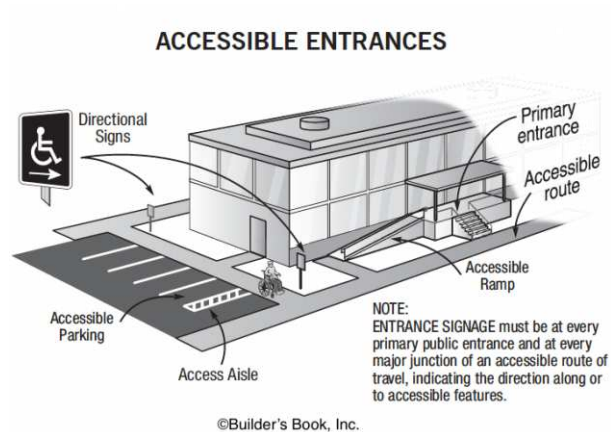
Create an accessible route with crushed stone or other outdoor material from parking or walkway to lower amphitheater

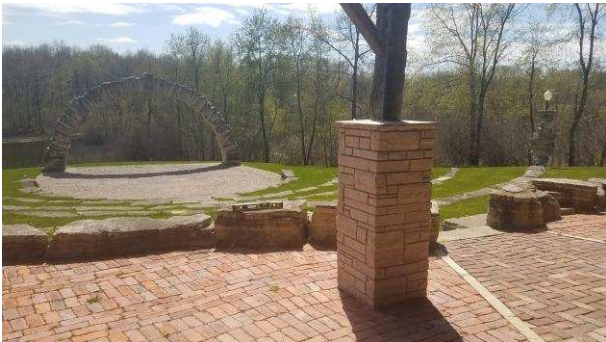
Number of Seats	Minimum Number of Required Wheelchair Spaces
4 to 25	1
26 to 50	2
51 to 150	4
151 to 300	5
301 to 500	6
501 to 5000	6, plus 1 for each $\frac{100}{150}$ or fraction thereof, between 501 through 5000
5001 and over	$\frac{46}{5000}$, plus 1 for each 200, or fraction thereof, over 5000

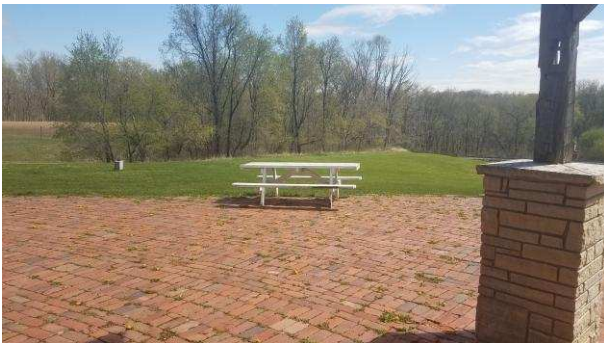
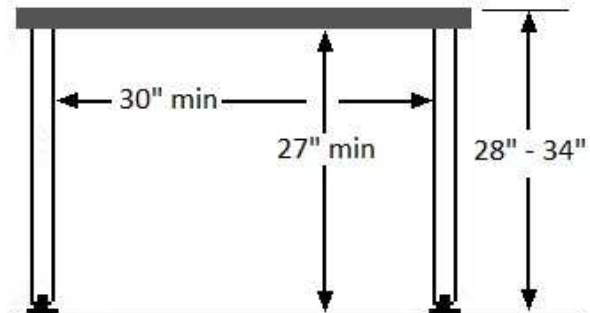
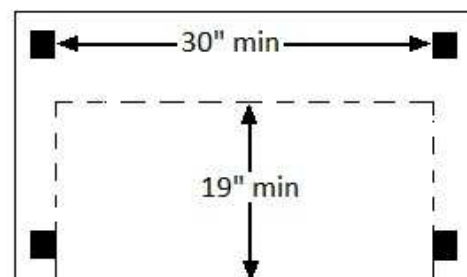
Replace 5% of the tables with ones providing the required knee and toe clearances
