# Site Accessibility Evaluation

## **Solon Shed**

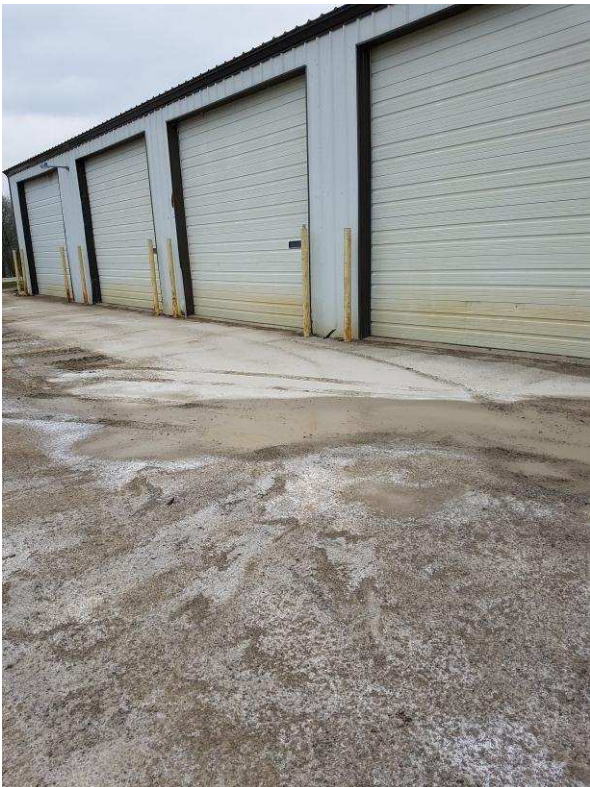
Total Number of Parking Spaces Provided in Parking Facility	Minimum Number of Required Accessible Parking Spaces
1 to 25	1
26 to 50	2
51 to 75	3
76 to 100	4
101 to 150	5
151 to 200	6
201 to 300	7
301 to 400	8
401 to 500	9
501 to 1000	2 percent of total
1001 and over	20, plus 1 for each 100, or fraction thereof, over 1000

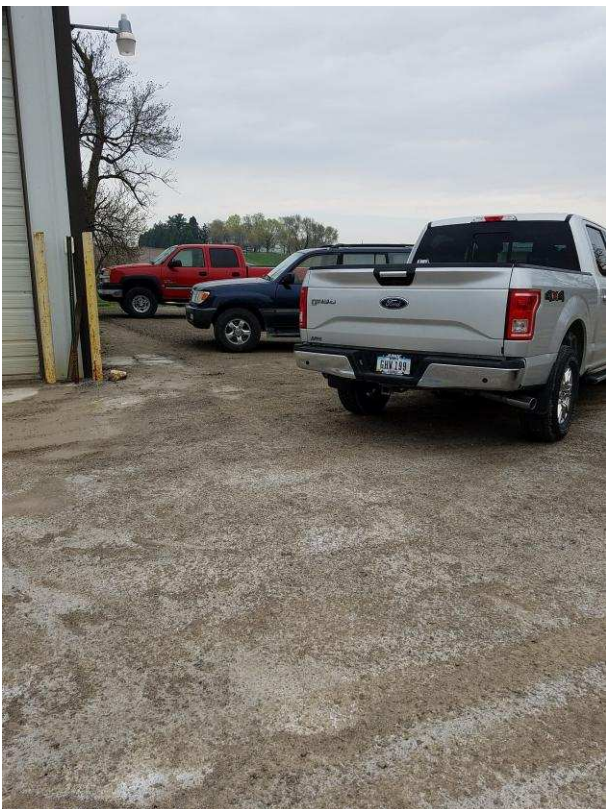
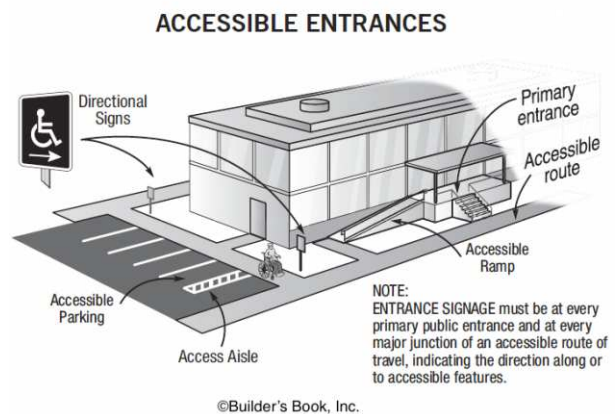
**Finding #2 Additional Finding Photos**

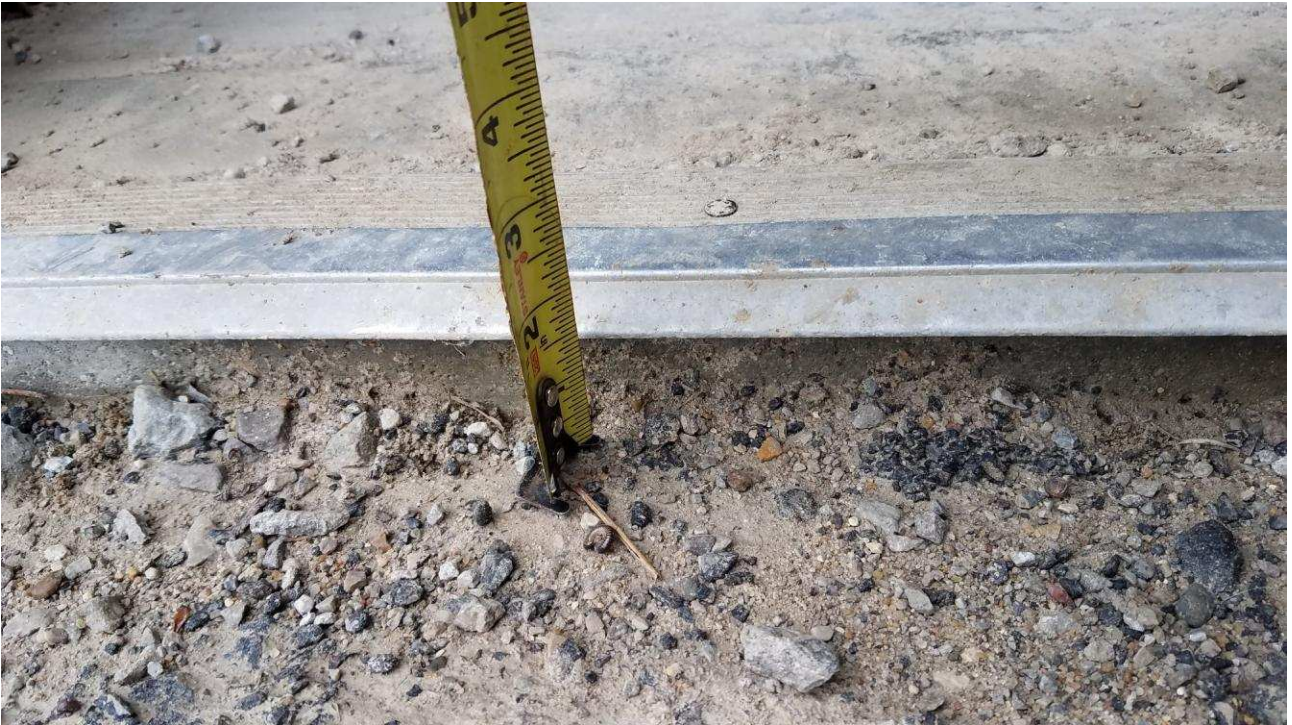
**Finding #3 Additional Finding Photos**

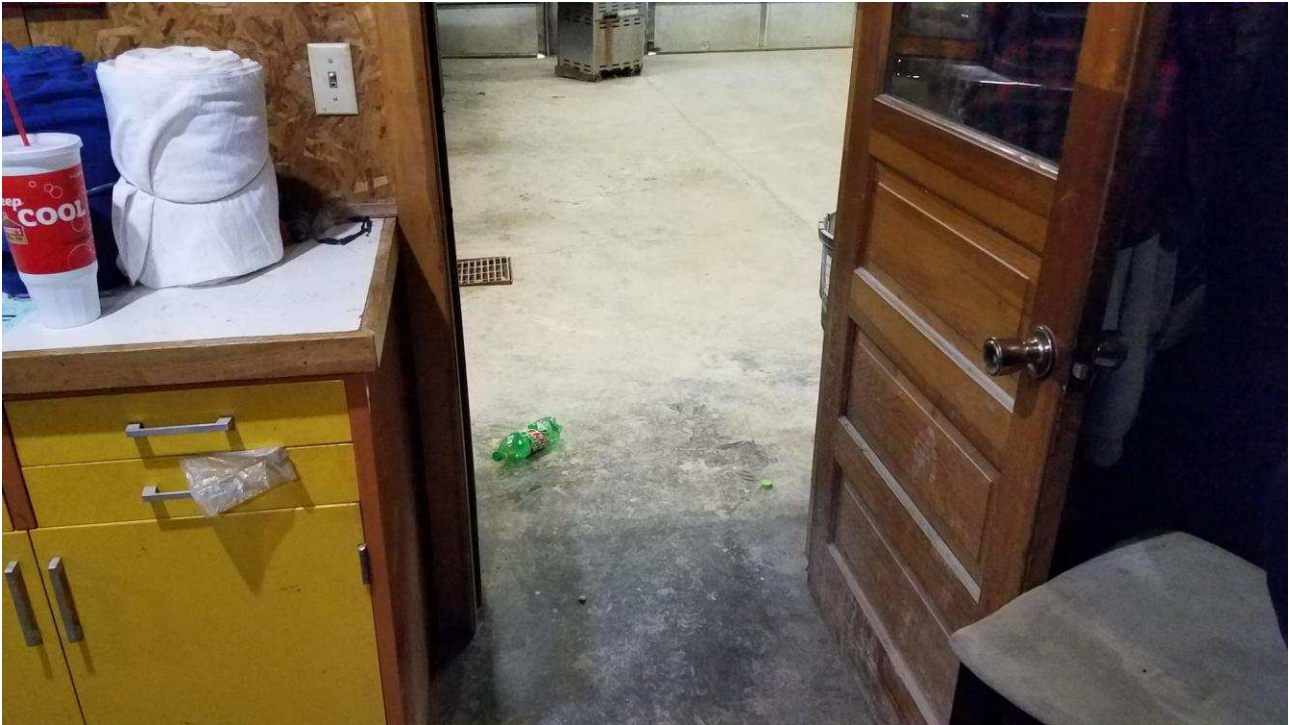
**Finding #4 Additional Finding Photos**

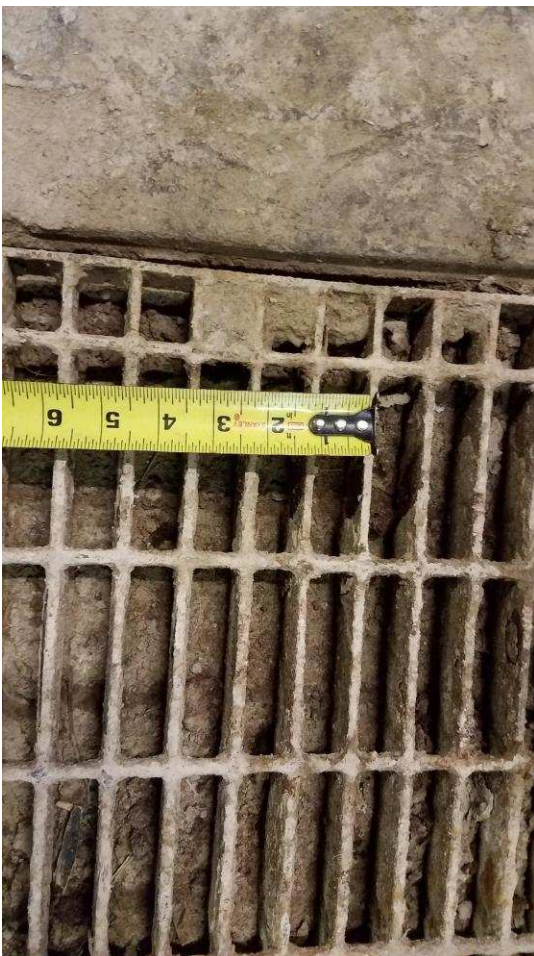
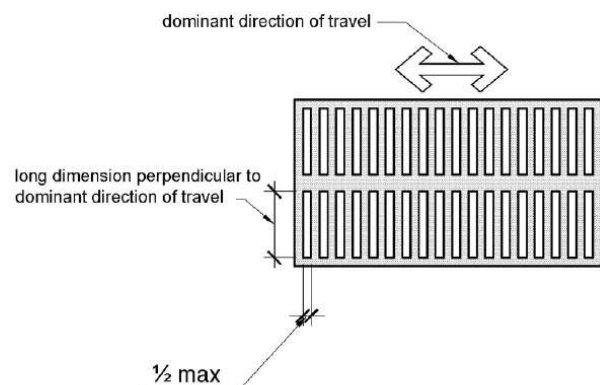
**Finding #5 Additional Finding Photos**

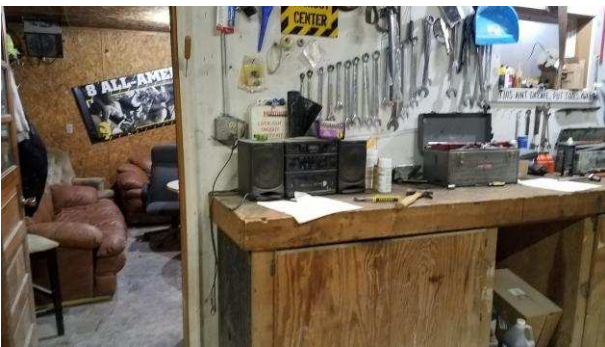
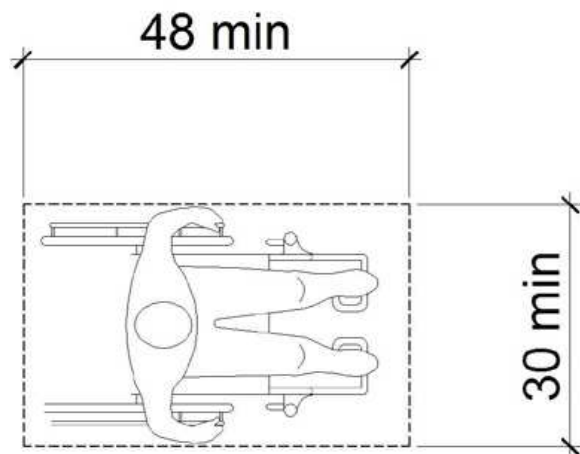
For deficit, leave as is, employee work area pursuant to 2010 Standards 106.5 Defined Terms, until an employee with a disability works here

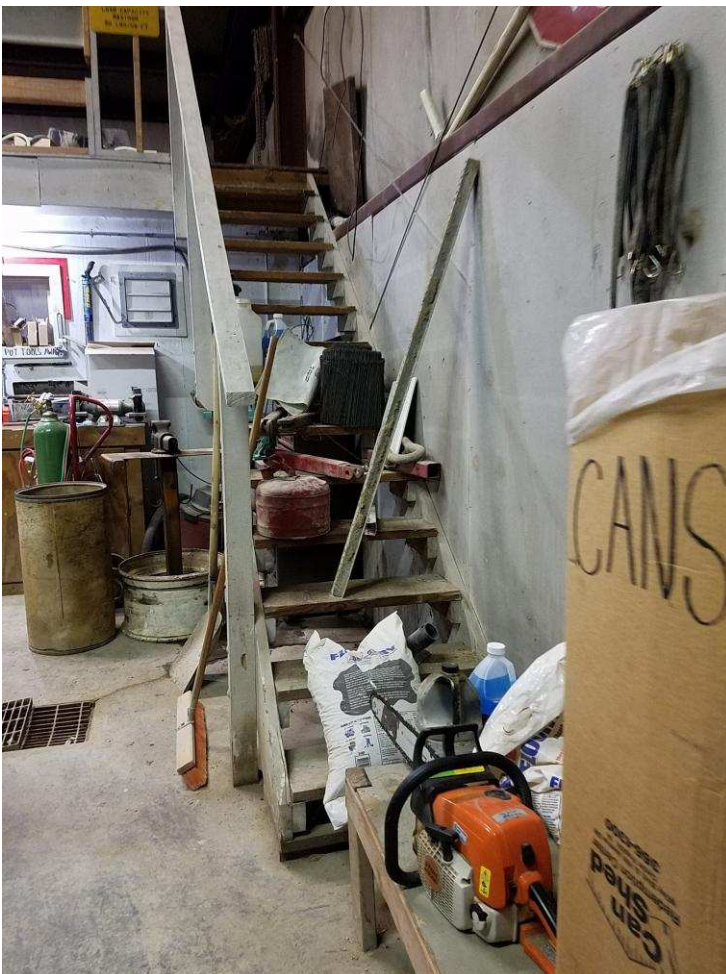
No AR to upper level employee area, leave as is, and reassign duties if an employee with disabilities requires access here

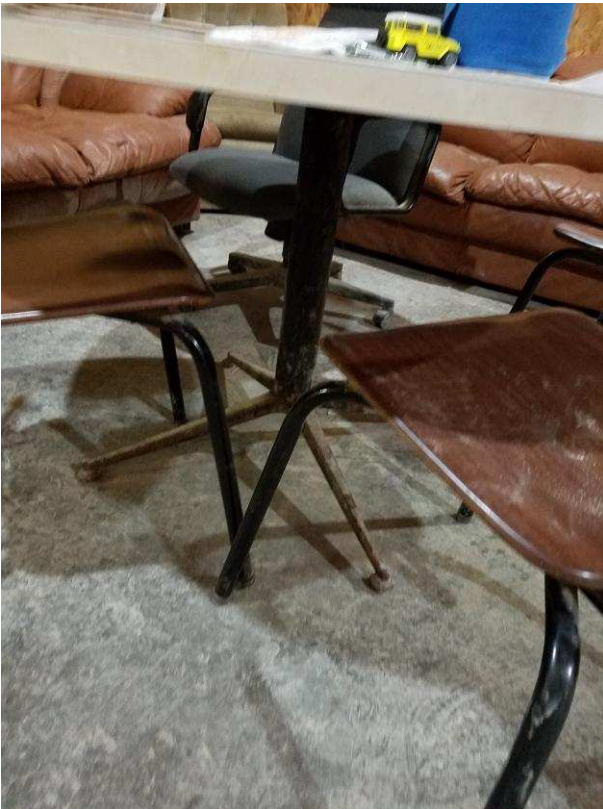
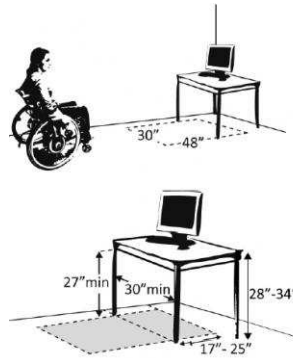
Replace the table with ones providing required knee and toe clearances

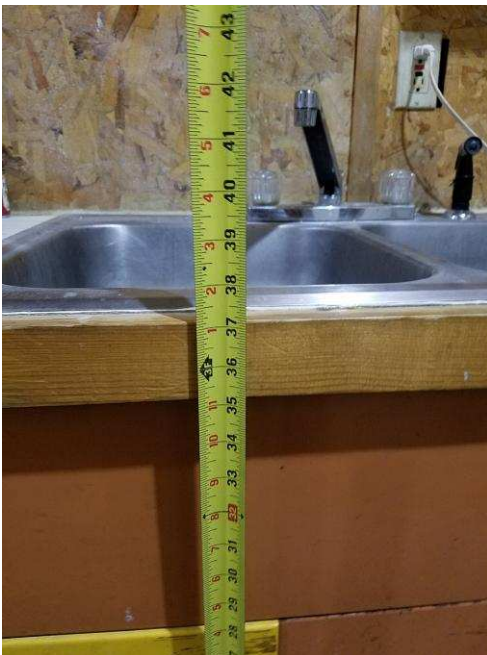
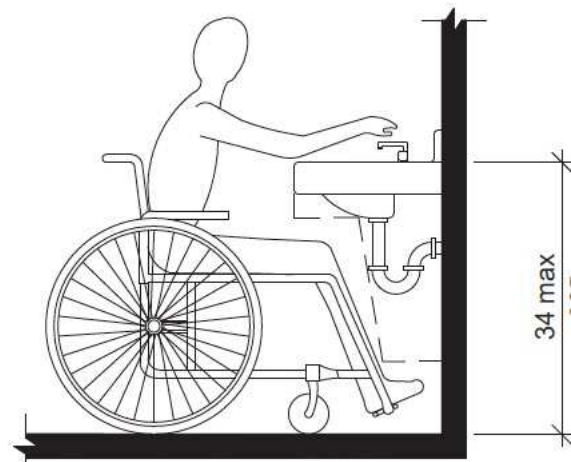
**Finding #9 Additional Finding Photos**

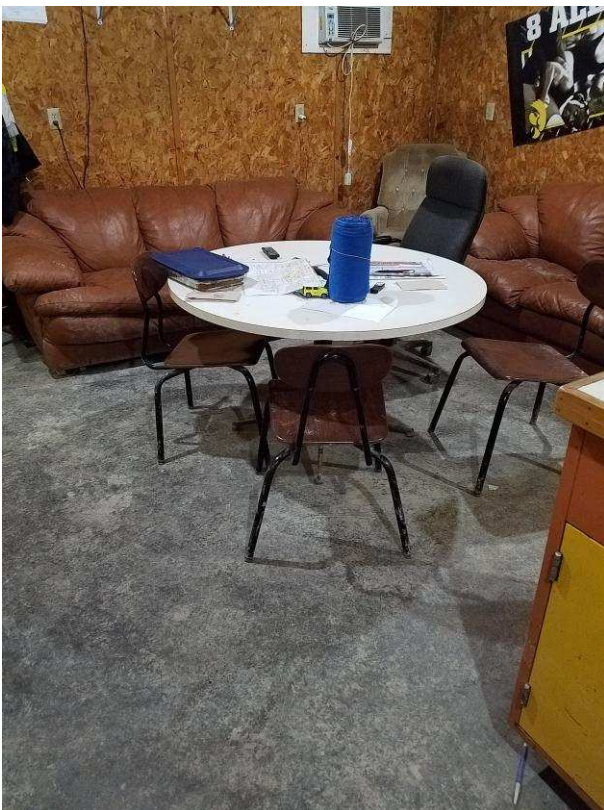
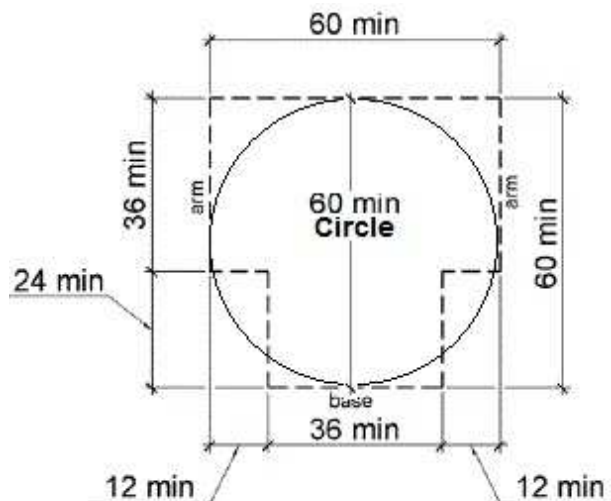
Relocate obstacles to create turning space in breakroom

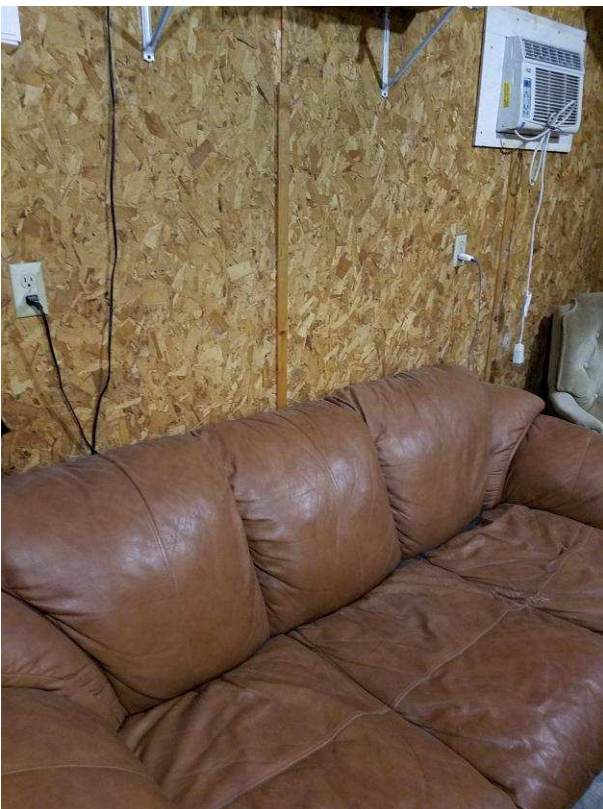
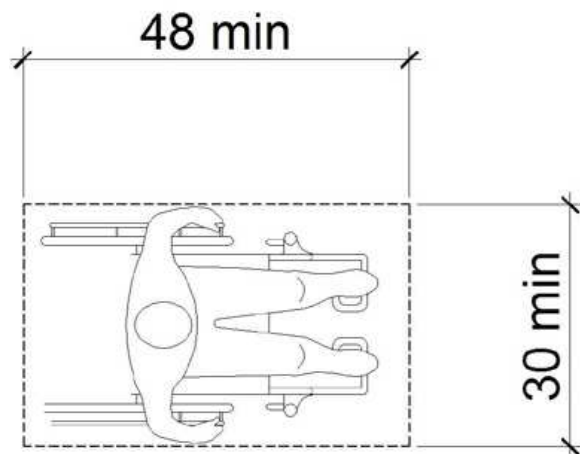
For deficit, leave as is, employee work area pursuant to 2010 Standards 106.5 Defined Terms, until an employee with a disability works here

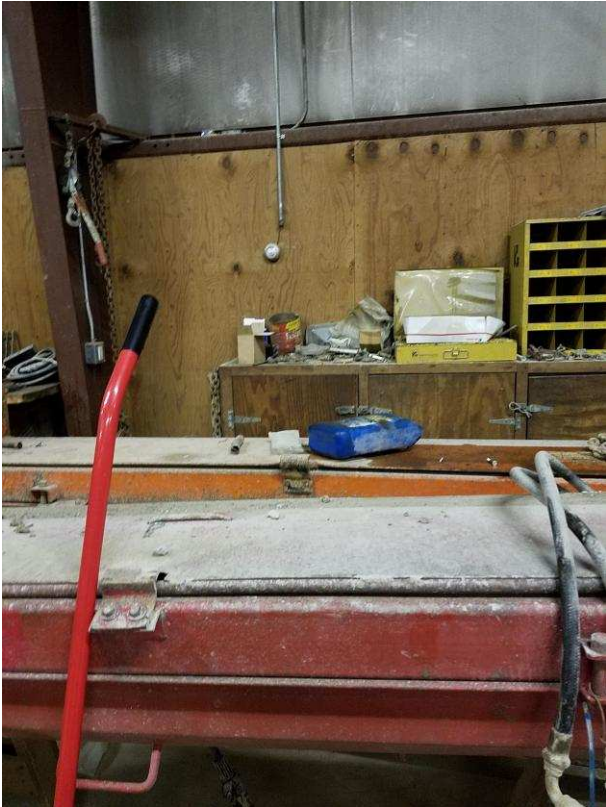
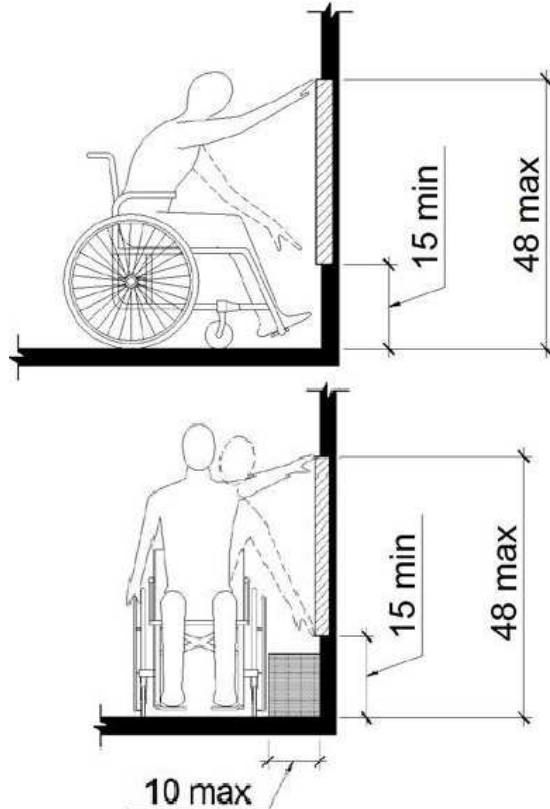
**Finding #12 Additional Finding Photos**

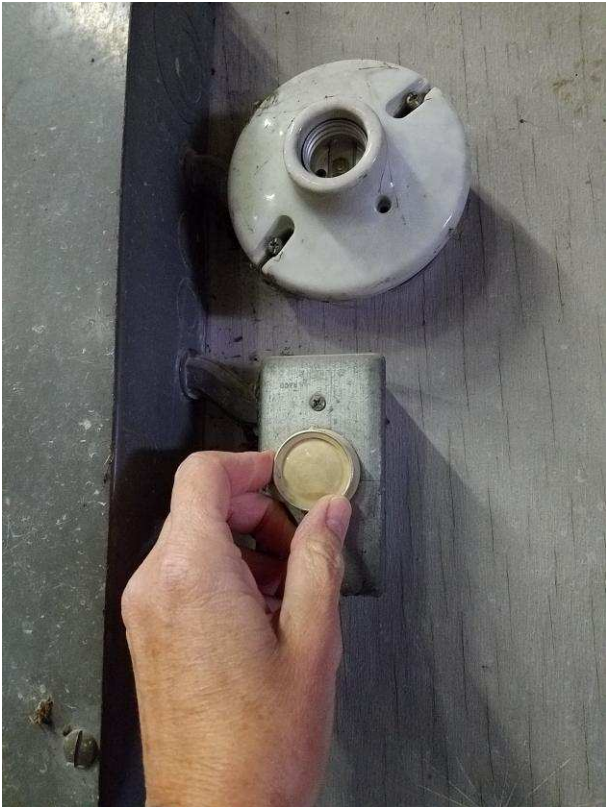
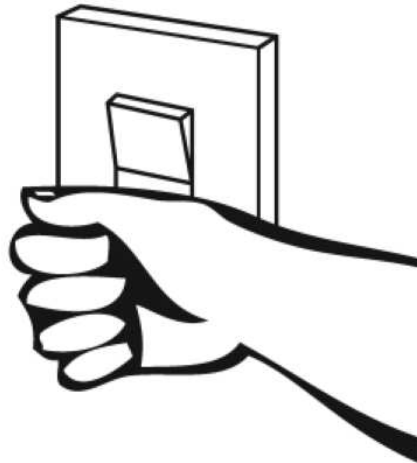
**Finding #13 Additional Finding Photos**

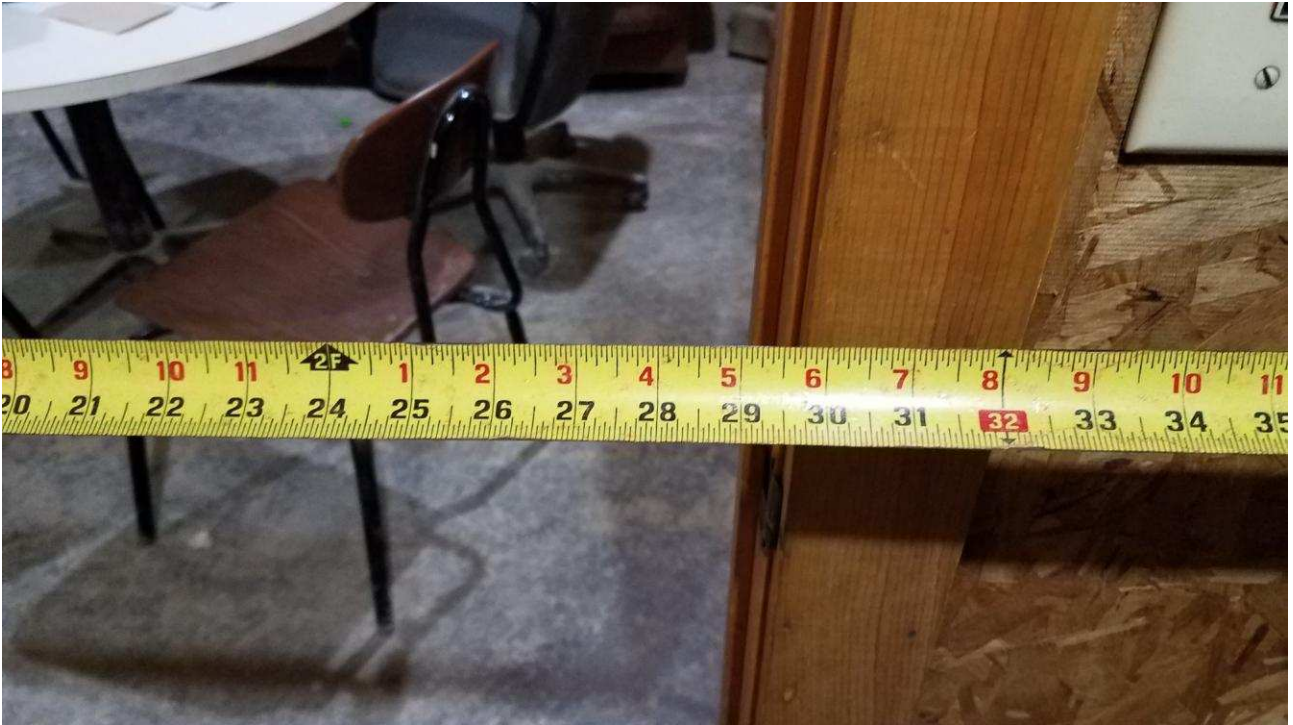
**Finding #14 Additional Finding Photos**

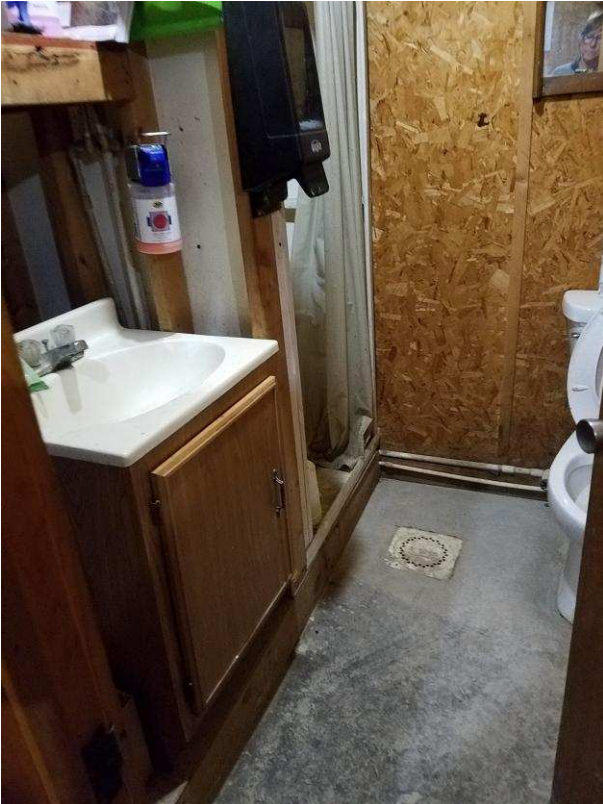
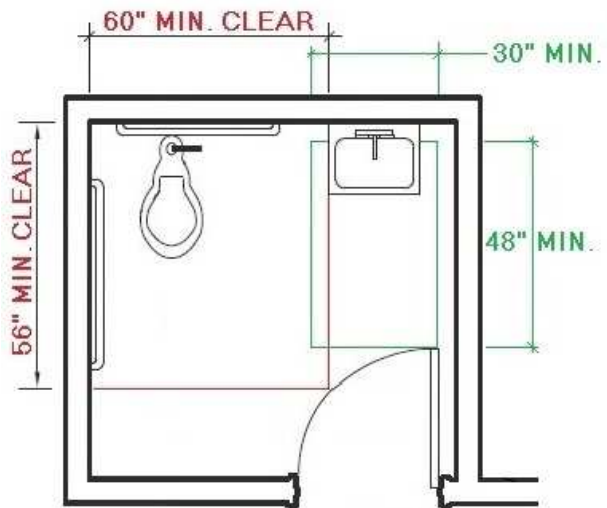
**Finding #15 Additional Finding Photos**
