Site Accessibility Evaluation

Administration Building

913 S Dubuque St
Iowa City, IA 52240

Inspection Date: 11/27/2018
Inspector: Shelley Zuniga

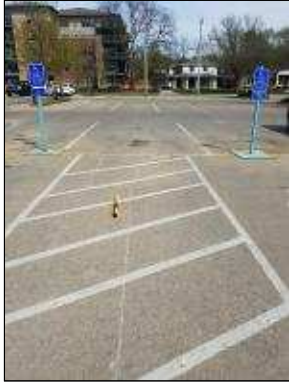
Finding #3 Additional Finding Photos

public lot - large crack
in access aisle 1" CIL
in valve cover in aisle;
signage not fixed and
overlap stall space

Resurface stalls and access aisles to eliminate gaps and cracks; install permanent signage to eliminate overlap into stalls

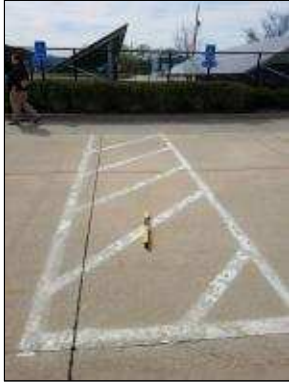
Finding #7 Additional Finding Photos

The van stall is missing a sign identifying it as a van accessible stall.

Add one van parking sign to one accessible stall and repaint stall and access aisle to 11' and 5' or 8' and 8'

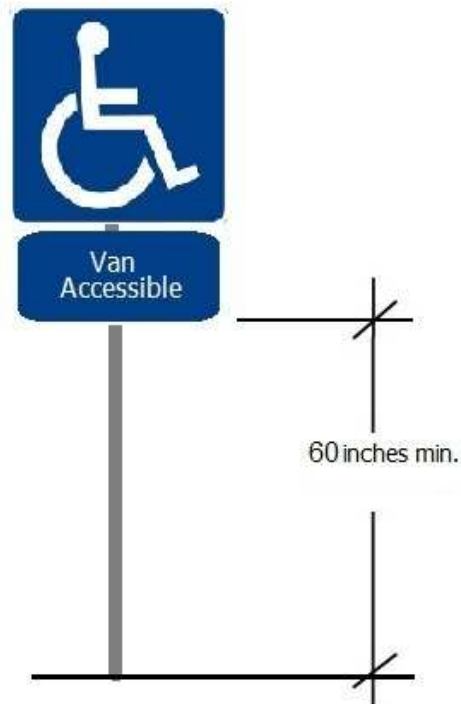
The parking sign/s are missing.

employee lot - one
stall missing sign, all
lack R7-8 signage

Acquire and mount at appropriate heights and locations accessible parking signs for all the stalls

Acquire and mount correct fine sign for all stalls per state or local statute

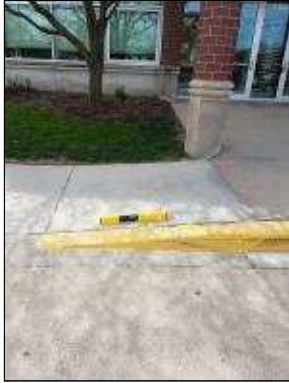
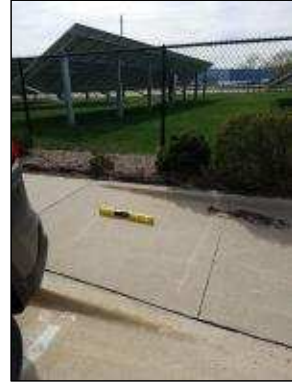
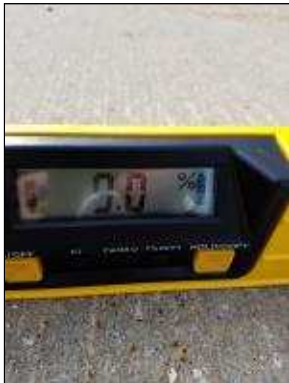
Finding #10 Additional Finding Photos

Detectable warnings are missing for the parallel curb ramp.

missing at curb ramp
and hazardous way
from employee lot

Install compliant detectable warning at curb ramps as a smart practice

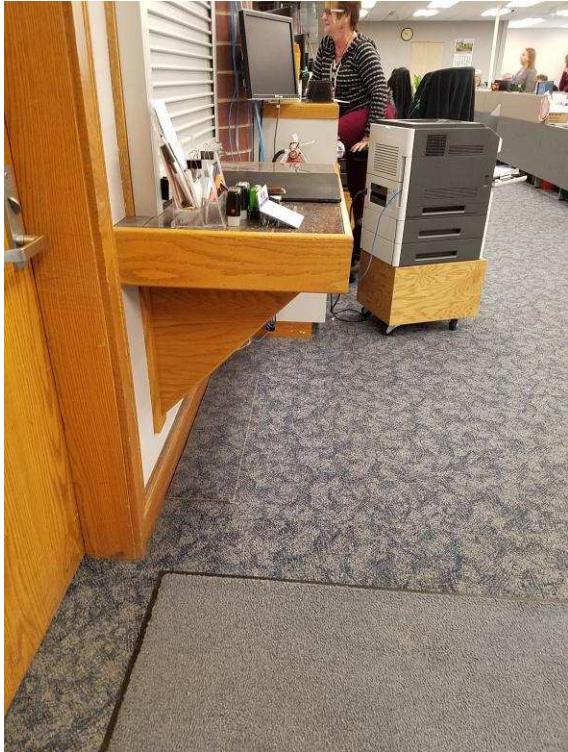
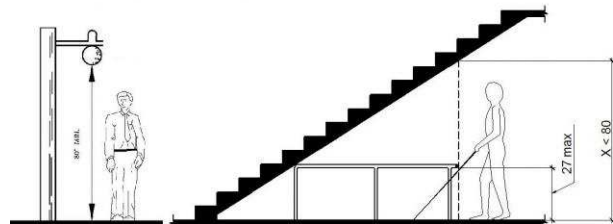
First Floor Treasurer

Wall-mounted objects that have leading edges between 27 inches and 80 inches from the floor must not project more than 4 inches into the circulation path. Protruding objects that extend to the floor or within 27 inches of the floor are cane detectable and are therefore not hazardous. Where it is necessary or desirable to have objects protrude from the wall, a manner of cane detection must be provided.

For deficit, leave as is, employee work area pursuant to 2010 Standards 106.5 Defined Terms, until an employee with a disability works here

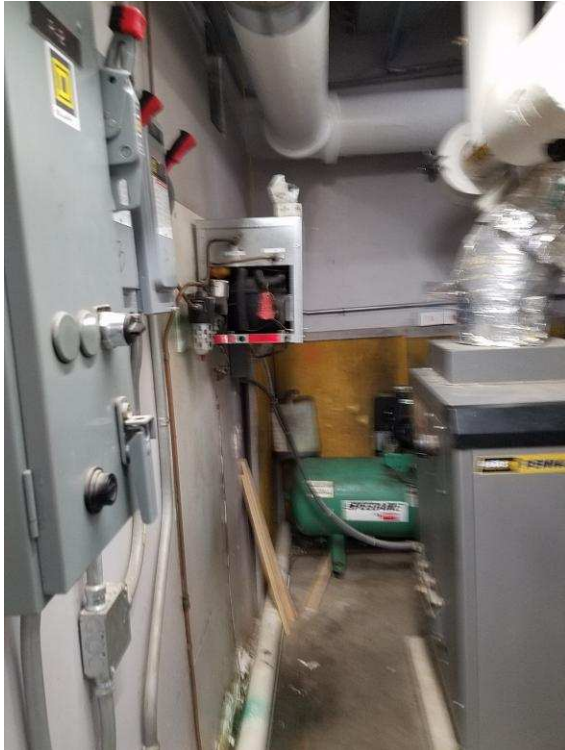
First Floor Mechanical

Wall-mounted objects that have leading edges between 27 inches and 80 inches from the floor must not project more than 4 inches into the circulation path. Protruding objects that extend to the floor or within 27 inches of the floor are cane detectable and are therefore not hazardous. Where it is necessary or desirable to have objects protrude from the wall, a manner of cane detection must be provided.

For deficit, leave as is, employee work area pursuant to 2010 Standards 106.5 Defined Terms, until an employee with a disability works here

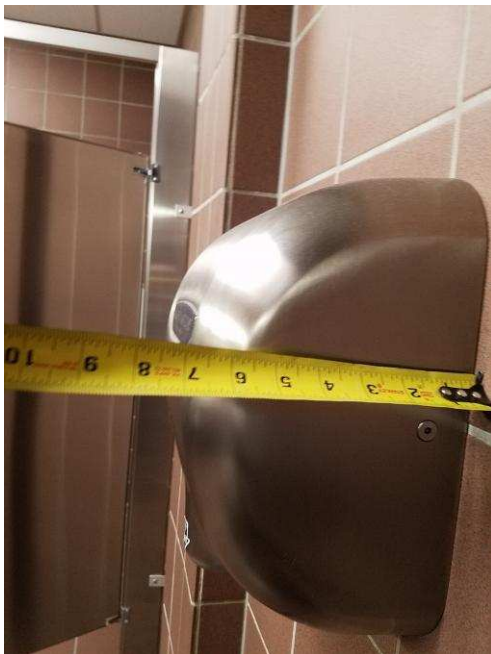
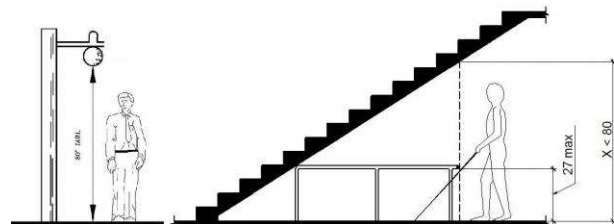
Finding #110 Additional Finding Photos

Wall-mounted objects that have leading edges between 27 inches and 80 inches from the floor must not project more than 4 inches into the circulation path. Protruding objects that extend to the floor or within 27 inches of the floor are cane detectable and are therefore not hazardous. Where it is necessary or desirable to have objects protrude from the wall, a manner of cane detection must be provided.

Relocate protruding objects or place cane detectable warning or bollard at foot of item

For deficit, leave as is, employee work area pursuant to 2010 Standards 106.5 Defined Terms, until an employee with a disability works here

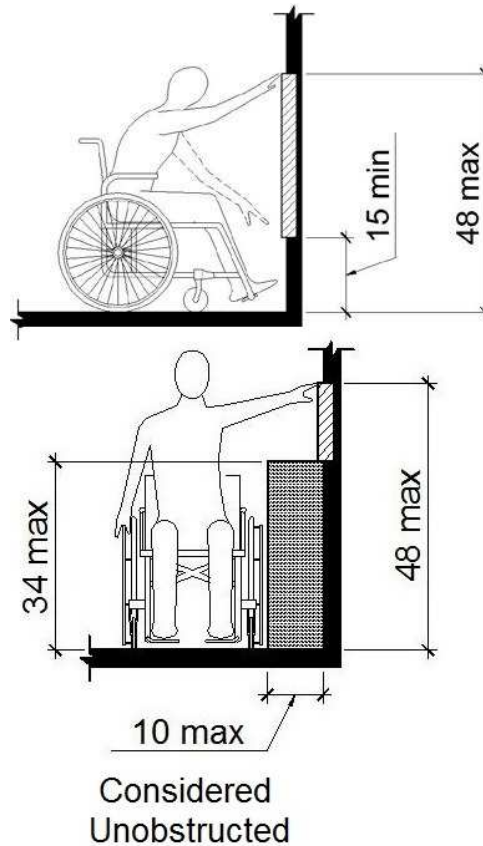
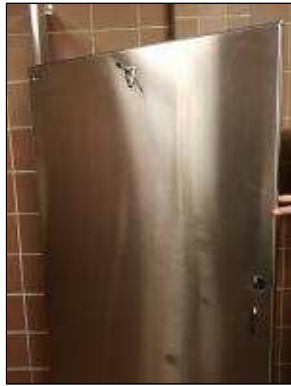
Finding #111 Additional Finding Photos

fails to self close, no exterior hardware

Adjust stall door to be self-closing and install exterior hardware that is operable without a tight pinch or grasp

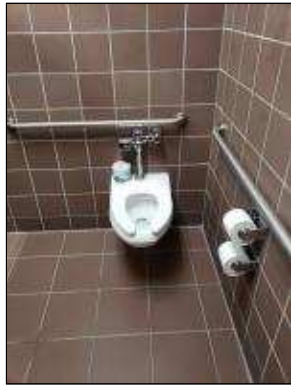
Finding #114 Additional Finding Photos

First Floor Men's

Remount side grab bar to max 12" from the rear wall at the close end and min 54" on the far end, and 33" to 36" aff

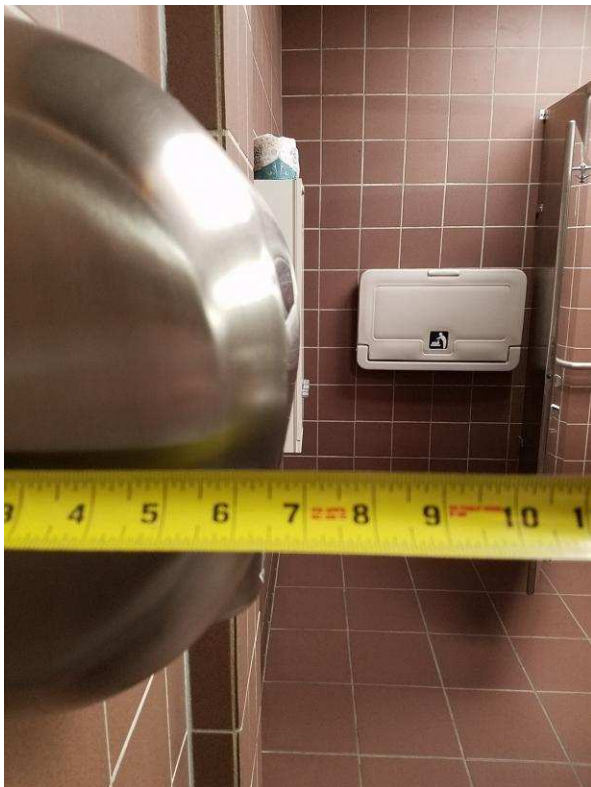
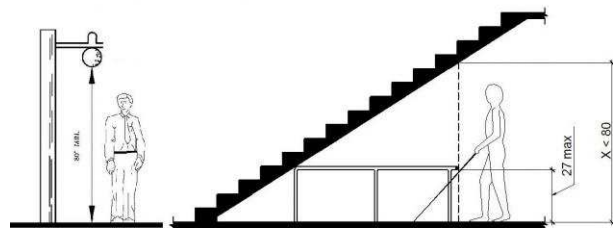
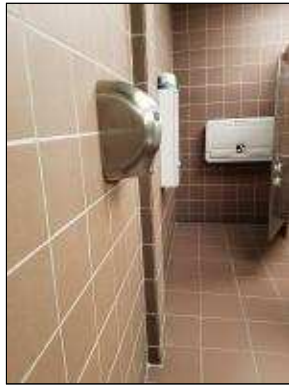
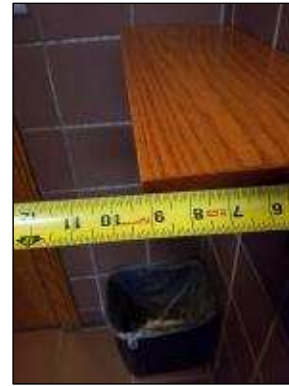
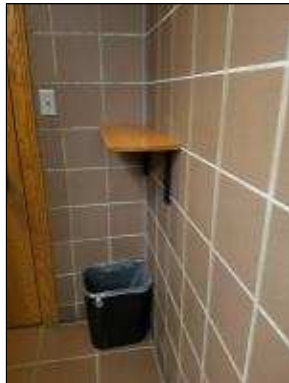
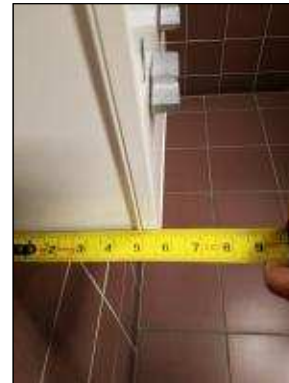
Finding #120 Additional Finding Photos

Wall-mounted objects that have leading edges between 27 inches and 80 inches from the floor must not project more than 4 inches into the circulation path. Protruding objects that extend to the floor or within 27 inches of the floor are cane detectable and are therefore not hazardous. Where it is necessary or desirable to have objects protrude from the wall, a manner of cane detection must be provided.

Relocate protruding objects or place cane detectable warning or bollard at foot of item

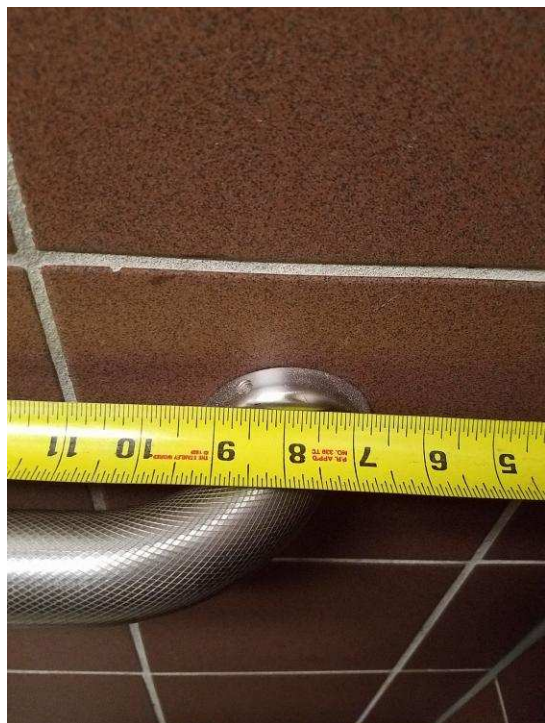
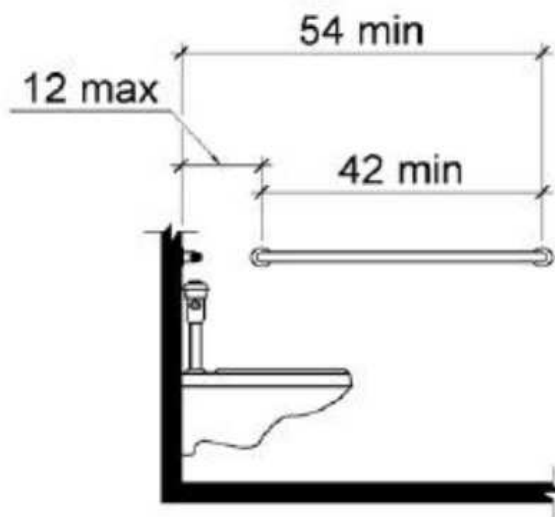
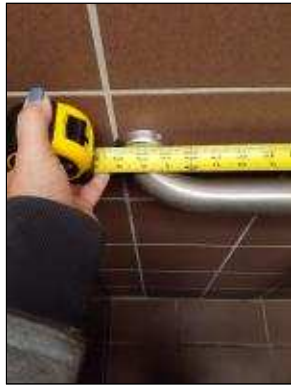
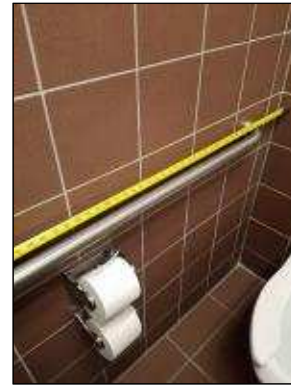
Finding #123 Additional Finding Photos

First Floor Women's

Remount rear grab bar to behind the toilet, 12" to one side of center and 24" to the other and 33" to 36" aff

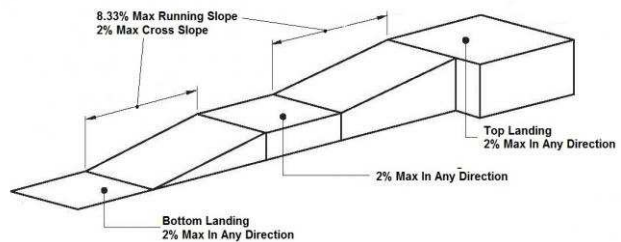
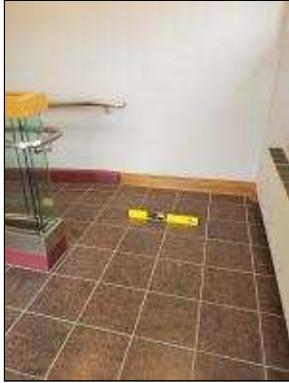
Finding #131 Additional Finding Photos

Second Floor IAR

Correct slope of ramp to max 8.33%

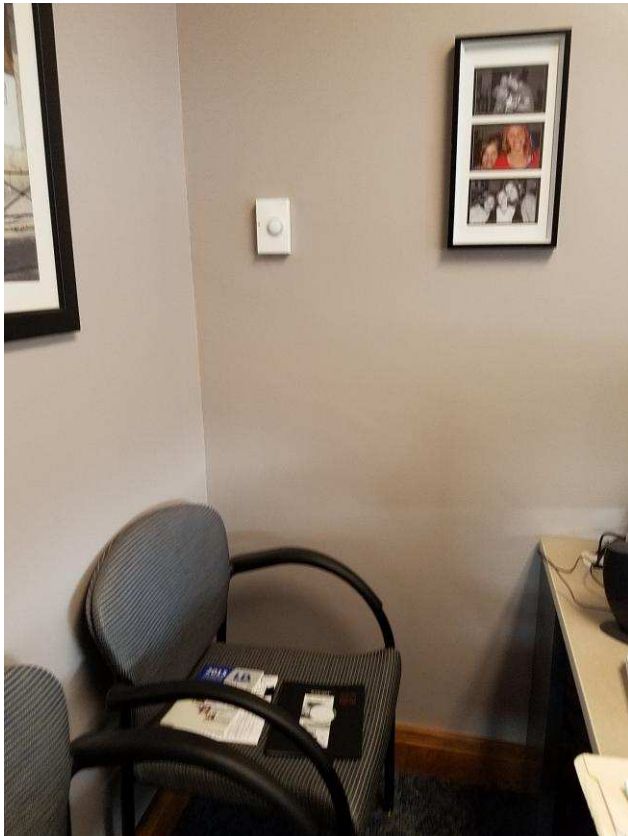
Tina G. - outlets fail

For deficit, leave as is, employee work area pursuant to 2010 Standards 106.5 Defined Terms, until an employee with a disability works here

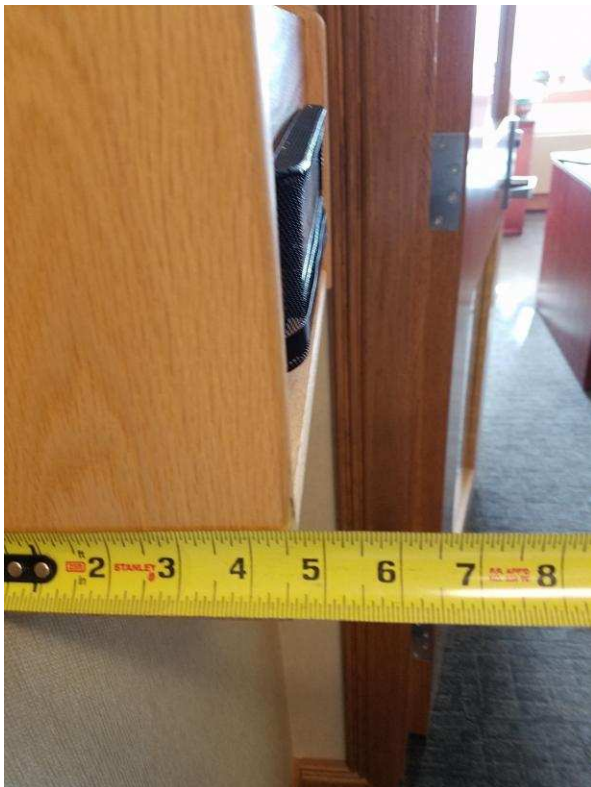
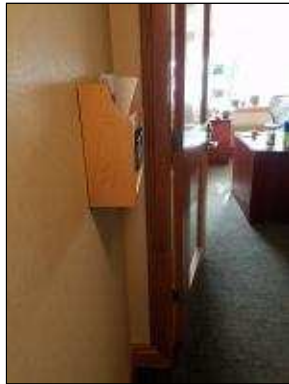
Finding #210 Additional Finding Photos

Wall-mounted objects that have leading edges between 27 inches and 80 inches from the floor must not project more than 4 inches into the circulation path. Protruding objects that extend to the floor or within 27 inches of the floor are cane detectable and are therefore not hazardous. Where it is necessary or desirable to have objects protrude from the wall, a manner of cane detection must be provided.

Relocate protruding objects or place cane detectable warning or bollard at foot of item

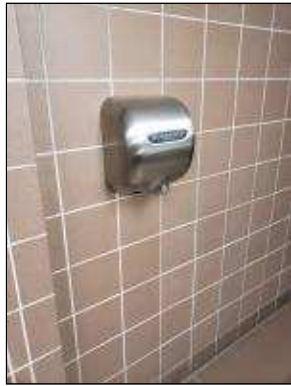
Finding #243 Additional Finding Photos

Wall-mounted objects that have leading edges between 27 inches and 80 inches from the floor must not project more than 4 inches into the circulation path. Protruding objects that extend to the floor or within 27 inches of the floor are cane detectable and are therefore not hazardous. Where it is necessary or desirable to have objects protrude from the wall, a manner of cane detection must be provided.

Relocate protruding objects or place cane detectable warning or bollard at foot of item

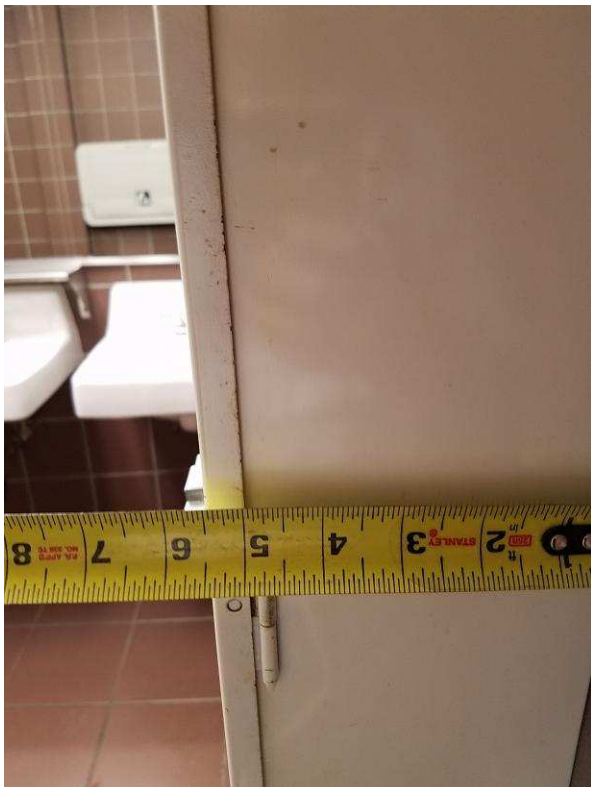
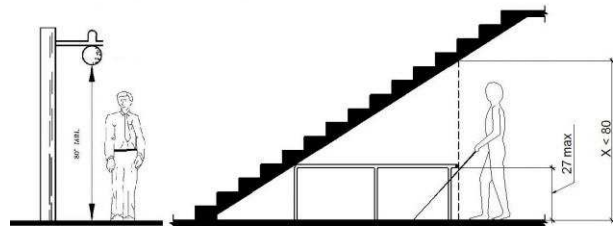
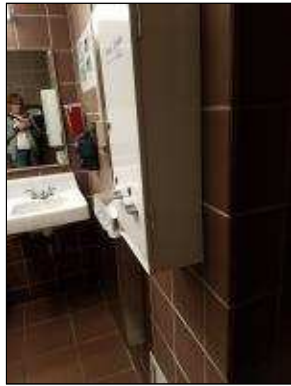
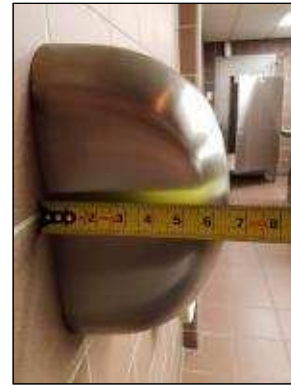
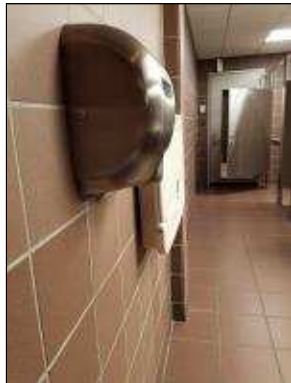
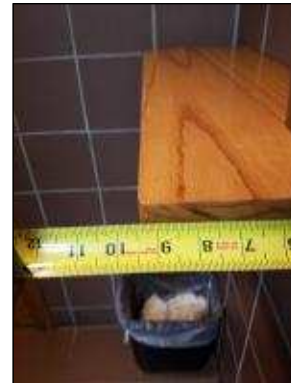
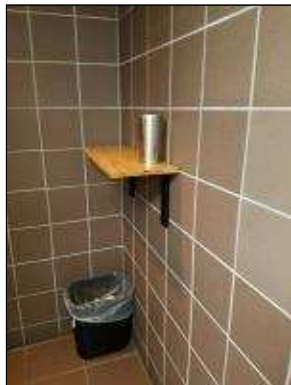
Finding #254 Additional Finding Photos

Wall-mounted objects that have leading edges between 27 inches and 80 inches from the floor must not project more than 4 inches into the circulation path. Protruding objects that extend to the floor or within 27 inches of the floor are cane detectable and are therefore not hazardous. Where it is necessary or desirable to have objects protrude from the wall, a manner of cane detection must be provided.

Relocate protruding objects or place cane detectable warning or bollard at foot of item
