Site Accessibility Evaluation

SEATS and Secondary Roads

**4810 Melrose Ave
Iowa City, IA 52246**

***Inspection Date: 11/29/2018
Inspector: Shelley Zuniga***

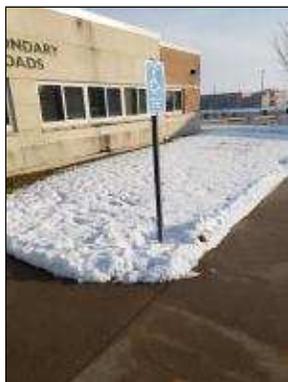
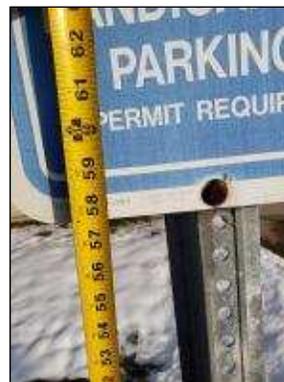
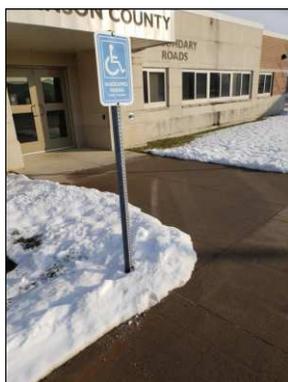
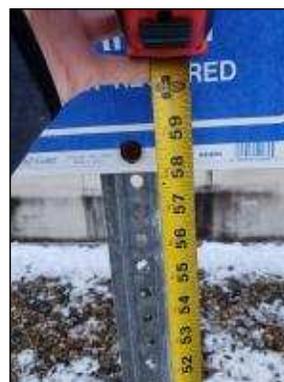
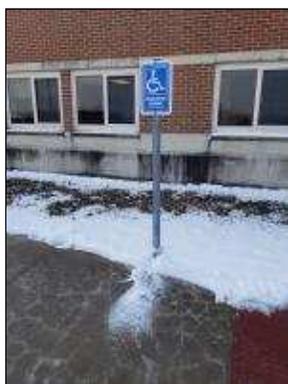
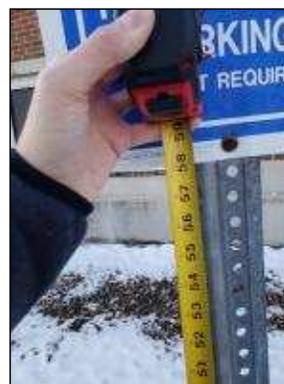
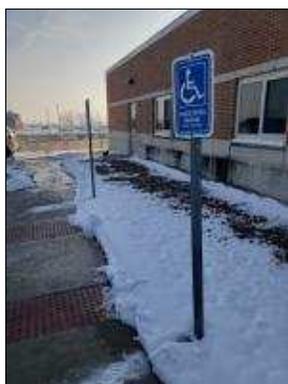
Finding #1 Additional Finding Photos

front- signs fail 54"
and 57"; back- both
58"

Raise existing accessible parking signs so lowest end of bottom sign is min 60" aff

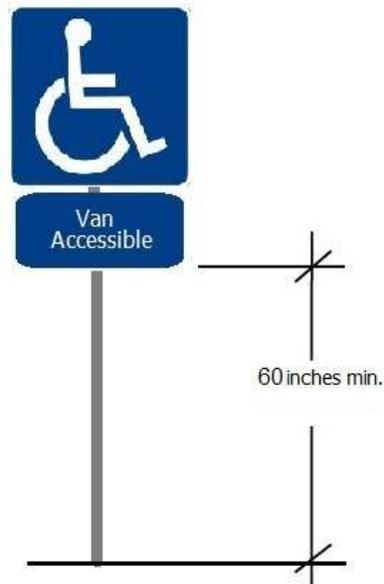
The van stall is missing a sign identifying it as a van accessible stall.

Add one van parking sign to one accessible stall and repaint stall and access aisle to 11' and 5' or 8' and 8' in back lot

Add one van parking sign to van accessible stall and assure stall and access aisle are 11' and 5' or 8' and 8' in front lot

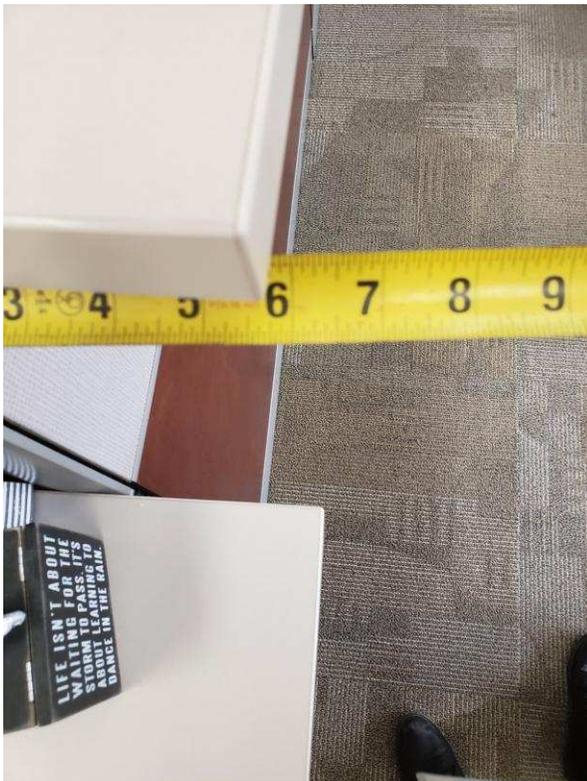
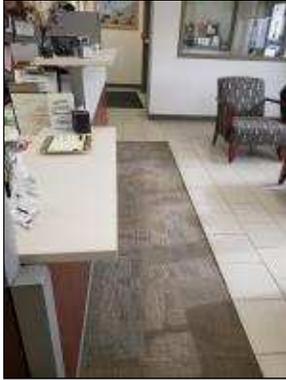
Finding #7 Additional Finding Photos

Wall-mounted objects that have leading edges between 27 inches and 80 inches from the floor must not project more than 4 inches into the circulation path. Protruding objects that extend to the floor or within 27 inches of the floor are cane detectable and are therefore not hazardous. Where it is necessary or desirable to have objects protrude from the wall, a manner of cane detection must be provided.

Relocate protruding objects or place cane detectable warning or bollard at foot of item

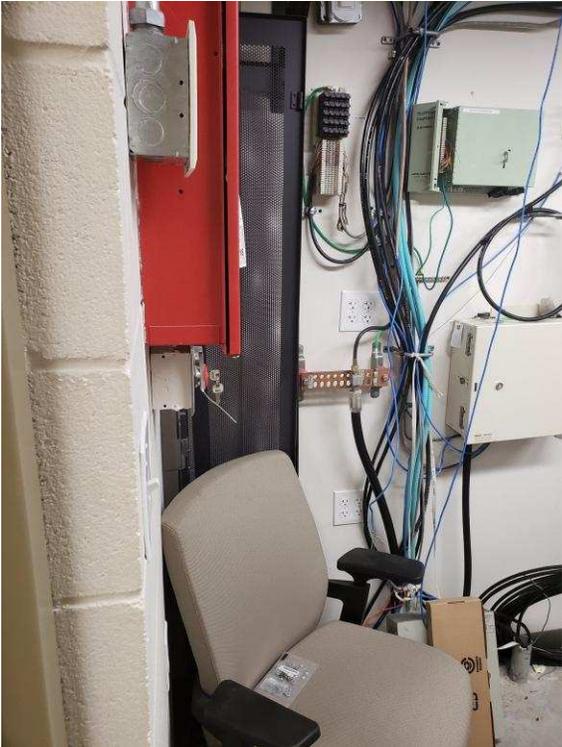
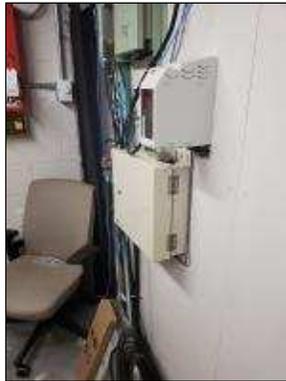
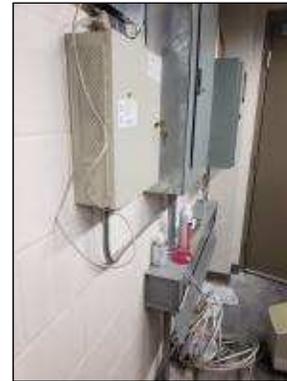
Finding #19 Additional Finding Photos

Wall-mounted objects that have leading edges between 27 inches and 80 inches from the floor must not project more than 4 inches into the circulation path. Protruding objects that extend to the floor or within 27 inches of the floor are cane detectable and are therefore not hazardous. Where it is necessary or desirable to have objects protrude from the wall, a manner of cane detection must be provided.

For deficit, leave as is, employee work area pursuant to 2010 Standards 106.5 Defined Terms, until an employee with a disability works here

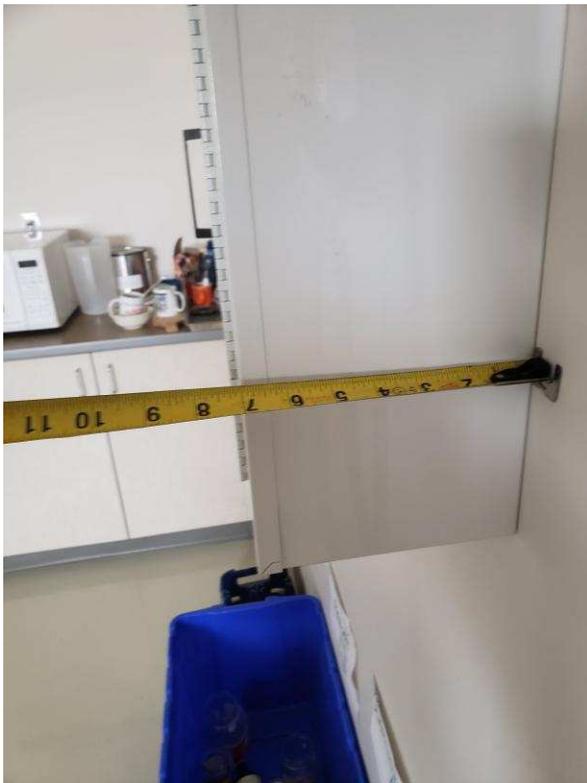
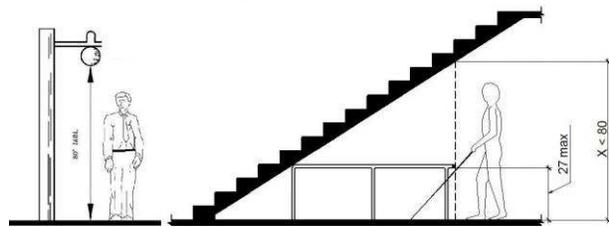
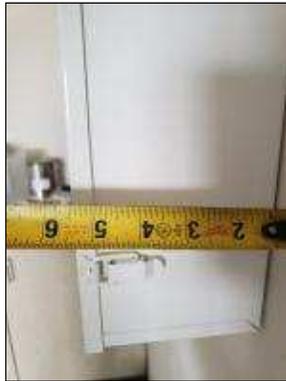
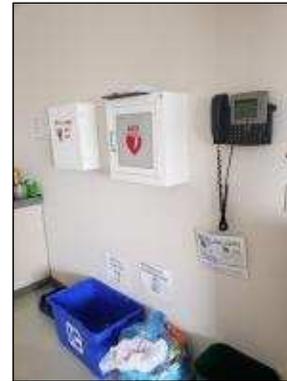
Finding #28 Additional Finding Photos

Wall-mounted objects that have leading edges between 27 inches and 80 inches from the floor must not project more than 4 inches into the circulation path. Protruding objects that extend to the floor or within 27 inches of the floor are cane detectable and are therefore not hazardous. Where it is necessary or desirable to have objects protrude from the wall, a manner of cane detection must be provided.

Relocate protruding objects or place cane detectable warning or bollard at foot of item

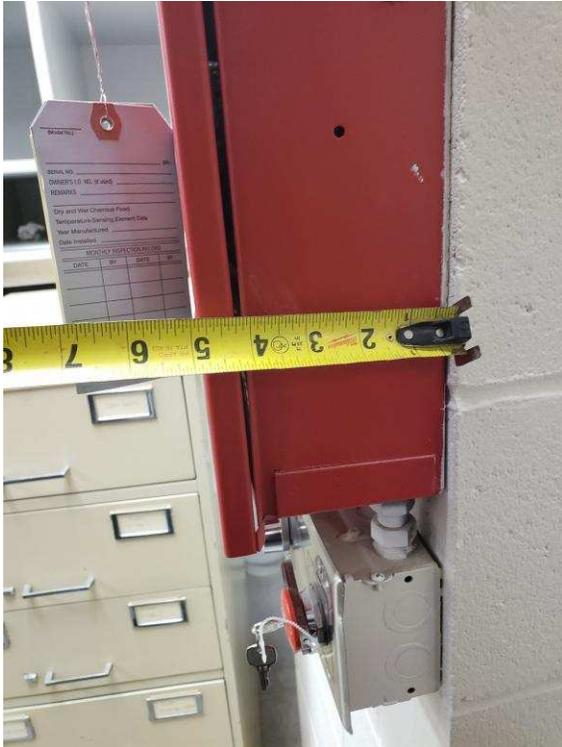
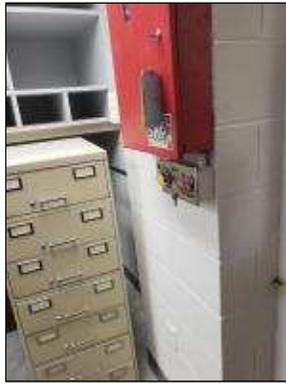
Finding #31 Additional Finding Photos

Wall-mounted objects that have leading edges between 27 inches and 80 inches from the floor must not project more than 4 inches into the circulation path. Protruding objects that extend to the floor or within 27 inches of the floor are cane detectable and are therefore not hazardous. Where it is necessary or desirable to have objects protrude from the wall, a manner of cane detection must be provided.

For deficit, leave as is, employee work area pursuant to 2010 Standards 106.5 Defined Terms, until an employee with a disability works here

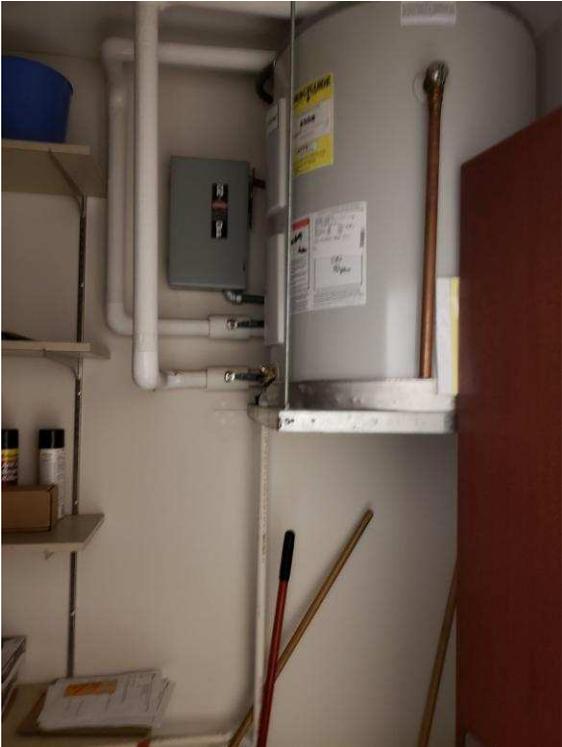
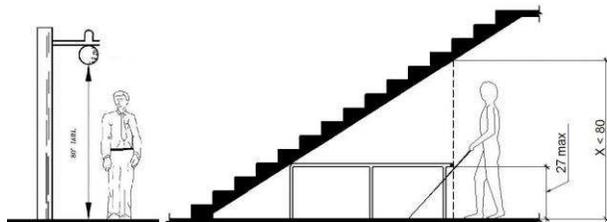
Wall-mounted objects that have leading edges between 27 inches and 80 inches from the floor must not project more than 4 inches into the circulation path. Protruding objects that extend to the floor or within 27 inches of the floor are cane detectable and are therefore not hazardous. Where it is necessary or desirable to have objects protrude from the wall, a manner of cane detection must be provided.

For deficit, leave as is, employee work area pursuant to 2010 Standards 106.5 Defined Terms, until an employee with a disability works here

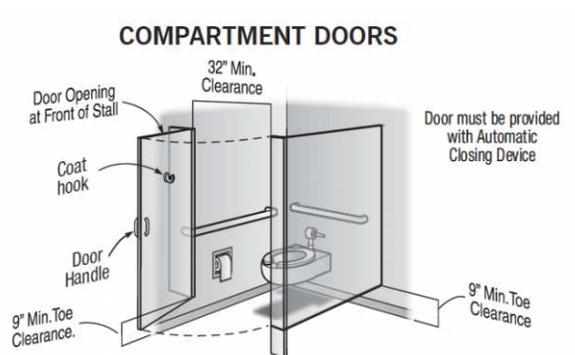
door fails to self-close

Replace or adjust stall door of accessible stall with one that is self-closing

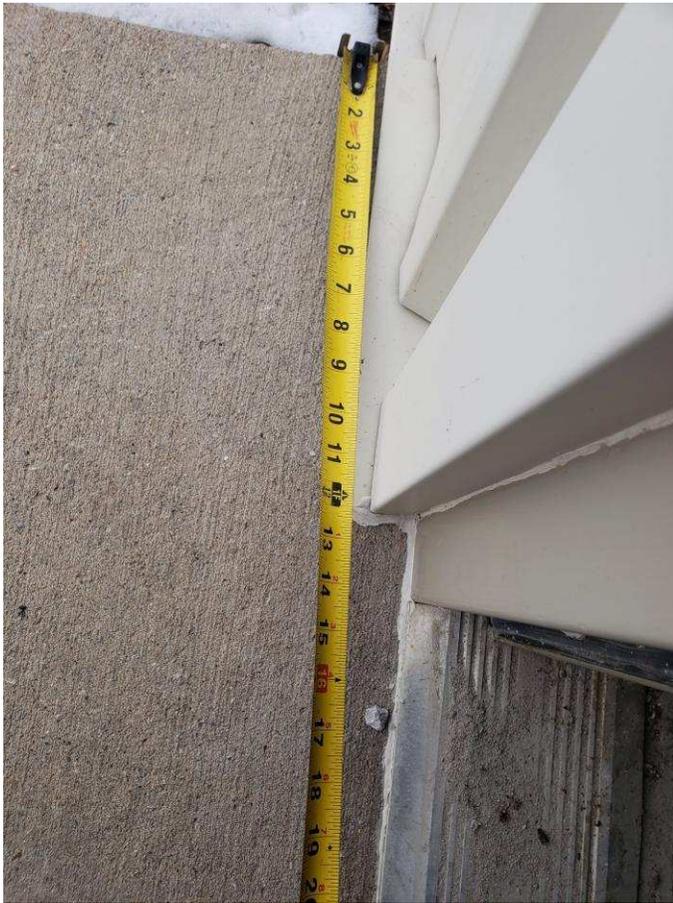
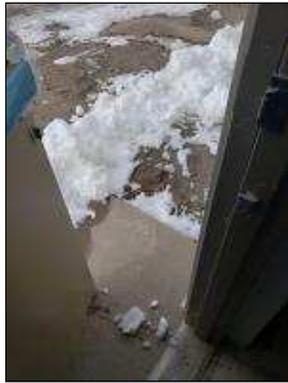
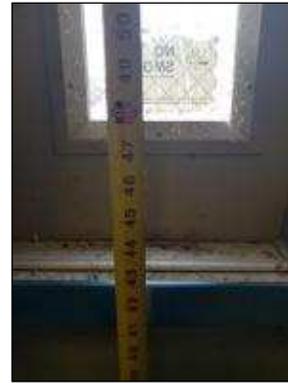
Finding #110 Continued

Exterior doors are recommended to be maintained at 8.5 lbf as a smart practice. Force is to be measured at the operating hardware or 30 inches from the hinges, whichever is greater.

For all doors along the public circulation route, replace doors with ones having sidelight viewing windows max 43" aff

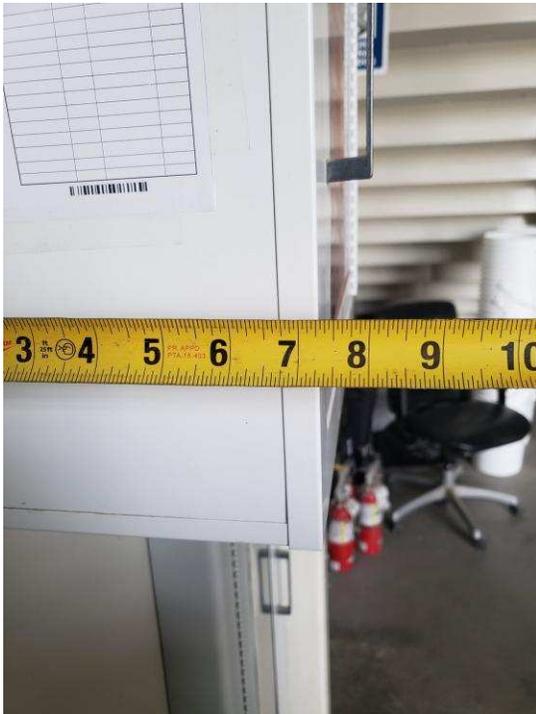
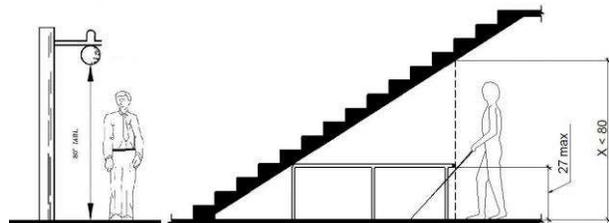
Wall-mounted objects that have leading edges between 27 inches and 80 inches from the floor must not project more than 4 inches into the circulation path. Protruding objects that extend to the floor or within 27 inches of the floor are cane detectable and are therefore not hazardous. Where it is necessary or desirable to have objects protrude from the wall, a manner of cane detection must be provided.

For deficit, leave as is, employee work area pursuant to 2010 Standards 106.5 Defined Terms, until an employee with a disability works here

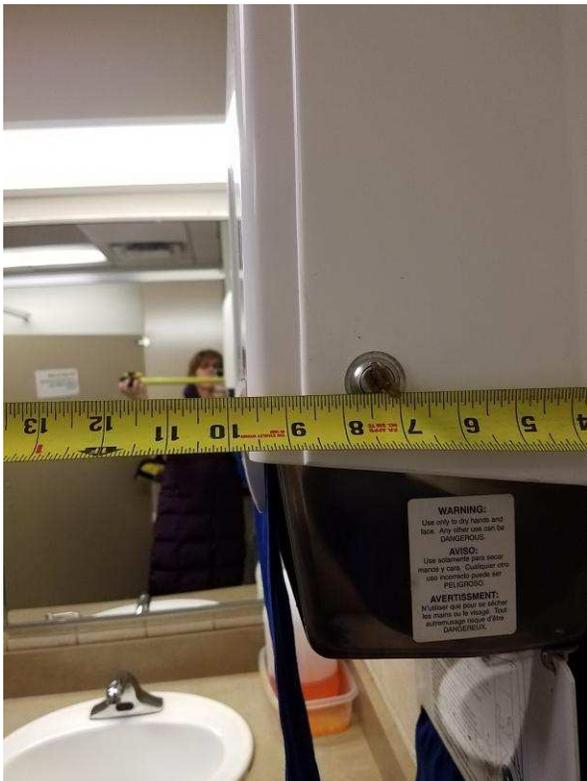
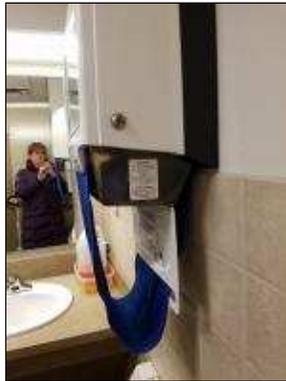
Finding #135 Additional Finding Photos

Wall-mounted objects that have leading edges between 27 inches and 80 inches from the floor must not project more than 4 inches into the circulation path. Protruding objects that extend to the floor or within 27 inches of the floor are cane detectable and are therefore not hazardous. Where it is necessary or desirable to have objects protrude from the wall, a manner of cane detection must be provided.

Relocate protruding objects or place cane detectable warning or bollard at foot of item

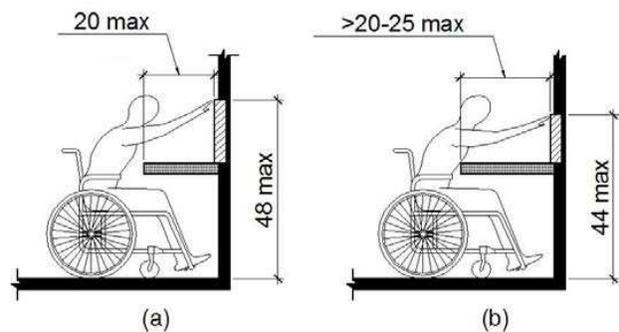
The controls are located such that operation require reaching across burners.

kitchen- stove fails

Replace oven with one having controls on the front panel

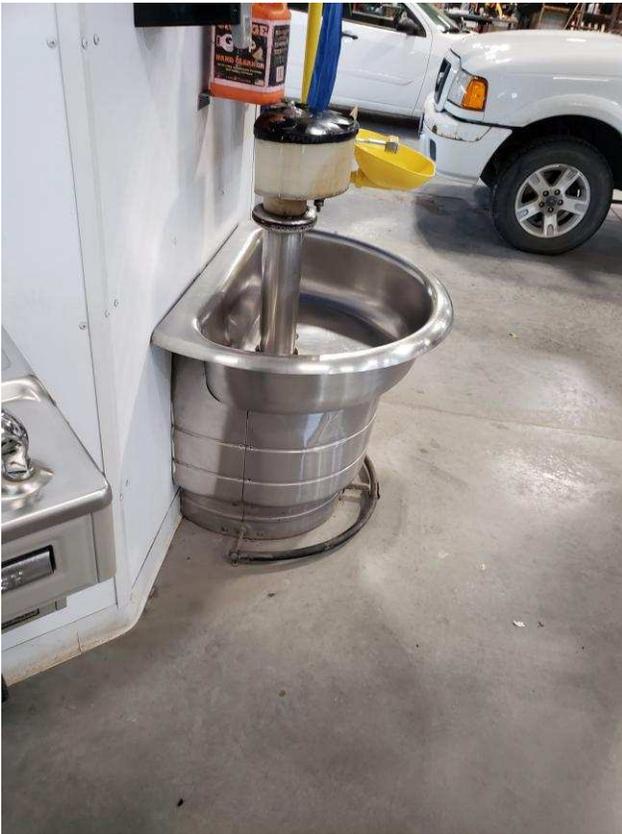
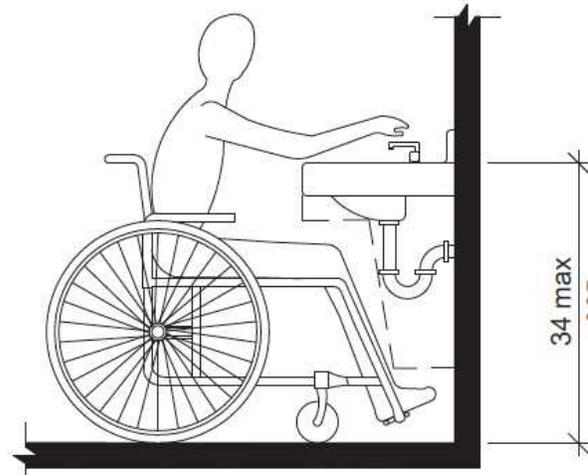
Finding #170 Continued

garage- sink fails, foot push

Recommendation:

For deficit, leave as is, employee work area pursuant to 2010 Standards 106.5 Defined Terms, until an employee with a disability works here

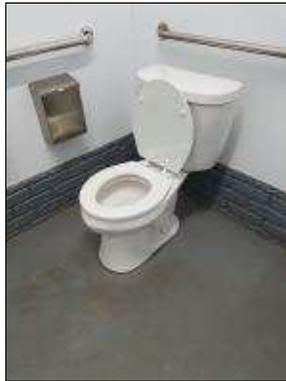
Finding #183 Additional Finding Photos

Fleet Services Restroom

Replace toilet tank with one having flush mechanism on the open side, in the alternative, install an auto flush unit

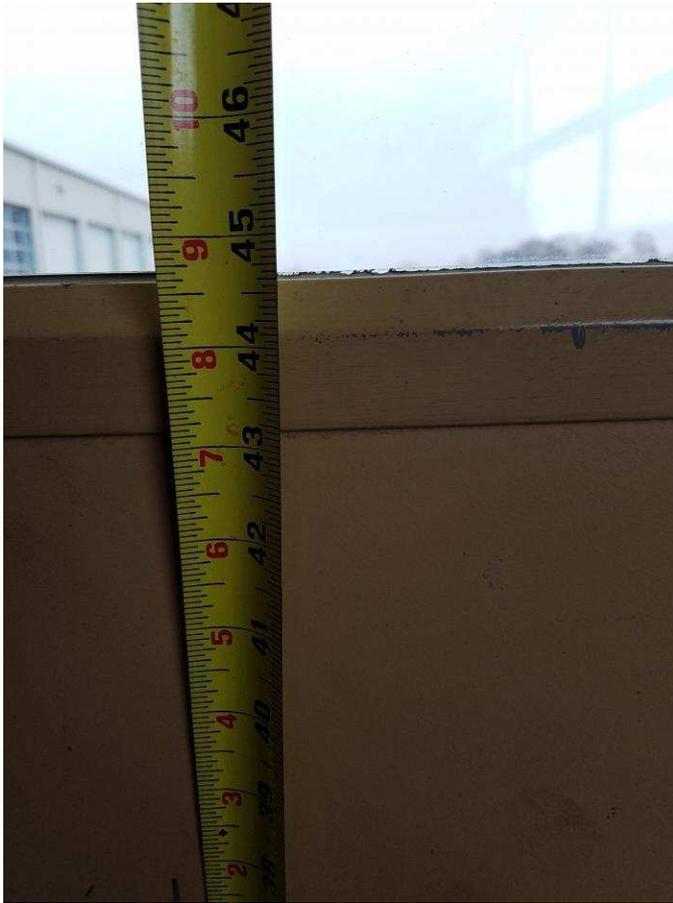
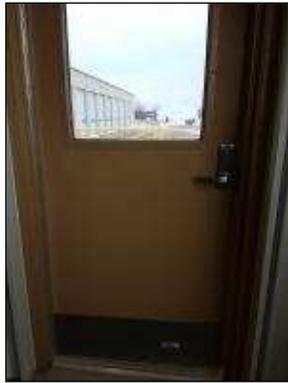
Finding #187 Continued

Secondary Roads Maintenance

Exterior doors are recommended to be maintained at 8.5 lbf as a smart practice. Force is to be measured at the operating hardware or 30 inches from the hinges, whichever is greater.

For all doors along the public circulation route, replace doors with ones having sidelight viewing windows max 43" aff

For all doors along the public circulation route, fill and maintain gaps at doorways to max .5"

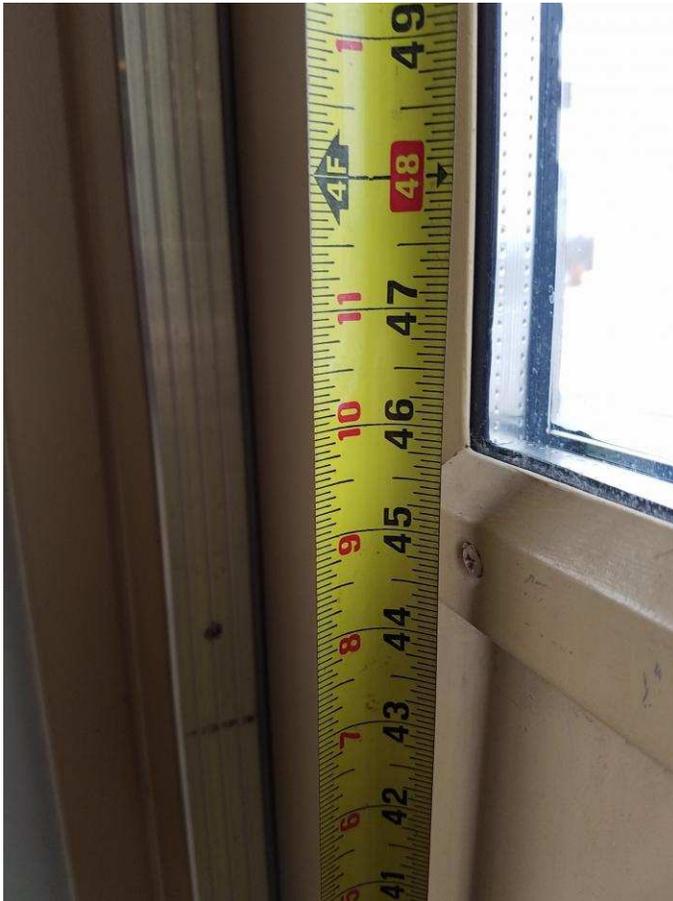
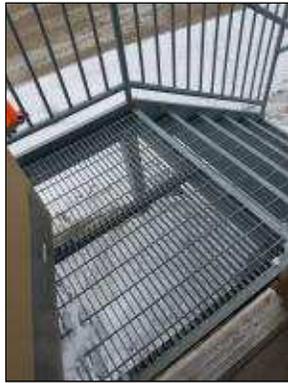
Finding #188 Continued

Secondary Roads Maintenance

Exterior doors are recommended to be maintained at 8.5 lbf as a smart practice. Force is to be measured at the operating hardware or 30 inches from the hinges, whichever is greater.

For all doors along the public circulation route, replace doors with ones having sidelight viewing windows max 43" aff

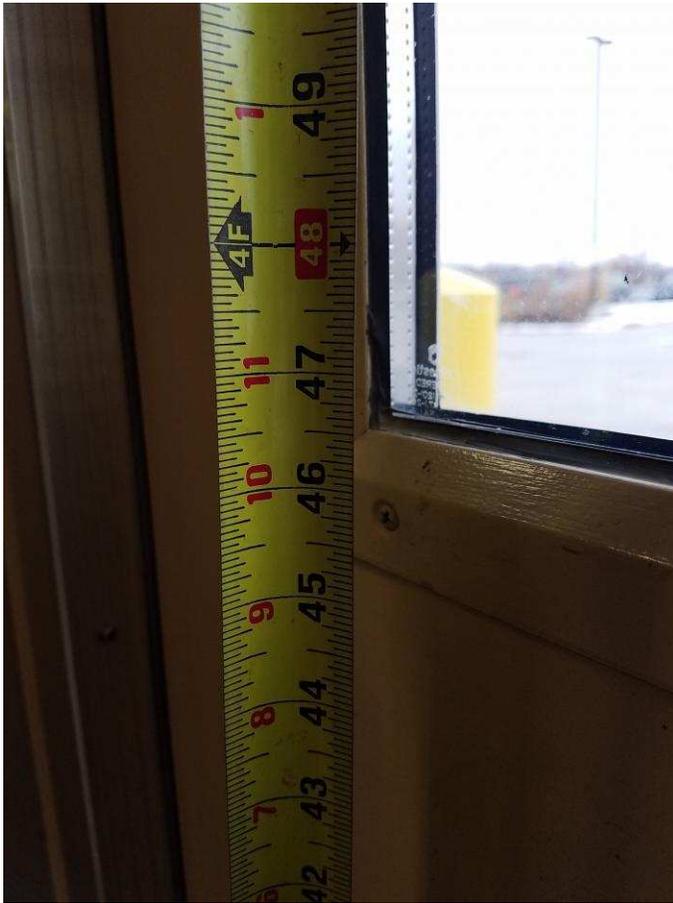
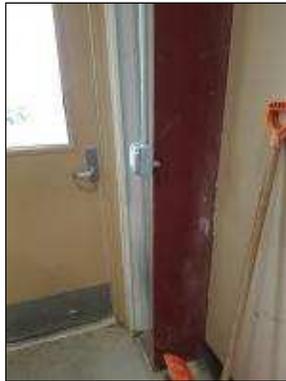
Finding #189 Continued

Secondary Roads Maintenance

For all doors along the public circulation route, inspect, adjust, and maintain 5 lbf to open interior doors

For all doors along the public circulation route, replace doors with ones having sidelight viewing windows max 43" aff

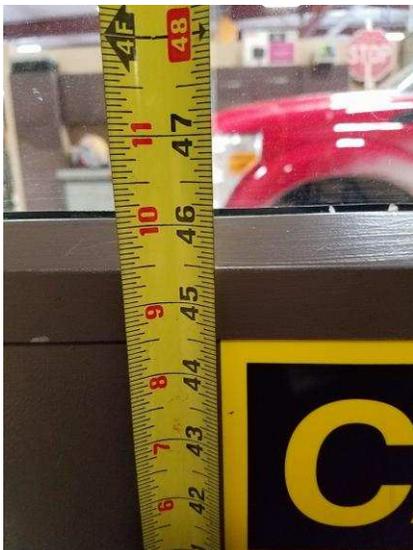
Secondary Roads Maintenance

For all doors along the public circulation route, replace doors with ones having sidelight viewing windows max 43" aff

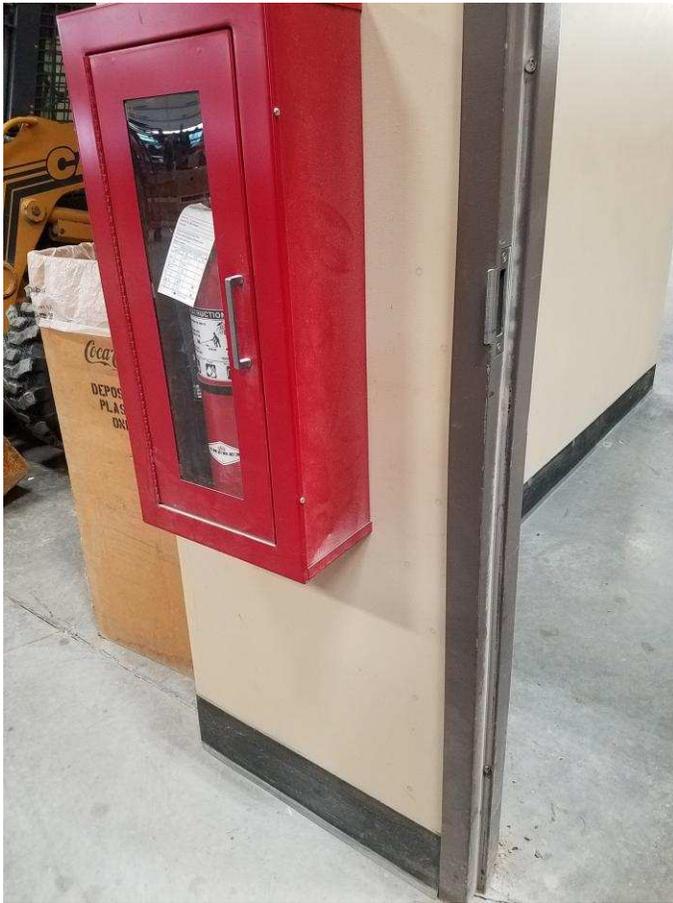
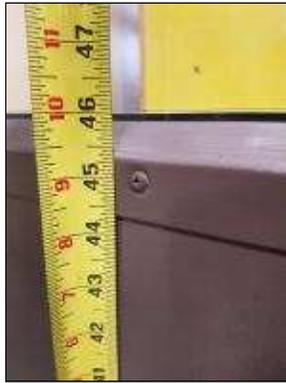
Finding #191 Continued

Secondary Roads Maintenance

For all doors along the public circulation route, provide required maneuvering clearance on push and pull side of doors

For all doors along the public circulation route, replace doors with ones having sidelight viewing windows max 43" aff

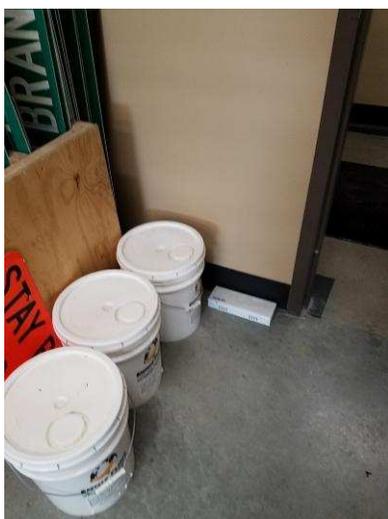
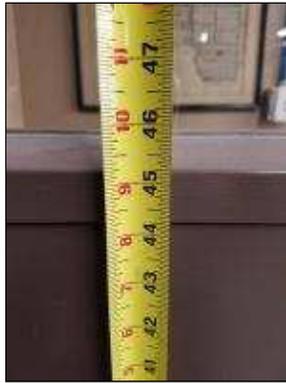
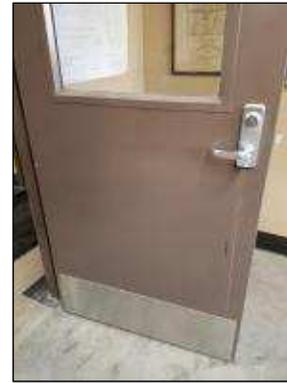
Finding #192 Additional Finding Photos

Secondary Roads Maintenance

For all doors along the public circulation route, provide required maneuvering clearance on push and pull side of doors

For all doors along the public circulation route, replace doors with ones having sidelight viewing windows max 43" aff

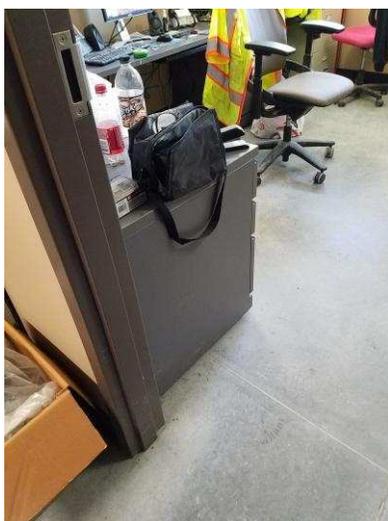
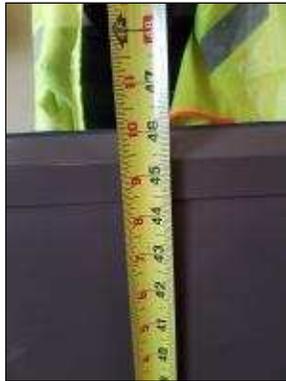
Finding #193 Additional Finding Photos

Secondary Roads Maintenance

For all doors along the public circulation route, replace doors with ones having sidelight viewing windows max 43" aff

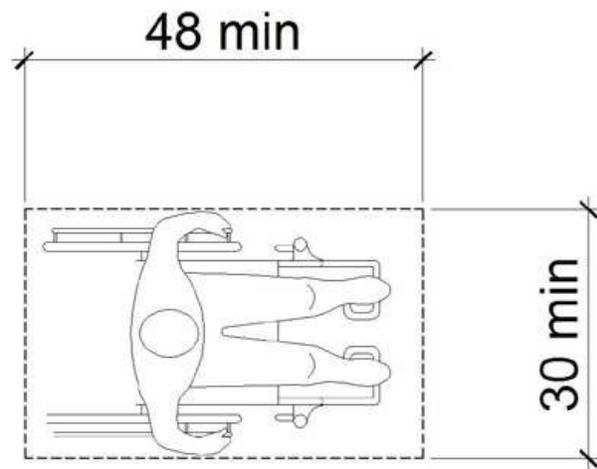
Secondary Roads Maintenance

For all doors along the public circulation route, provide required maneuvering clearance on push and pull side of doors

For all doors along the public circulation route, inspect, adjust, and maintain 5 lbf to open interior doors

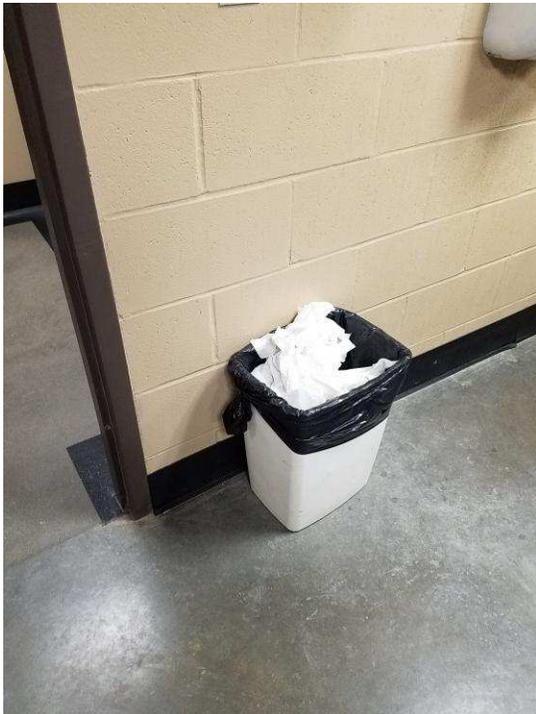
Secondary Roads Maintenance

Exterior doors are recommended to be maintained at 8.5 lbf as a smart practice. Force is to be measured at the operating hardware or 30 inches from the hinges, whichever is greater.

For all doors along the public circulation route, replace doors with ones having sidelight viewing windows max 43" aff

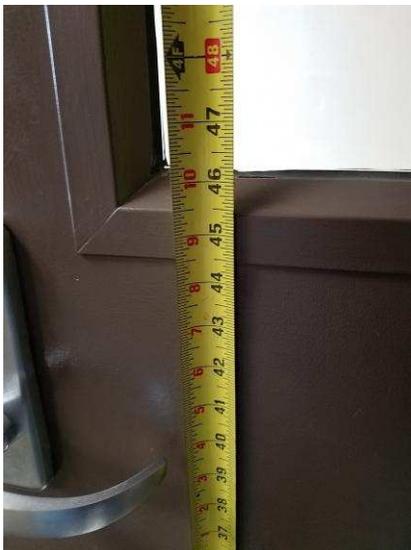
Secondary Roads Maintenance

For all doors along the public circulation route, replace doors with ones having sidelight viewing windows max 43" aff

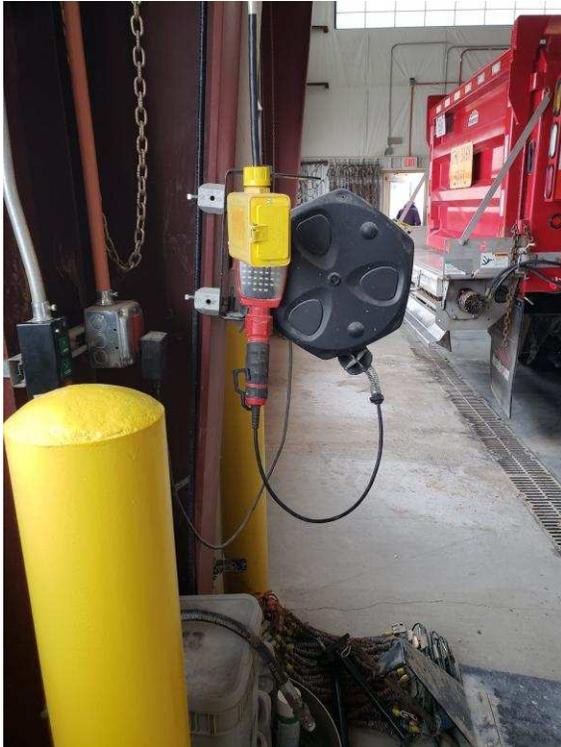
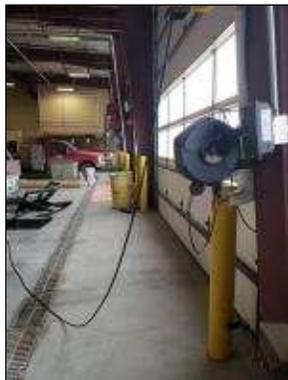
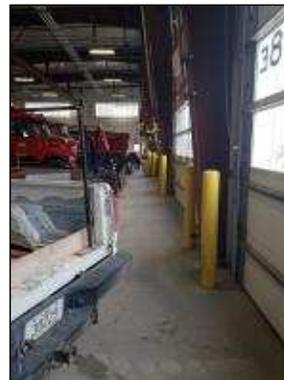
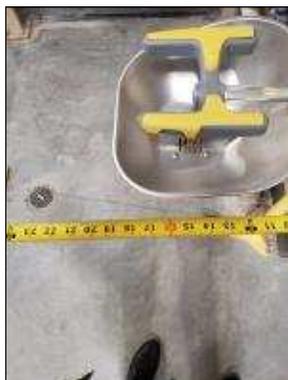
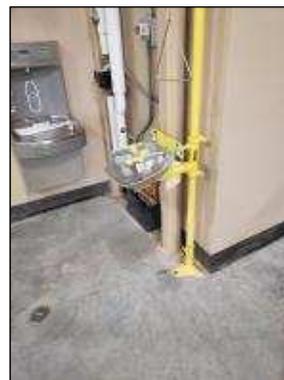
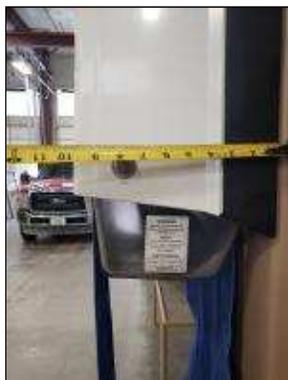
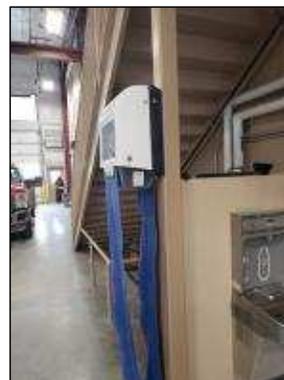
Finding #219 Additional Finding Photos

Wall-mounted objects that have leading edges between 27 inches and 80 inches from the floor must not project more than 4 inches into the circulation path. Protruding objects that extend to the floor or within 27 inches of the floor are cane detectable and are therefore not hazardous. Where it is necessary or desirable to have objects protrude from the wall, a manner of cane detection must be provided.

For deficit, leave as is, employee work area pursuant to 2010 Standards 106.5 Defined Terms, until an employee with a disability works here

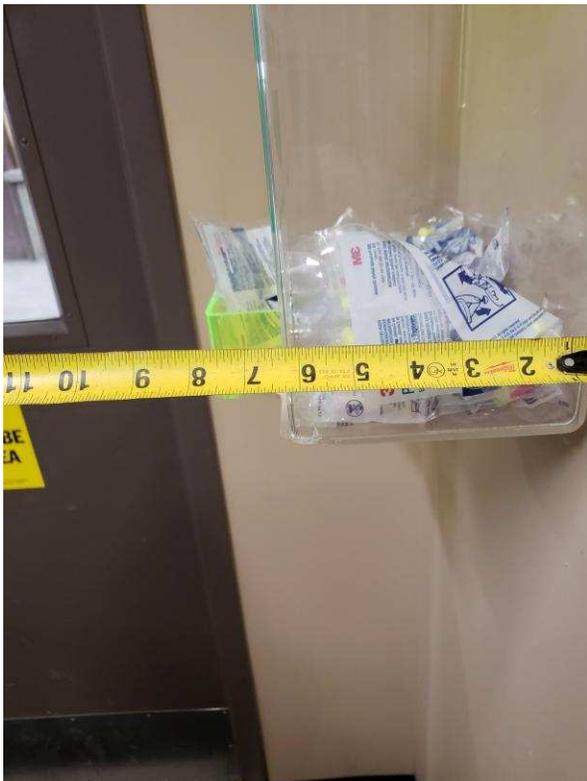
Finding #225 Additional Finding Photos

Wall-mounted objects that have leading edges between 27 inches and 80 inches from the floor must not project more than 4 inches into the circulation path. Protruding objects that extend to the floor or within 27 inches of the floor are cane detectable and are therefore not hazardous. Where it is necessary or desirable to have objects protrude from the wall, a manner of cane detection must be provided.

Relocate protruding objects in corridor or place cane detectable warning or bollard at foot of items listed

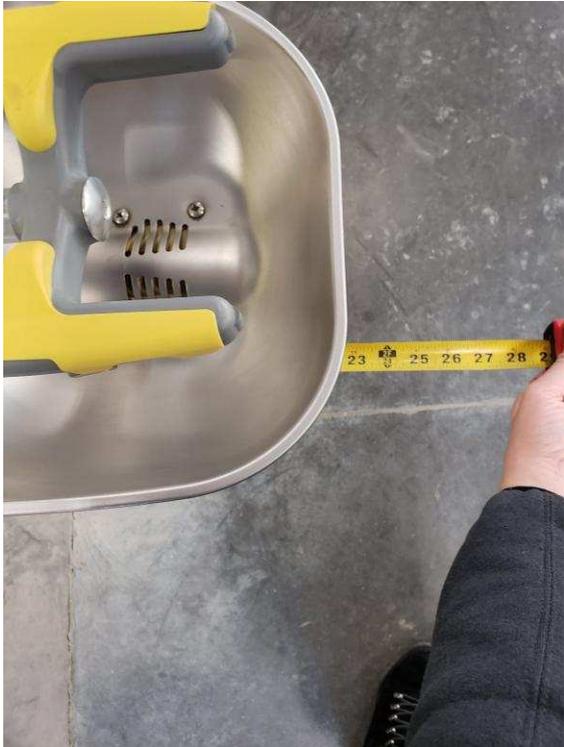
Wall-mounted objects that have leading edges between 27 inches and 80 inches from the floor must not project more than 4 inches into the circulation path. Protruding objects that extend to the floor or within 27 inches of the floor are cane detectable and are therefore not hazardous. Where it is necessary or desirable to have objects protrude from the wall, a manner of cane detection must be provided.

For deficit, leave as is, employee work area pursuant to 2010 Standards 106.5 Defined Terms, until an employee with a disability works here

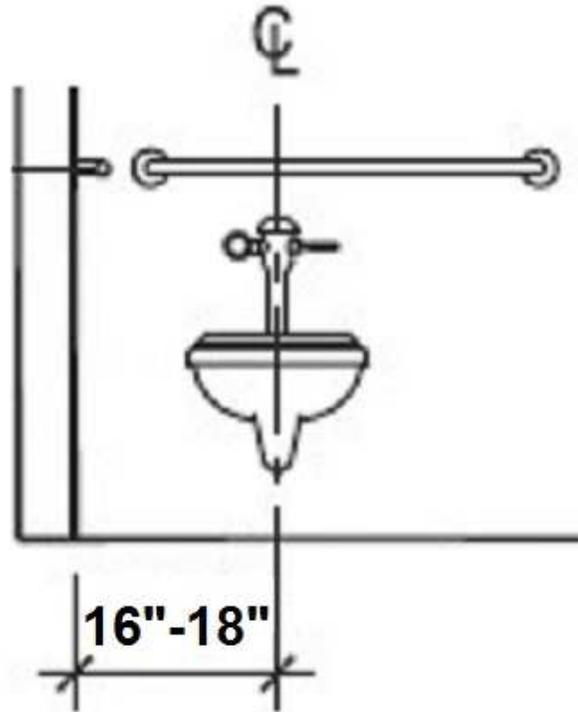
Center line of toilet is 18.75" from wall, should not exceed 18", leave as is citing construction tolerance

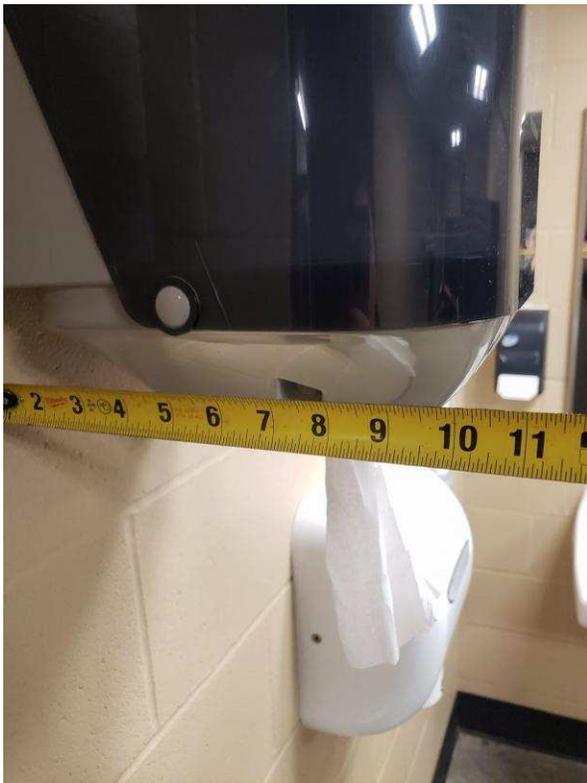
Wall-mounted objects that have leading edges between 27 inches and 80 inches from the floor must not project more than 4 inches into the circulation path. Protruding objects that extend to the floor or within 27 inches of the floor are cane detectable and are therefore not hazardous. Where it is necessary or desirable to have objects protrude from the wall, a manner of cane detection must be provided.

Relocate protruding objects or place cane detectable warning or bollard at foot of item

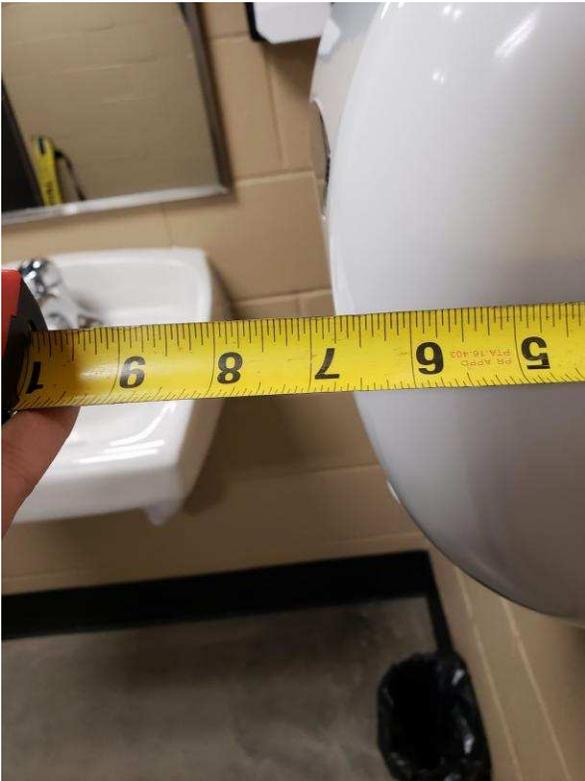
Wall-mounted objects that have leading edges between 27 inches and 80 inches from the floor must not project more than 4 inches into the circulation path. Protruding objects that extend to the floor or within 27 inches of the floor are cane detectable and are therefore not hazardous. Where it is necessary or desirable to have objects protrude from the wall, a manner of cane detection must be provided.

Relocate protruding objects or place cane detectable warning or bollard at foot of item

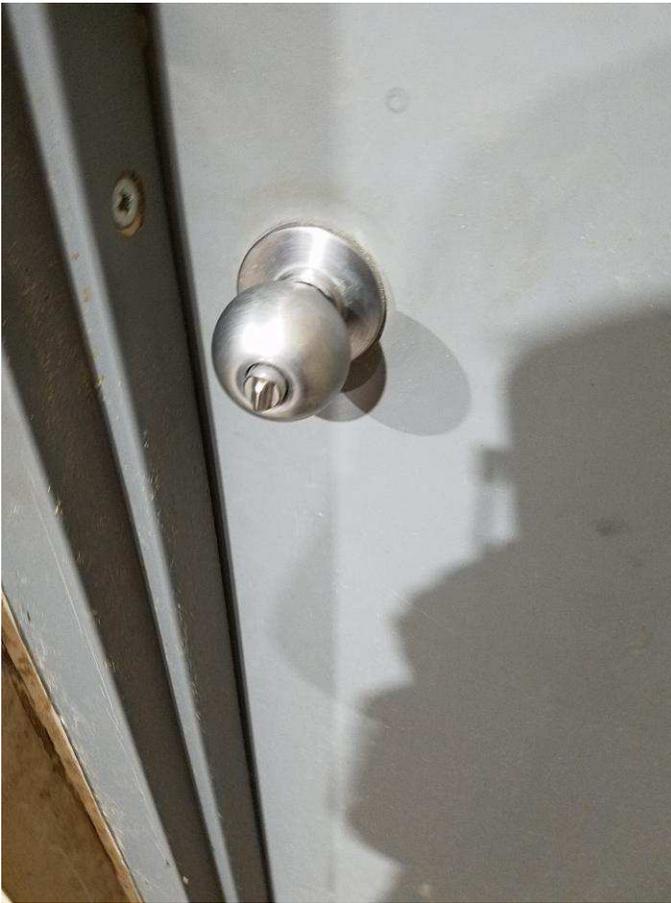
Finding #271 Continued

Exterior doors are recommended to be maintained at 8.5 lbf as a smart practice. Force is to be measured at the operating hardware or 30 inches from the hinges, whichever is greater.

For all doors along the public circulation route, replace hardware with lever hardware or hardware operable without a tight pinch or grasp

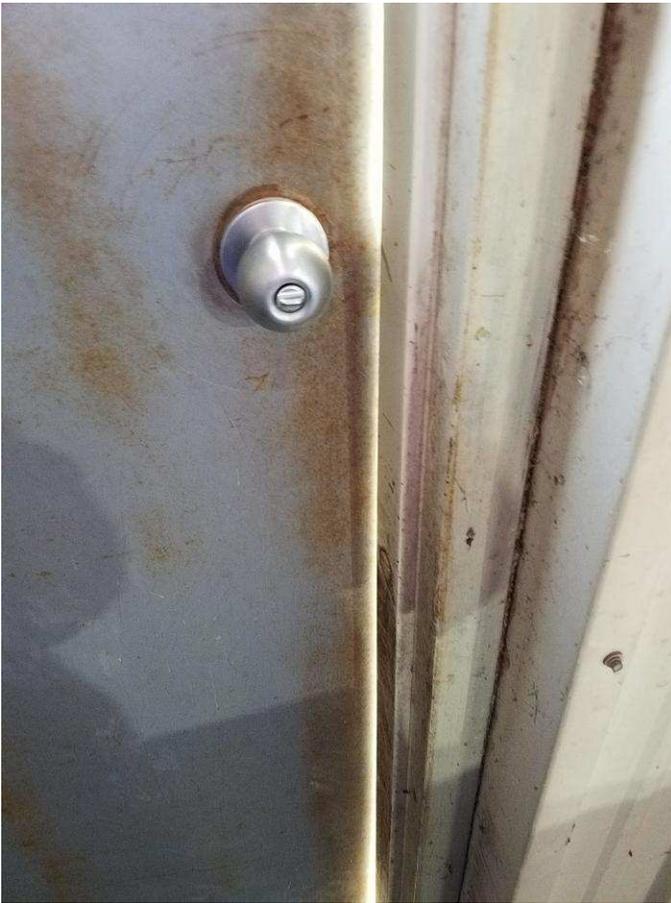
Finding #272 Continued

Exterior doors are recommended to be maintained at 8.5 lbf as a smart practice. Force is to be measured at the operating hardware or 30 inches from the hinges, whichever is greater.

For all doors along the public circulation route, replace hardware with lever hardware or hardware operable without a tight pinch or grasp

For all doors along the public circulation route, replace doors with ones having sidelight viewing windows max 43" aff

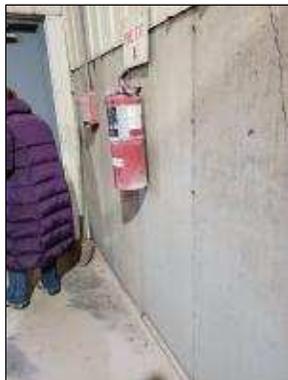
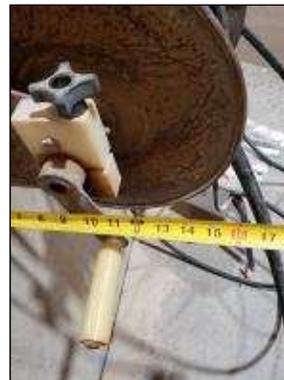
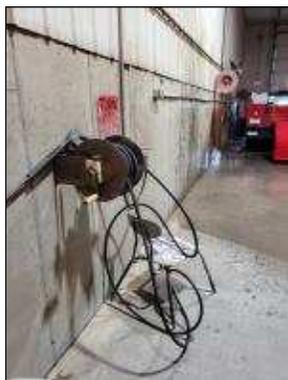
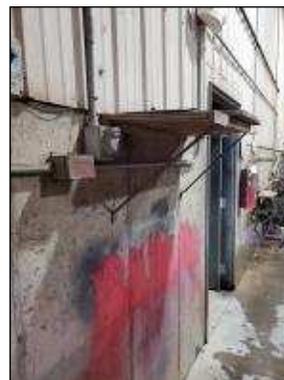
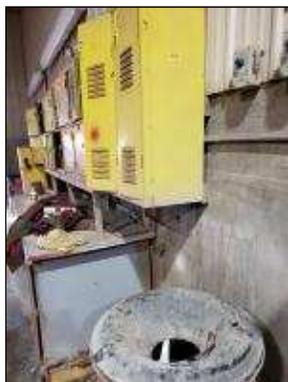
Finding #274 Additional Finding Photos

Wall-mounted objects that have leading edges between 27 inches and 80 inches from the floor must not project more than 4 inches into the circulation path. Protruding objects that extend to the floor or within 27 inches of the floor are cane detectable and are therefore not hazardous. Where it is necessary or desirable to have objects protrude from the wall, a manner of cane detection must be provided.

For deficit, leave as is, employee work area pursuant to 2010 Standards 106.5 Defined Terms, until an employee with a disability works here

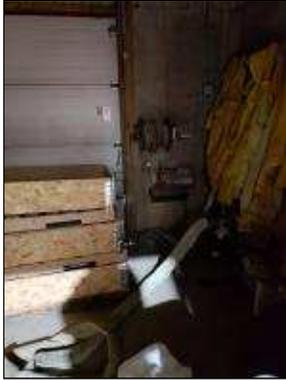
Finding #275 Additional Finding Photos

Wash Bay

For deficit, leave as is, employee work area pursuant to 2010 Standards 106.5 Defined Terms, until an employee with a disability works here
